# Building Survey

XXXXXXXXXXXX  
XXXXXXXXXXXX

**Date of Inspection:** 12/09/2011

**Job reference:** AA0000

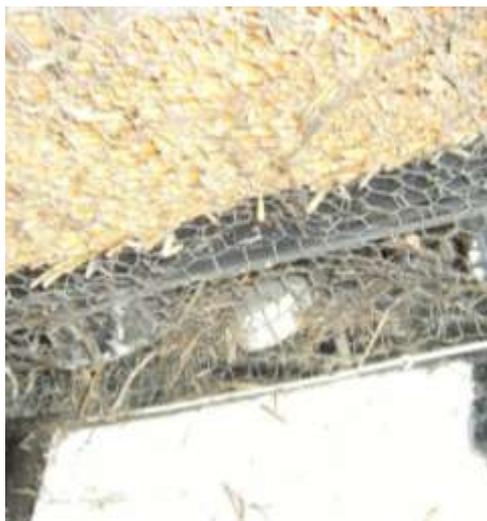
The main entrance door is to the left-hand side of the front elevation and no cracking was evident around the door. The door requires minor works as paint is flaking from the bottom and the frame is rotten at both bottom edges. An electrical connection was noted behind the wire netting which appears dangerous and is not an external connector (fig. 3).

**Figure 3: Electrical connection**

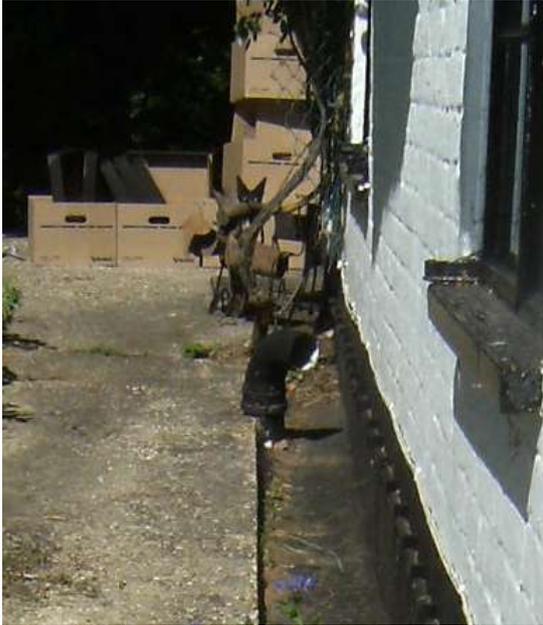
A vent pipe to the drainage system terminates beneath the second ground floor window, and leads into what appears to be a painted or bitumen lined gulley trough extending the full width of the property (fig. 4). This pipe contravenes current regulations as it should terminate at least 900mm above an opening window, if the window is within 3 meters of the pipe.

**Figure 4: Vent pipe and trough**

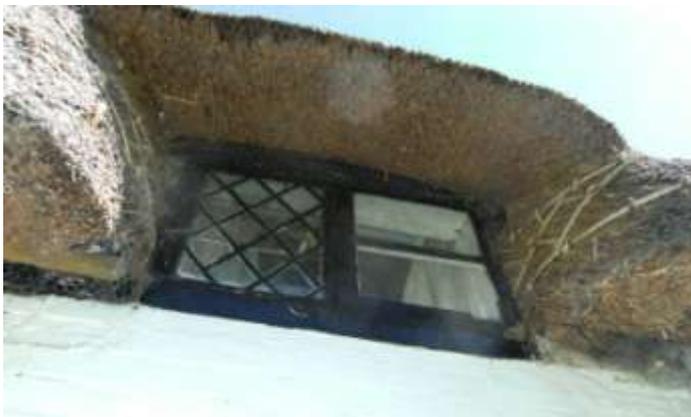
The windows are metal crittall windows and although old they are in reasonable condition. There is a shallow arch above the second ground floor window, with no cracking noted within the brickwork. The first floor window is beneath eyebrow straw covered dormor and has exposed timber beams, and is in reasonable condition for its age (fig. 5). The paintwork has flaked off the timber beams and cannot be repainted due to wire netting.

**Figure 5: First floor window**

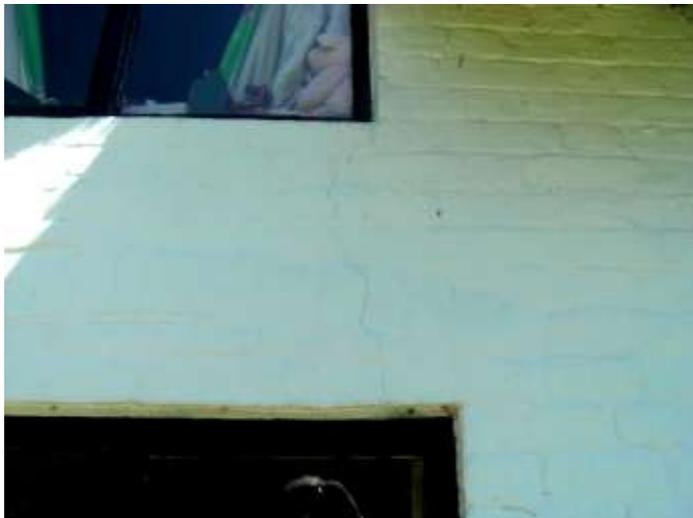
There is a 1mm wide hairline crack above the second ground floor window, up to the first floor window, which appears to be due to thermal movement (fig. 6). In addition, the ground floor window cill requires attention due to flaking paint.

**Figure 6: Hairline crack**

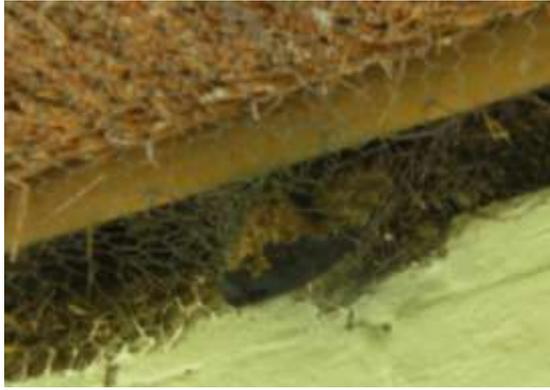
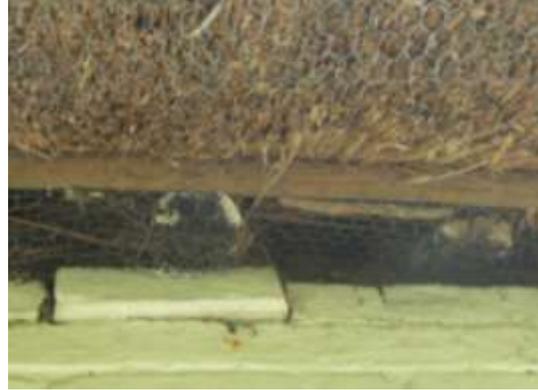
The right-hand cottage has the appearance of being older, with tree trunk rafters sticking through the wall plate beneath the thatch. In common with the left-hand cottage, the ends of some of the rafters were noted to be worm eaten and rotten (fig. 7). On the left-hand side of the property the thatch extends downwards to ground floor ceiling height with extended rafter feed. Here too, worm attack and rotten rafters were noted (fig. 8).

**Figure 7: Some rafters are rotten**

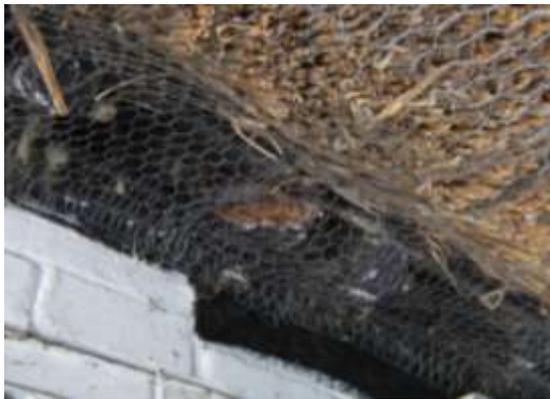
**Figure 8: Some additional rafters are rotting**

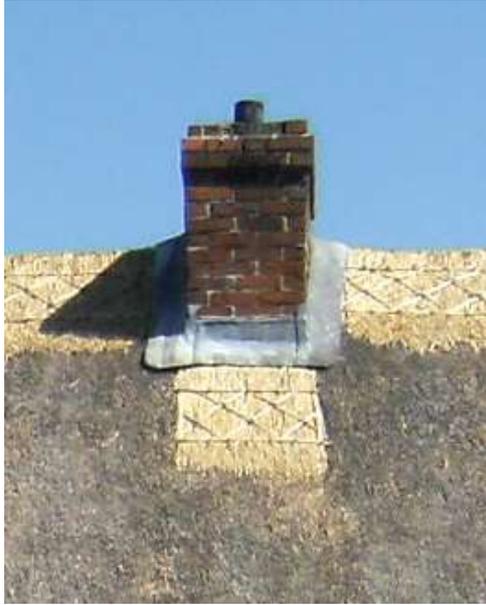
Figure 9: Chimney

Chimneys are to both ends of the property, appearing of some age, with the right-hand chimney spreading towards the top. There is no structural damage to the chimneys. The chimneys are flashed with lead to the thatch, which is acceptable, however it would normally be carried out with cement mortar on thatched properties (fig. 9).

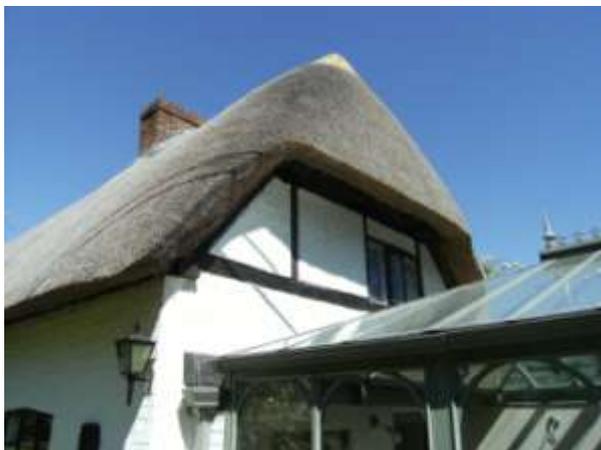
Figure 10: Conservatory

The right-hand gabled elevation is partly covered by the conservatory. The area that could be seen above the conservatory has half timber framing, with 100mm wide brick infill. The timber appears in reasonable condition. No cracking was noted within the brickwork. However, again the window is exceptionally old, appearing to have leaded lights with two of the lights broken. Where the conservatory has been added, there is a proprietary valley which drains to a hopper head, which enters a gully at floor level. The conservatory is of recent origin, having dwarf brick walls and timber glazed panels above. No distortions or damage were noted to the conservatory area (fig. 10).

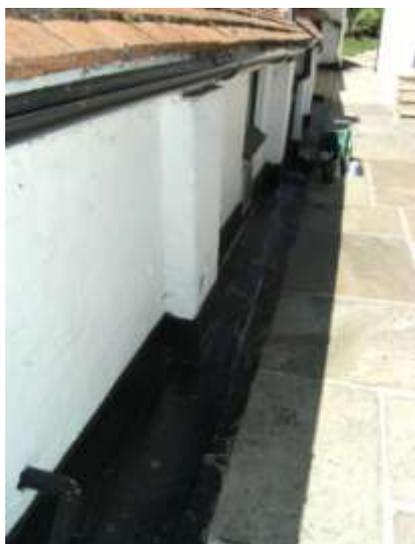
Figure 11: Gutter

There is a bitumen coated gulley area to the rear of the single-storey projection, extending to gulley outlets at either end. The gulley outlets require minor repointing. The gutter requires more brackets, as it was bowing (fig. 11).

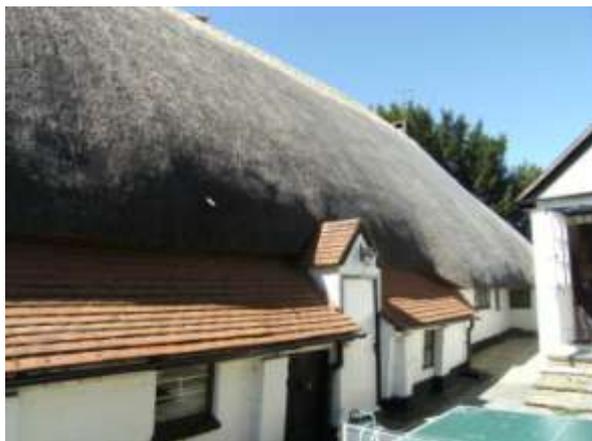
Figure 12: Rear projection

To the left-hand side of the rear elevation there is a further rear projection, constructed in 225mm wide brickwork. Here, the thatch extends down to approximately 1.2m above ground level (fig. 12).

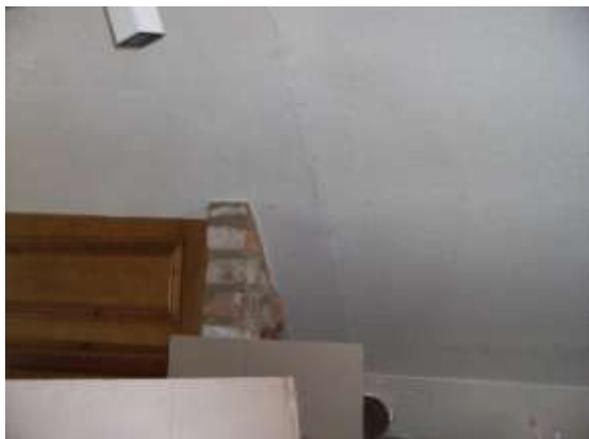
There is a shower room to the rear of the study, within the rear extended roof section (noted previously) to the left-hand side of the rear elevation. This gives a sloping ceiling area to the rear, where splits were noted on plasterboard joints (fig. 13). The ceiling is also finished with a woodchip paper. The timber planking to the floor continues into the room. The rear wall is finished with ceramic tiles along with the right-hand wall around the shower cubicle. No significant structural defects are evident within the room.

**Figure 13: Splits in plasterboard**

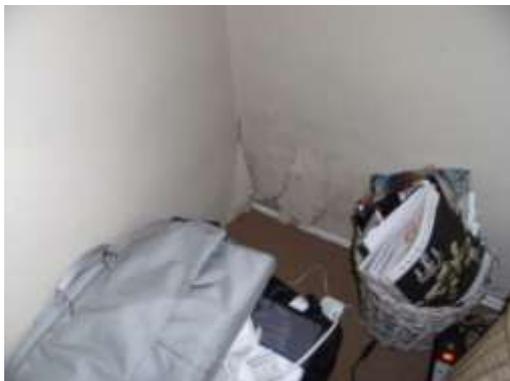
Figure 16: Evidence of damp in the lounge

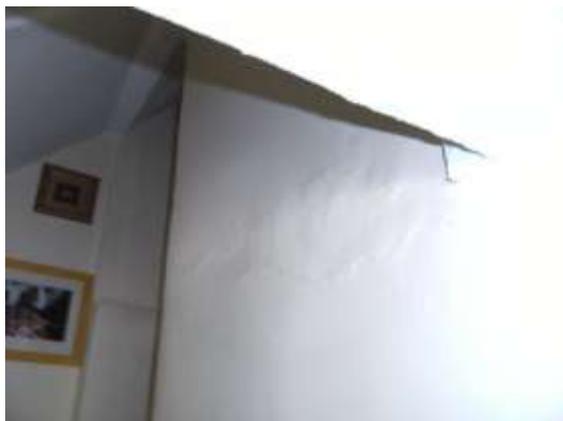
To the rear of the lounge area is a lobby with a stairway to first floor that extends against the rear wall and up to the front of the property. The rear wall is half brick thick, 100mm wide. A plaster repair has been carried out to the front wall on the right-hand side by the stairway (fig. 18). However, no new distortions are evident in that area. The ceiling again has an Artex finish. There are exposed cables down the wall to plug sockets. The lower area below ground level of the rear wall has been thickened to 225mm thick.

**Figure 18: Plaster repair**

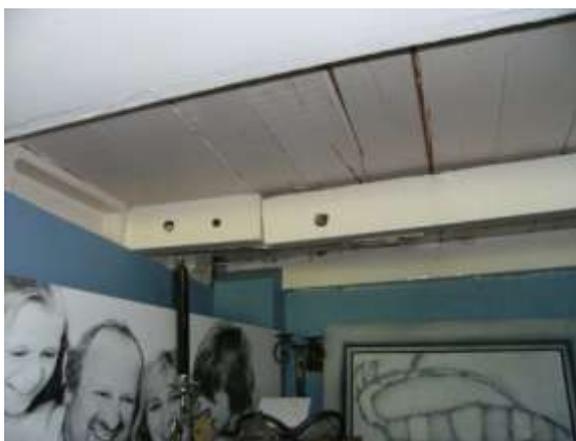
The floorboards to the first floor room above the music room are showing to the rear of the room and a spliced floor joist was noted, which has only been finished with one bolt to the right-hand side, giving a distortion on the splicing (fig. 21). This splicing requires amendment.

**Figure 20: Spliced floor joint**

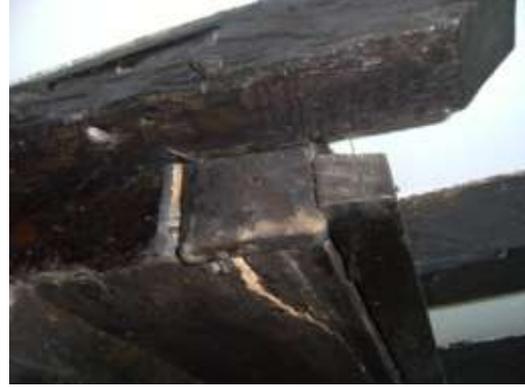
Figure 22: Damage to the stairway

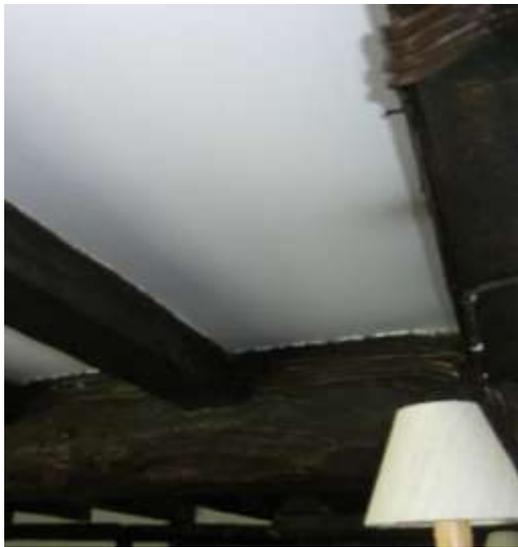
Figure 23: Exposed cables

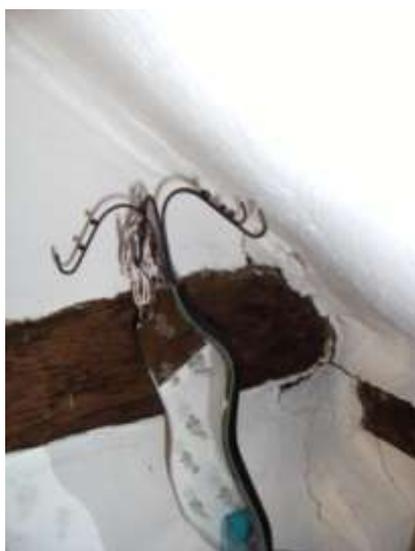
The right-hand rear lobby staircase leads up directly into the left-hand bedroom of the original right-hand cottage, again having a beamed ceiling with beams to the walls. This is the master bedroom. The first floor external wall appears to be 100mm thick, constructed within the timber beams which are slight out of verticality. A separation joint was noted within the front right-hand corner, indicative of some slight lateral spread, which probably occurred when the property was re-thatched (fig. 29).

**Figure 28: Separation joint in left-hand bedroom**

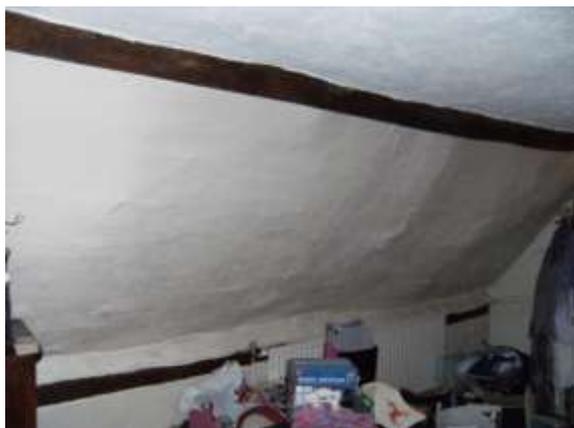
The right-hand bedroom extends the full depth of the property, and is accessed off the middle bedroom. Again, the room is partially within the roof space, with no lateral tiling of the bottom of the rafter legs. Part of the ceiling appears to be collapsing (fig. 30).

**Figure 29: Collapsing ceiling**

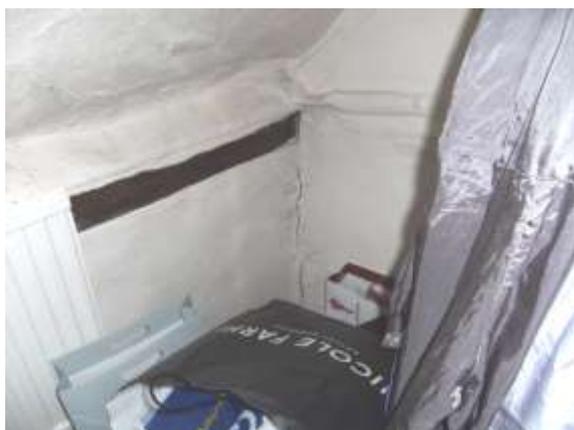
A separation joint which mirrors that which was noted within the left-hand bedroom is evident where the dividing wall met the front wall, indicating some slight lateral spread (fig. 31). This cracking however does have an aged appearance, being dark in colour with dirt and debris within the crack.

**Figure 30: Separation joint in right-hand bedroom**

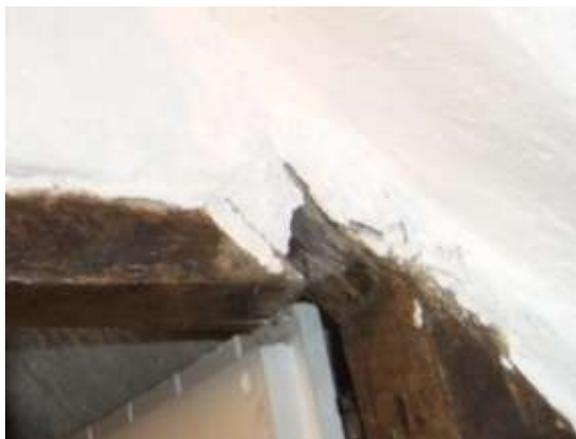
**Figure 31: Dropped door head**

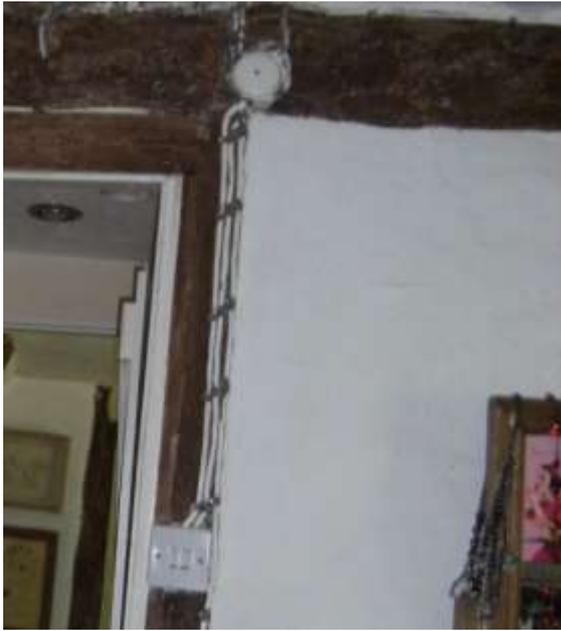
Figure 33: Exposed electrical cables

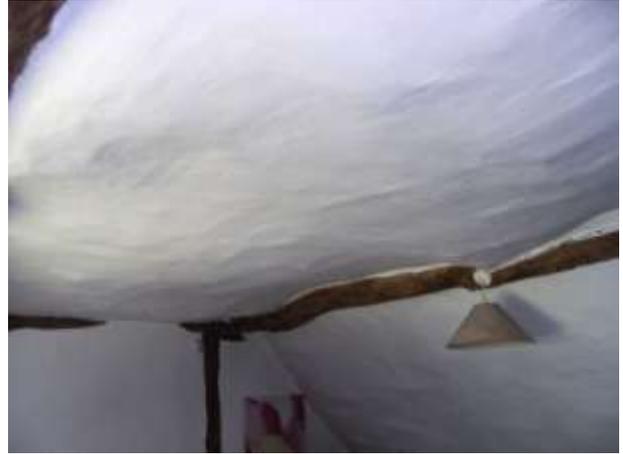
The left hand bedroom again has severe distortions to both ceilings and walls, with exposed purlins evident within the ceiling area (fig. 33). Beams are also evident within the left and right-hand walls. The ceiling joists are tree branches, along with the rafters. Consequently, the lath and plaster has followed the branches, which over the years have distorted, causing the distortions to both ceiling and walls. No current cracking is evident within the ceiling area. However, some of the plaster sounds hollow. Again, extensive exposed electric cables were noted nailed to the walls (fig. 34). Old cracking is evident at the junction of the front wall with the right-hand dividing wall of the right-hand bedroom of the left-hand cottage (fig. 35). Again, this appears to be some old lateral spread, more than likely having occurred at the time the property was re-thatched. The raised window with the eyebrow thatching over is to the front of the room, where a valley type construction is evident either side of the window. This is not evident externally, as the thatch gently follows the rise in the roof.

Figure 32: Distorted ceiling

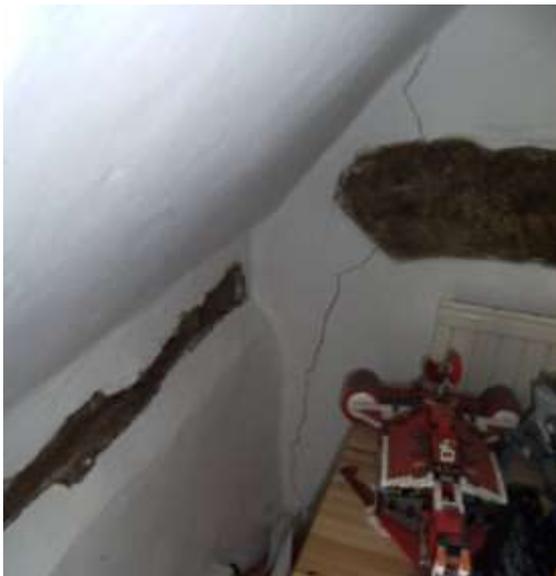
Figure 34: Crack in wall

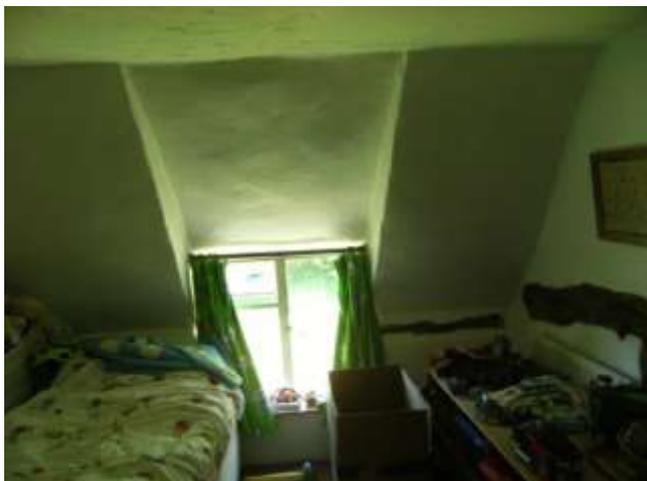
The right-hand bedroom within the left-hand cottage again has a window slightly within the roof space, with the roof surface slightly raised, which again was not noted externally due to the gentle sloping of the thatch (fig. 36). The cracking noted within the front left-hand bedroom against the front wall and separating wall is evident. However it has an aged appearance, being dark in colour with dirt and debris within the crack, and indicating some slight lateral spread in the past. Again,

ceiling and walls have distortions in the plasterwork, along with the floor, due to the distortions on the beamed rafters.

**Figure 35: Window within roof space**

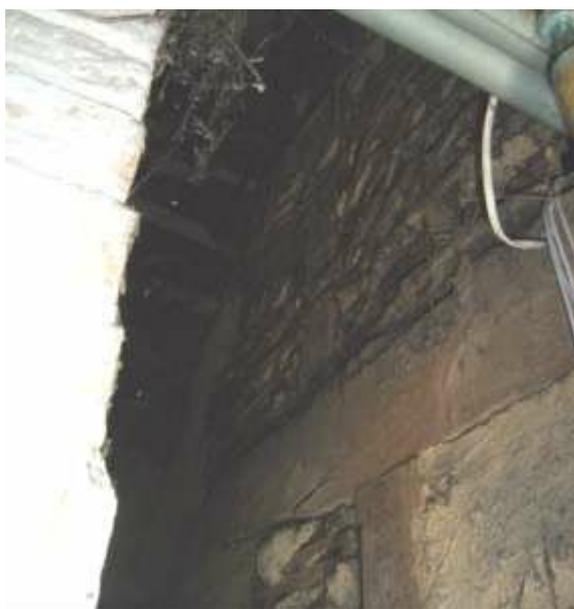
The separating wall between the two sections of the roof space is wattle and daub (fig. 38). It has been known for wattle and daub to contain anthrax spores which can last in excess of 600 years consequently we would advise that the wattle and daub is tested to confirm it is safe.

**Figure 37: Wattle and daub**

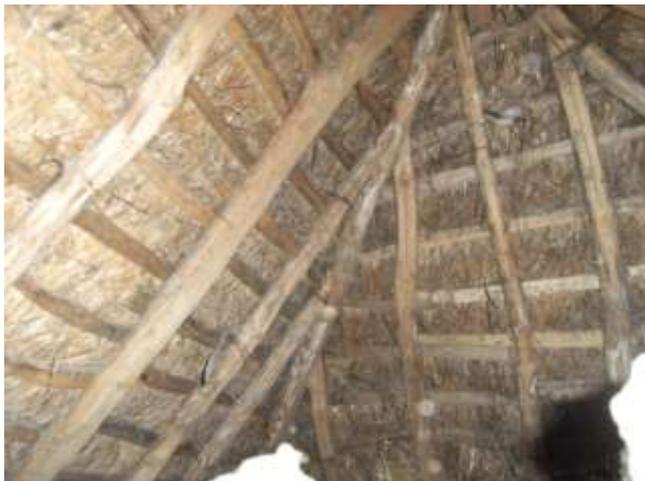
The right-hand bedroom roof space is accessed via an observation hatch in the ceiling, and has similar distortions as that in the other roof spaces (fig. 40).

**Figure 39: Right-hand bedroom roof space**
