Structural Report

The roof at the property known as

In accordance with instructions received from Ms. R. Clive on 25th January 2011 we have been asked to carry out a Specific Structural Inspection on the cracking above windows and around wall heads at first floor level at the property known as 37 Hillyfield Road, Marsh Hill, Birmingham B23 7HB. The inspection was carried out on Wednesday 26th January 2011. All comments are based on visual inspection only and no opening up of areas was carried out.

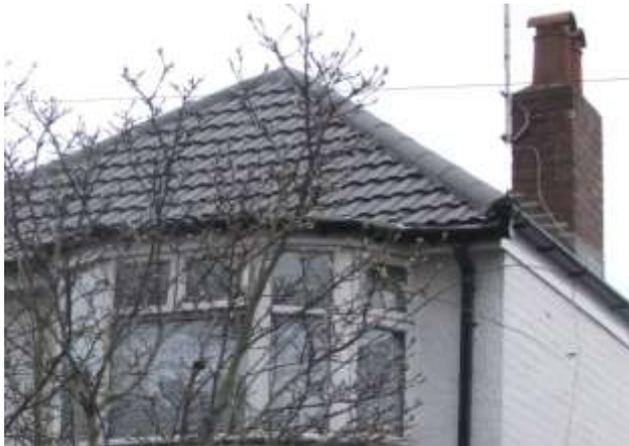
The new roof covering that has been installed appears to have been installed to a reasonable quality with the lead flashing around the remaining chimney in the right hand elevation in acceptable condition. Hip tiles appear firmly fixed with a coloured mortar so as not to stand out from the dark roof colouring. The roof surface is generally flat with the hiplines straight.

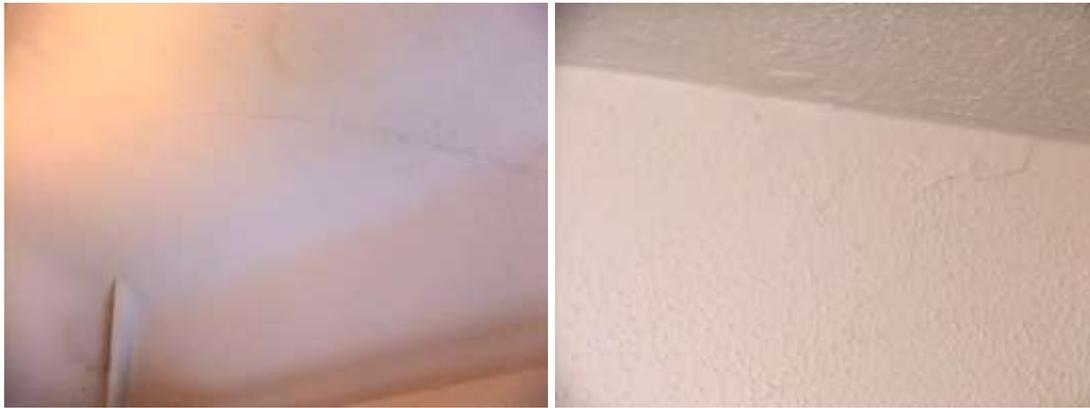
Within the rear left hand bedroom the hip beam was showing and there was a diagonal hairline crack, which had been filled extending across the rear left hand corner of the artex finished ceiling. The front wall of the same room again there was a hairline crack extending vertically downwards from the area where the flat part of the ceiling joined the sloping part of the ceiling. Within the middle of the rear window again hairline cracking was evident within the plaster above the window and through the reveal.

All the cracking that has occurred is classed as 'Category 0 negligible' in accordance with building research establishment digest 251 for specification of damage to buildings in relation to crack widths.

In some cases this can cause serious distortions to a roof however in this particular case the roof structure appeared relatively substantial internally. We consider due to the age of the building there is more than likely a timber lintel over the windows internally and due to the weight of the roof being supported on the inner leaf of the brickwork the additional weight is imposing additional stresses, which is causing a deflection of the timber lintels. This in turn is manifesting itself as minor cracks.

As the cracking is negligible at current times we consider it is the existing structural timbers taking up the additional loading. The timbers appears to be of sufficient size to withstand the additional loadings consequently we would advise that the cracking should cease after a period of time and we would advise a period of 12 months is given for the stresses in the roof to equalize and the cracking to cease.

We therefore consider that the cracking may increase or continue until approximately October 2011 at which time it will be a case of reassessing the movement and if no further movement has occurred than the additional loadings to the roof surface have had no significant structural affect to the building however if increased cracking occurs over that period of time and cracks become worse it will then be a case of strengthening the roof to prevent further deflection of both purlins and hip members.

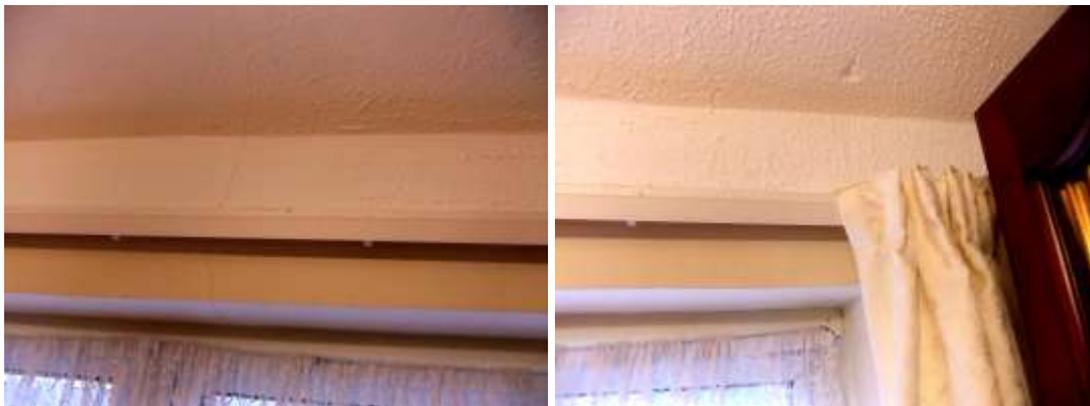
Within the rear right hand bedroom hairline cracking, which extended upwards from the window and through the reveal was evident in three places across the window.

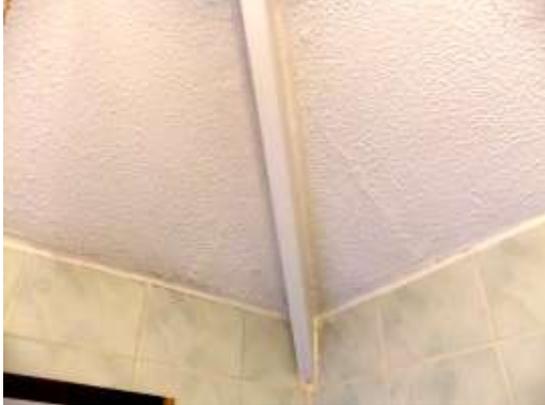
In the bathroom situated on the front left hand corner horizontal crack had formed at the junction of the flat part of the ceiling with the sloping part of the ceiling, which again was hairline.

Due to the property being a hipped property again loadings to the roof surface are transferred from the purlins to the hip members on all corners. Consequently the additional loading will also be causing a slight further deflection of the hip members. To compound the situation the ceiling joists are not at the bottom of the rafters but approximately 400mm above the wall plate. Consequently any increase in loading on the roof structure will be transposed into a horizontal and vertical load causing a slight lateral movement at the head of the wall, which would cause the cracking noted at the junction of the flat part of the ceiling with the sloping part of the ceiling.

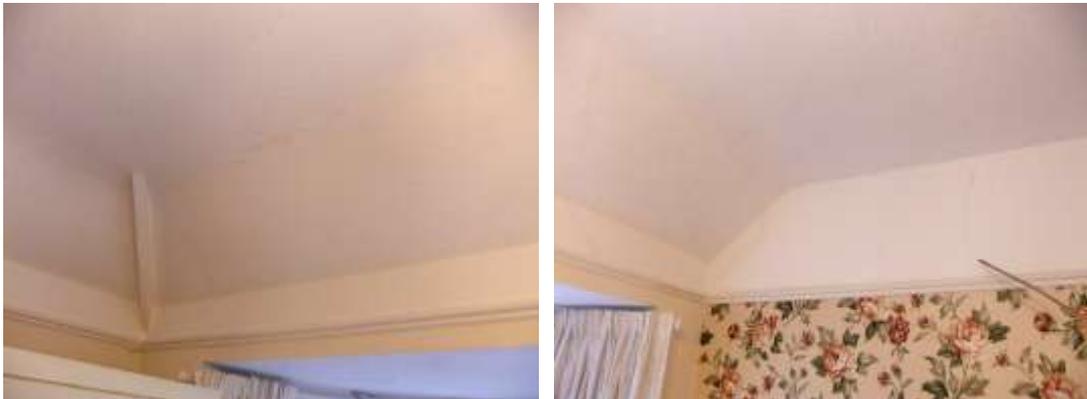
In the front right hand bedroom the bay window noted externally was evident within the front wall and hairline cracking extended downwards from the ceiling to the opening of the bay window and through the bay window surface again in two locations with further hairline cracking to the right hand wall and on the junction of the ceiling with the sloping area.

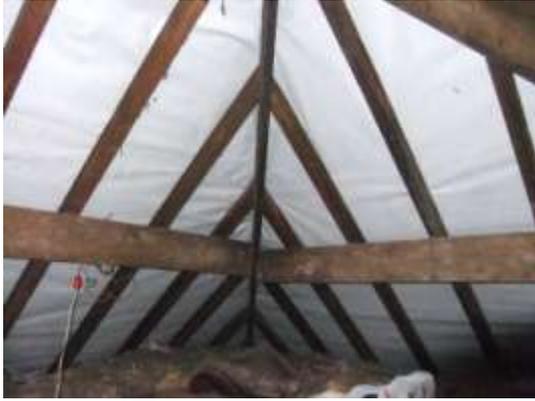
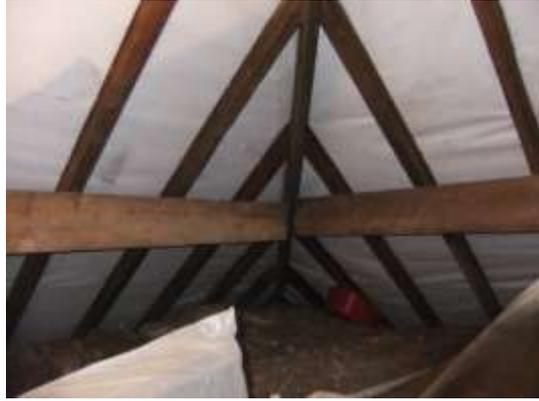
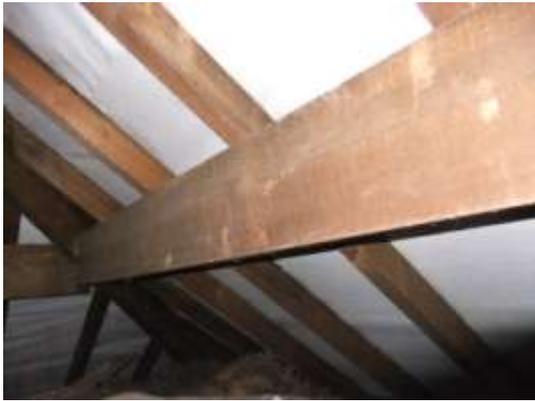
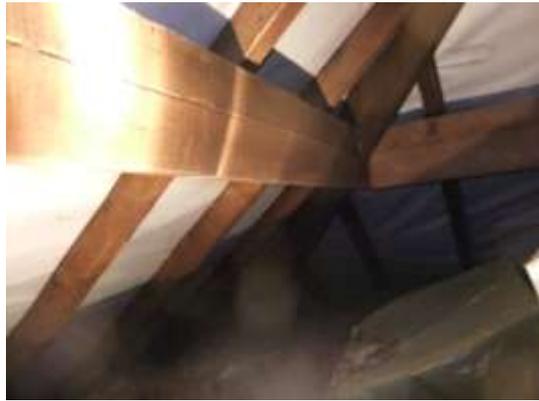
The roof area was accessed by an access hatch within the ceiling of the landing area. This revealed that the underside of the tiles had been felted with a breathable felt as per current regulations. One purlin was in each roof surface supported on hip beams and no significant distortions had occurred at the time of our inspection to either the rafters or the hip beams. Tile debris was within the roof area.

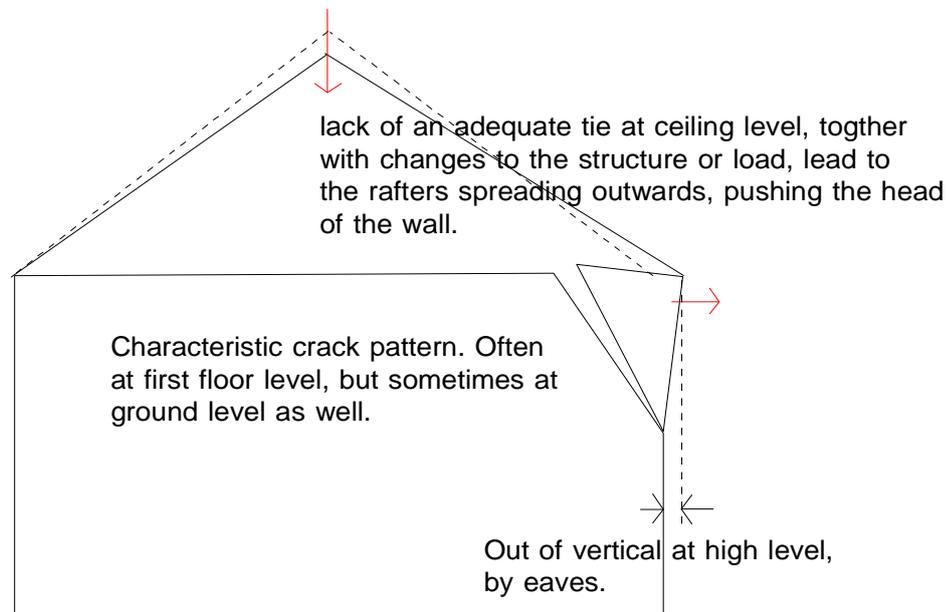
original roof line shown dotted

The pattern of distress is indicative of roof spread. This is a commonly encountered problem in older properties where there (a) is no restraint, or tie, at the head of the wall and (b) may have been some change in loading. For example, recovering a roof with heavier tiles or perhaps some seasonal load due to wind pressure or snow.

Matters are exacerbated if any of the timbers are rotten or suffering from excessive deflection due to deterioration. Often the bottom of the rafters are not tied, allowing the roof frame to spread outwards as shown above.
