# Specific Structural Report

XXXXXXXXXXXX  
XXXXXXXXXXXX  
XXXXXXXXXXXX  
XXXXXXX

**Job reference:** XXXXXXXX

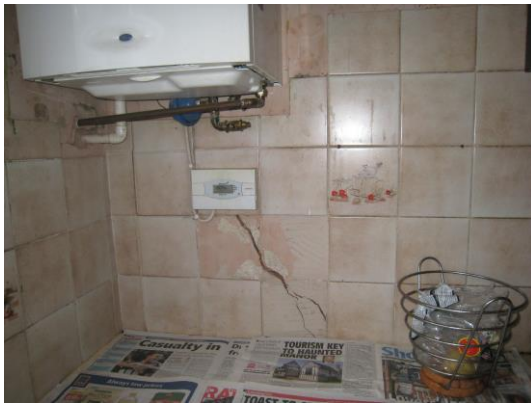
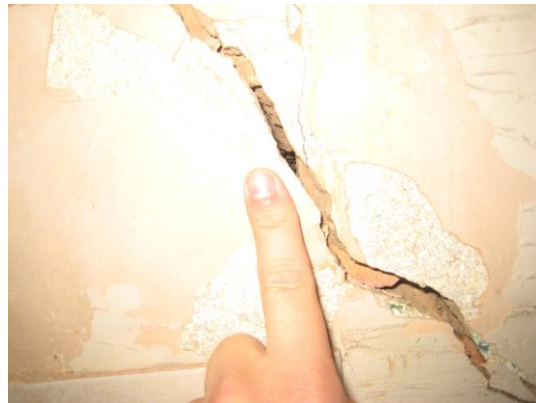
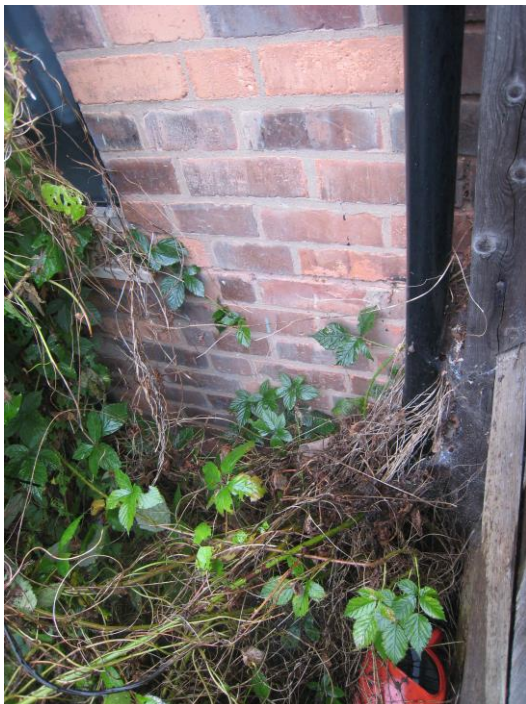
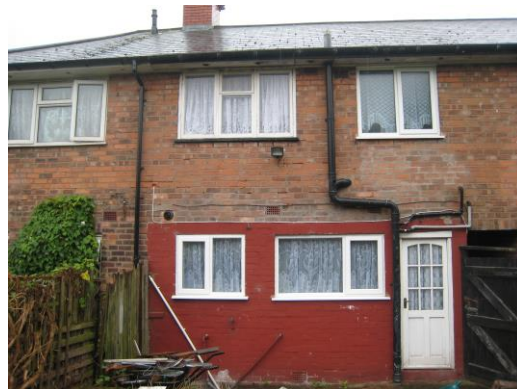
A moderate crack is to the rear right corner of the property evident that the foundation is sinking in the localised area. There is a gully to both the inspected property and the adjoining property on the external wall in the area of the cracking noted internally. The gully to the adjoining property appeared to have been blocked for a long period of time evidenced by overgrown plantation growing in and around the gully.

The property has suffered from structural movement localised to blocked gully to the adjoining property.

The diagonal aspect of the cracks, the fact they tend to increase in width with height and their general disposition is indicative of a minor episode of subsidence. The cause of movement appears to be an escape of water from the drainage system in the local area of the cracking noted.

The adjoining properties drain should be cleared of all over growth and plantation, leaving clear for the free flow of water from the rainwater down piper above.

Cracks 1mm wide or less will be filled (internal) or repointed (external). Where the cracks are wider than 1mm, but less than 5mm the underlying brickwork will be exposed and any broken or cracked bricks or blocks will be replaced prior to covering with expanded metal and making good the plaster finishes. Where cracks are 5mm across or wider some form of bed joint reinforcement should be introduced.

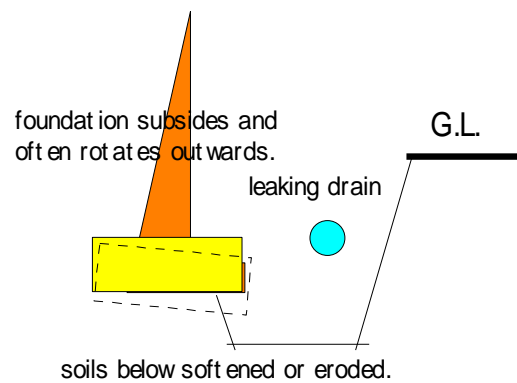
Water escaping from drains in non-cohesive soils can cause localised erosion as the finer particles of soil are washed away. It can also soften cohesive soils by reducing their shear strength.

The ground beneath the foundation softens, resulting in rotation and possible sinking of the foundation. Usually, the building stabilises following repairs to the damaged service.

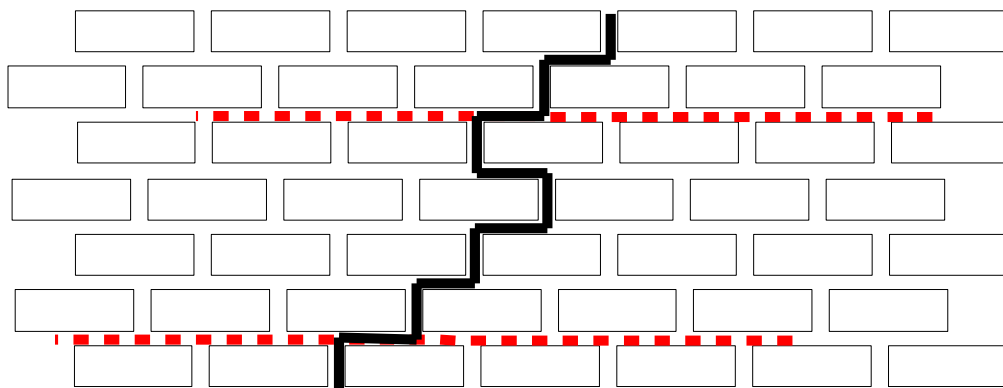
Red dotted lines indicate stainless steel helical rods - 2m long.

**Black line = crack.**

*Typical repair detail for cracks wider than 5mm across, and when active movement has been recorded less than 3 mm per annum.*

This will involve disc cutting a 20mm deep chase into the bed joint across a crack. An epoxy resin mortar is then pressure grouted into the open joint, and stainless steel rods are set into place.

These bars are supplied by Helifix Ltd., 54 Uxbridge Road, London, W12 8LP. Tel: 0181.749.4346, Fax: 0181.749.8639. Technical specification - 6mm diameter austenitic stainless steel, grade 304 with a cross sectional area of 7.45mm<sup>2</sup>. Helical pitch of 25 - 29mm, Tensile strength 1,325N/mm<sup>2</sup>, 0.1% proof stress = 965N/mm<sup>2</sup>.

The preferred epoxy resin grout for setting the bars into the bed joints is HeliBond MM2, a non-shrinkable cementitious grout which flows easily under pressure and reaches 80N/mm<sup>2</sup> in 14 days. Setting time about 15 minutes or less.
