# HomeBuyer Report

## Level 2

Property address	Somewhere Street, Anywhere, Everyplace, EV1 1WX
Client's name	John Smith
Date of inspection	1 October 2019

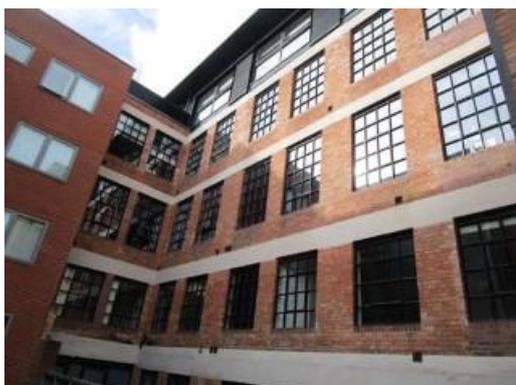
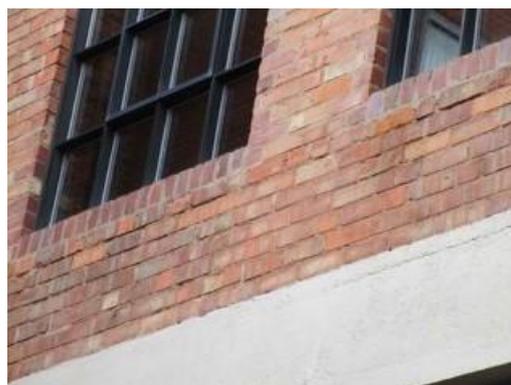
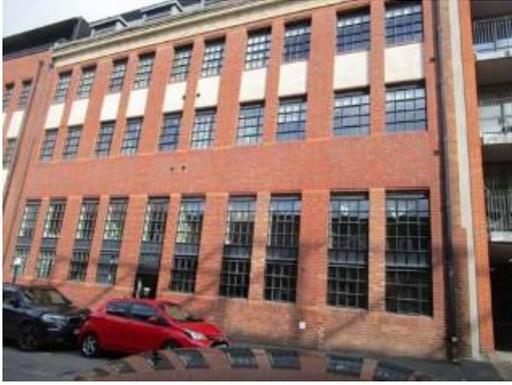
Where brickwork could be inspected it appeared to be in a generally satisfactory condition. There are isolated areas of deteriorated pointing which should be attended to in the short term as part of a proactive maintenance plan for the property.

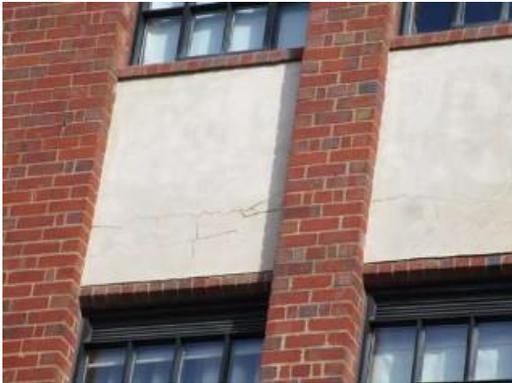
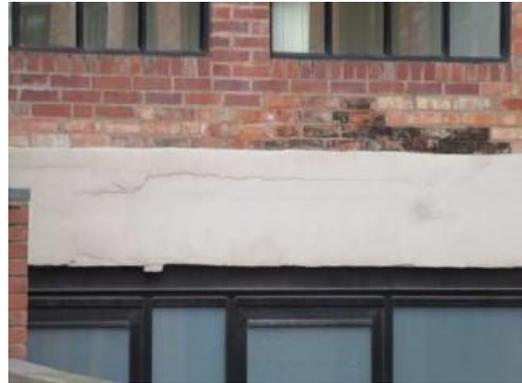
We have noted numerous areas of cracking and apparent live render. This should be attended to in the short term prior to redecoration work. One of the greatest costs associated with the repair to the render will likely be the access equipment and it would be prudent to enquire with the Managing Agent as to whether there are already plans in place for the necessary work.

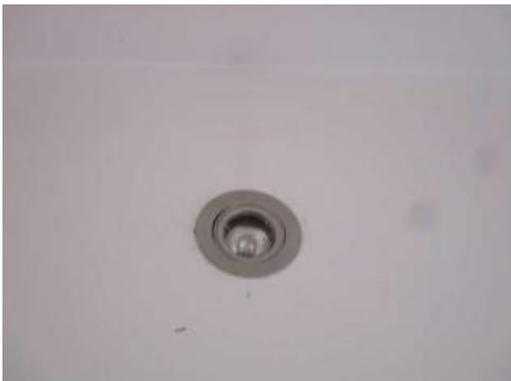
Some of the spotlights are noted to need repair. We also note general heat staining which we would suggest would benefit from isolated cleaning.

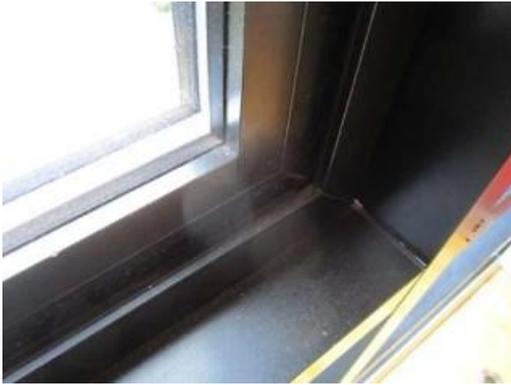
The opening lights do not close fully against the frame and as a result will be draughty and likely allow for issues of water ingress at the junction between the frame and the opening casement.

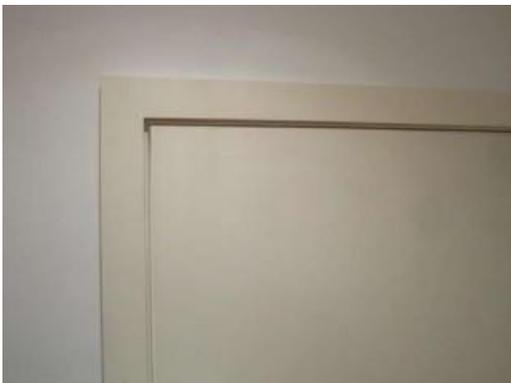
The door leading into the room gives the impression of intumescent strips and door closer and that it has been installed as a fire door however the hinges do not appear to satisfy modern day standard and the door itself is substantially ill-fitting within the frame. Should this be designed as a fire door the door requires complete replacement.

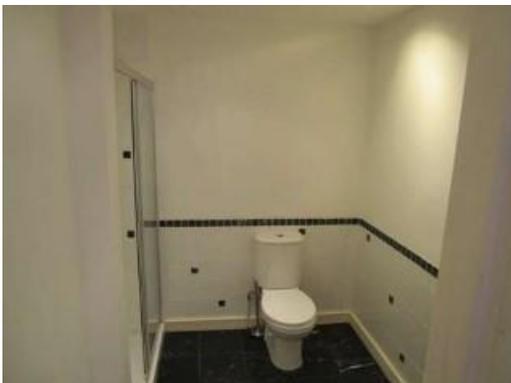
Mechanical extract fan is very noisy and we suggest it would benefit from replacement.

The mastic bead to the perimeter of the shower tray will benefit from renewal in the short term.

The spotlight above the shower does not appear to be the IP65 rating recommended and we recommend that it is replaced.

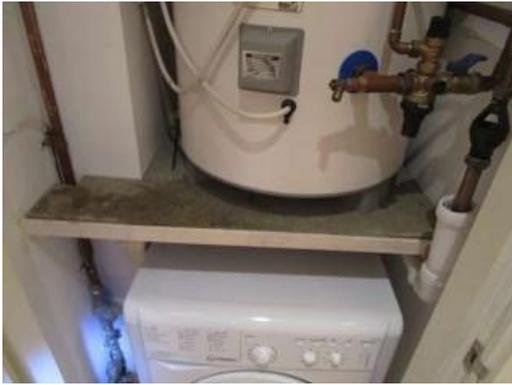
Within the cupboard is the hot water cylinder. You should obtain all service records in regard to this installation. There is damp staining to the decking supporting the cylinder although this was dry on the day of the survey suggesting it to be historic and it should be monitored.

The hot water is stored within the pressurised cylinder located within the cupboard adjacent the main entrance door. The cylinder is relatively modern and appeared serviceable although we have noted evidence of damp staining and have recommended inspection by a competent plumber to ensure there is no ongoing leaks.

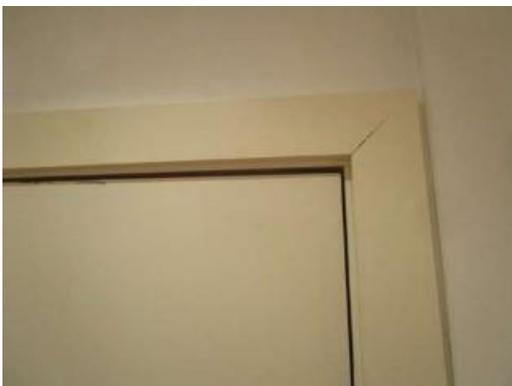
The door to the boiler cupboard appears to have been installed as a fire door although this would not satisfy modern day standards.

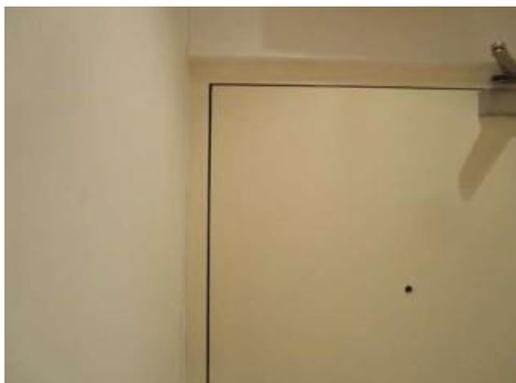
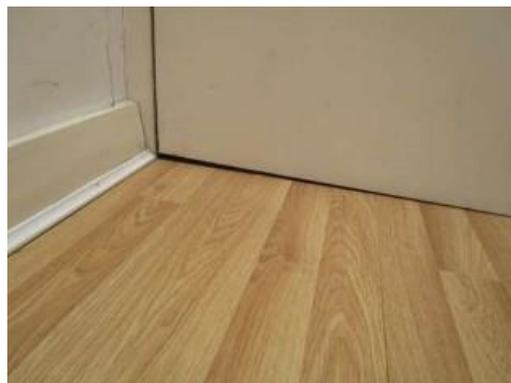
The main entrance door will have been designed as a fire door. The door closer is loose and requires re-fixing. We did note appropriate markings to the door hinges. Separation between the door and frame exceeds the 3mm recommended. We also note unevenness and a comparatively sizeable gap to the underside of the door. By modern day standard we would suggest that this would not be accepted.

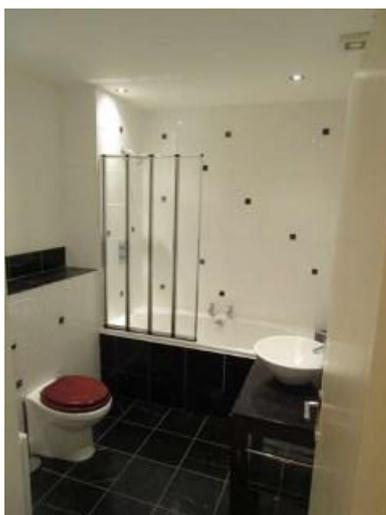
The electrical panel heater was not operating on the day of the survey. We note that it is inadequately fixed to the wall and requires re-fixing.

We would suggest that the spotlights are not the IP65 rating recommended and where placed above the bath should be replaced.

There are isolated repairs required to plaster finishes prior to redecoration as a result of shrinkage cracking and marks from fixings to the plasterboard lining.

We did note a number of broken floor tiles which will likely require replacement in the short term.

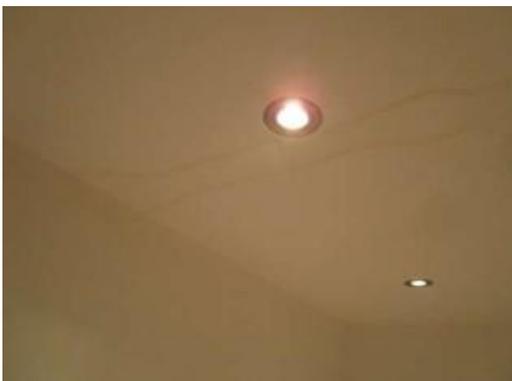
There is clearly dampness to the ceiling. Testing this with a damp meter did not identify any raised levels of dampness suggesting it to be historic and associated with the leaking services from the apartment above.

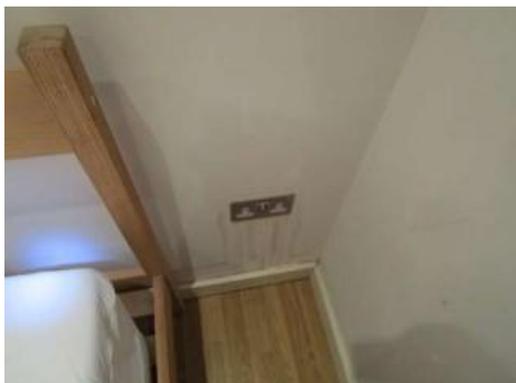
There is further damp staining to the corner of the room adjacent the bed. Testing this with a damp meter did not identify any raised levels of dampness suggesting this to be historic. It may be prudent to enquire as to whether there has been any significant escape of water from the apartment above.

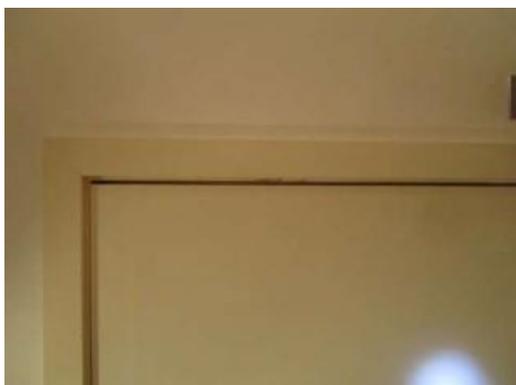
The door leading into the room is installed as a fire door. This is very ill-fitting and would not be accepted by modern day standards.

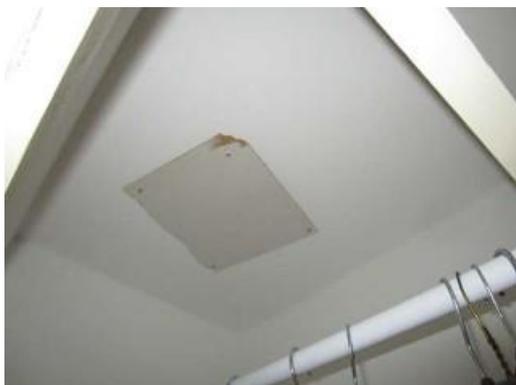
Within the cupboard we note that there are hatches cut within the ceiling. We would suggest that this is associated with some form of repair required and enquiries should be made with the Vendor as to the reason for the hatches.

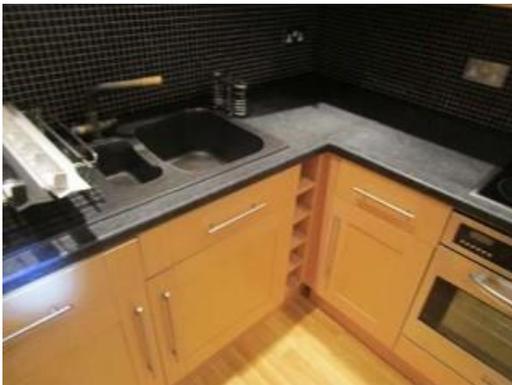
Kitchen units are in a fair condition. They are dated and would benefit from isolated repair in the short term.

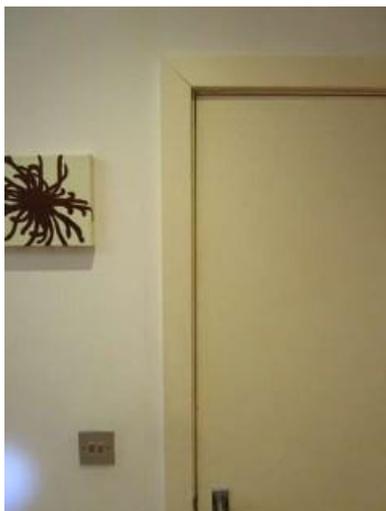
The door leading into the room appears to have been installed as a fire door. The separation between door and frame far exceeds 3mm and this would not be accepted by modern day standards.

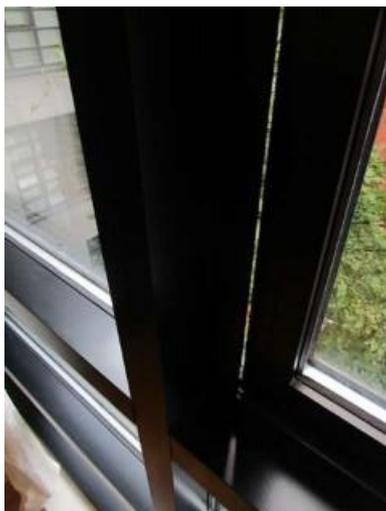
Opening lights to windows are ill-fitting and would be substantially draughty. These should be subject to repair in the immediate term. Should any access be required externally in order to carry out the repair this will attract a substantial cost.

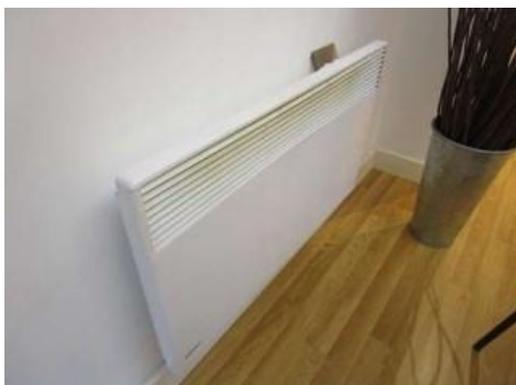
We note impact damage and heat staining to the electric panel heater and would suggest that this is subject to replacement.

The heating at the property is provided via electric panel heaters. These appeared operational although we have noted defects such as impact damage and heat staining. We also noted a smell of burning to the heater within the hallway and have recommended further testing.

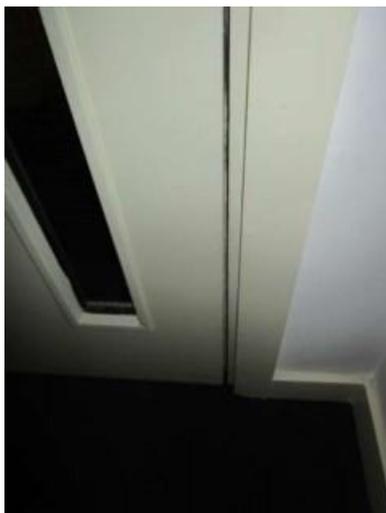
We note separation between fire doors exceeds the 3mm recommended. It may be prudent to enquire with the managing agent as to whether there is any reference to these in the fire risk assessment.

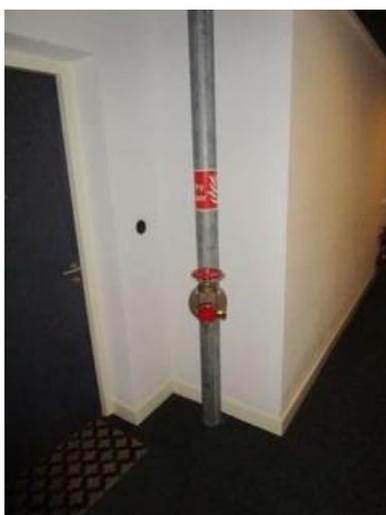
We noted dry riser and would recommend enquiries are made with the managing agent as to whether or not there is any regular servicing or inspection or testing of the dry riser. This should also apply to emergency lighting and the smoke detection installation.
