The Results of the Investigations into the Possible Sulphate Attack

Project Preface

Client name:	XXXXXXXXXXXX
Client address:	XXXXXXXXXXXX XXXXXXXXXXXX XXXXXXXXXXXX XXXXXXX
Senior Partner:	David J Allcott
Prepared at:	Allcott Associates LLP 35 St. Pauls Square Birmingham B3 1QX
Document prepared by:	Eur.Ing. David J Allcott BSc (Hons) CEng MICE MBE MIWEM
Date of Inspection:	XXXXXXXXXX
Job reference:	XXXXXXXXXX

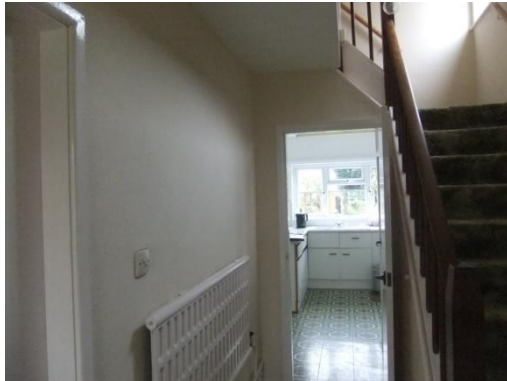
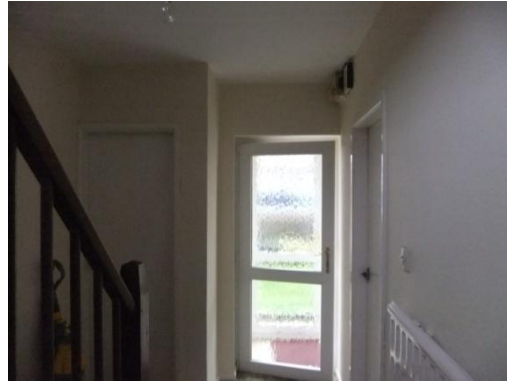
The floors within the property were generally level with no undue doming or localised lumpiness which is attributed to the attack having occurred.

No current distortions were noted on internal walls or around door frames to show any heaving of the floor slab.

Externally there was no lateral displacement of brickwork around the damp proof course to consider any lateral pressure exerted from the chemical attack of the slab.

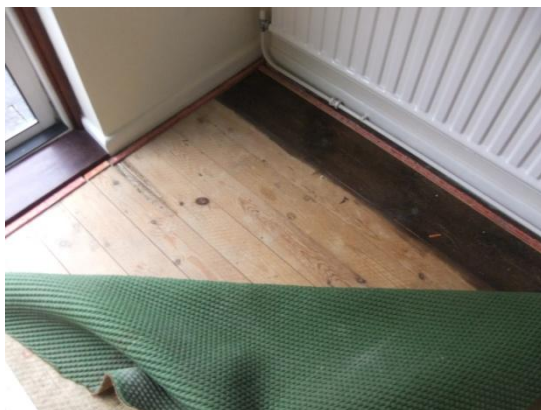
The floor to the left side of the property being the lounge and dining area were suspended timber floors and generally level with no undue doming of the timber from any sub-floor distortions.

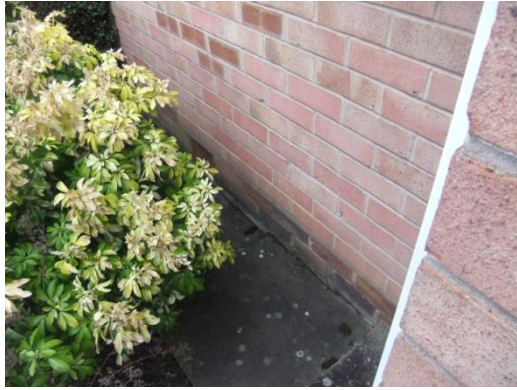
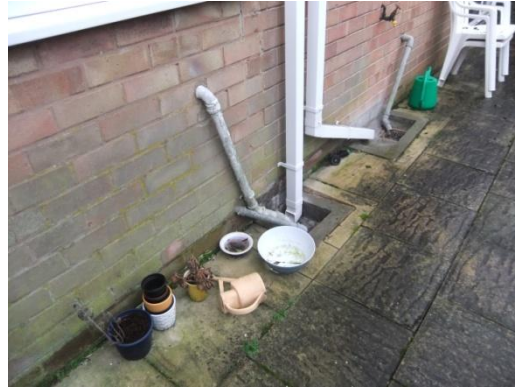
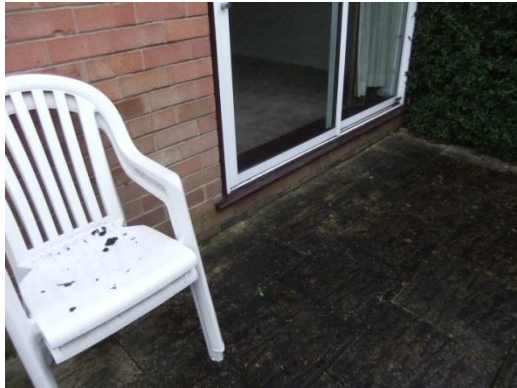
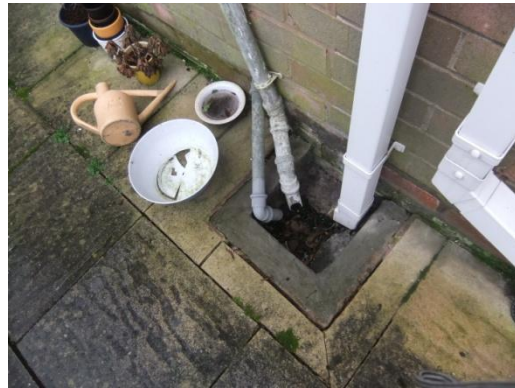
No cracking was noted either externally or internally to the walls.

No lateral spread or white efflorescence was noted externally around the damp proof course which can be an indication that expansion and the attack has occurred.

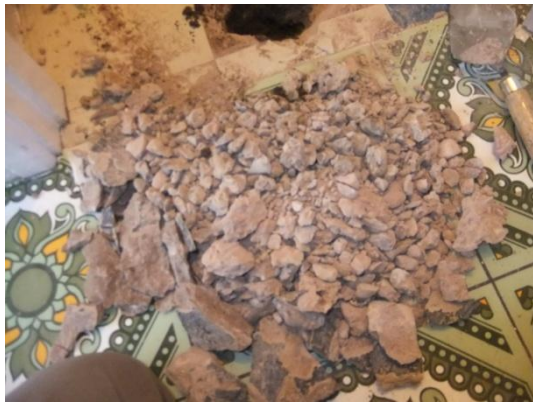
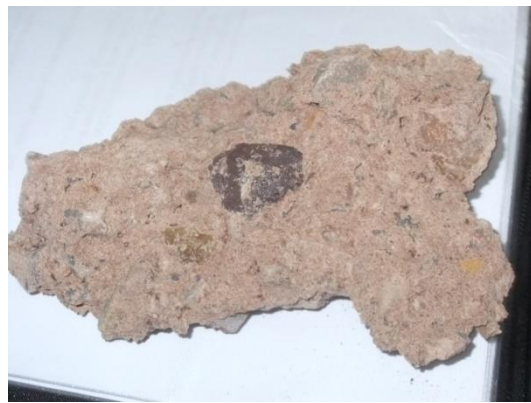
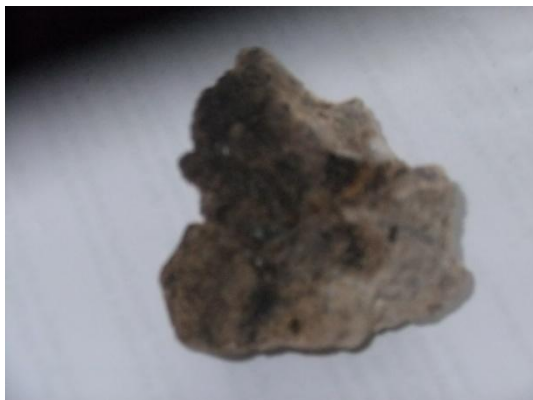
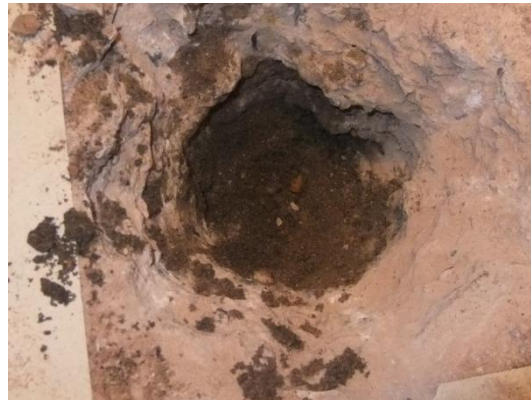
A trial hole was excavated through the concrete floor within the pantry area to the front right of the kitchen which was to the rear right corner of the property due to being close to the water source which as a requirement for the attack to occur on the rear right hand side of the property. This revealed that beneath a thermoplastic tile there was a 100mm depth of concrete being of reasonable quality and a greyish colour. Beneath the concrete was a pure black ash being a colliery waste by product. No damp proof membrane was present. The ash was directly onto the concrete interface.

present. The concrete had a grey colour with no indication that the reaction may have commenced.

The fill material was a black vesicular clinker and ash being a colliery waste with no polythene damp proof membrane between the concrete. The concrete had a dry consistency.

In conclusion the concrete samples from the trial holes taken in the Kitchen pantry were found to have relative low level of sulphates however the fill material had a high level of sulphates with the cement content of the concrete being lower than that recommended to resist the attack. The concrete was also relatively dry.

We **do not** therefore consider that Sulphate attack has occurred to the property. However this coupled with the classification of the fill material as being an aggressive material in accordance with BRE Special Digest is clear evidence that there is the potential for Sulphate attack to occur to the floors in the future if a drainage leak was to occur or other source of water became present to act as the catalyst.

As there is potential for the reaction to occur in the future if a drainage leak was to occur we therefore of the opinion that consideration should be given to the replacement of the floor slab before the reaction undoubtedly occurs in accordance with current Building regulation guidelines to prevent the chance of the reaction occurring in the future
