HomeBuyer Report

Somewhere Street, Anywhere,
Everyplace, EV1 1WX

1 October 2019

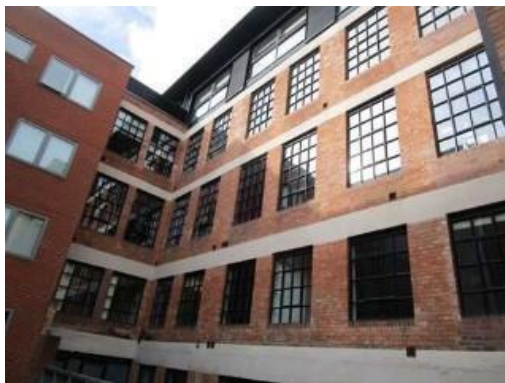
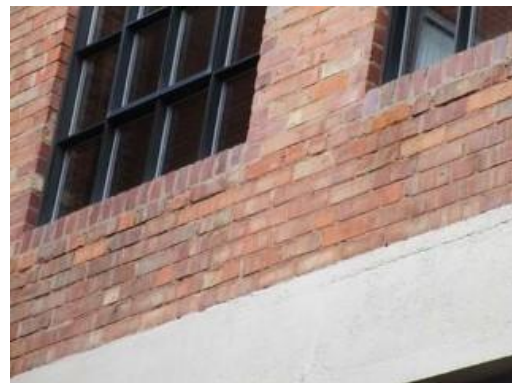
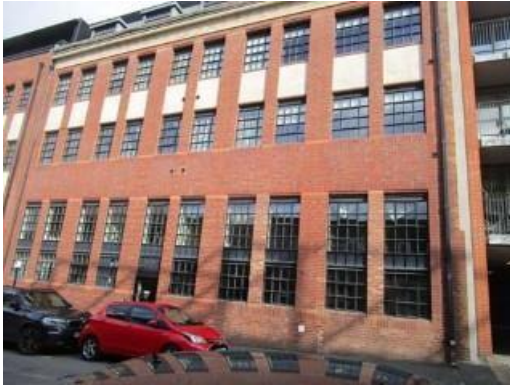
Where brickwork could be inspected it appeared to be in a generally satisfactory condition. There are isolated areas of deteriorated pointing which should be attended to in the short term as part of a proactive maintenance plan for the property.

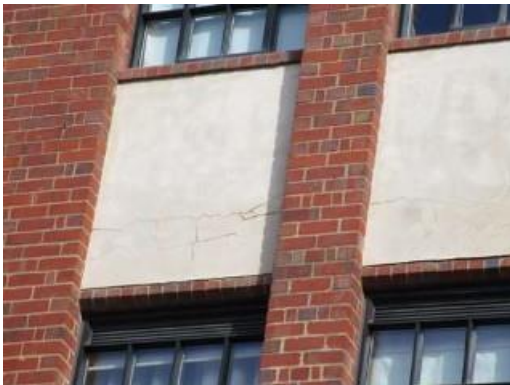
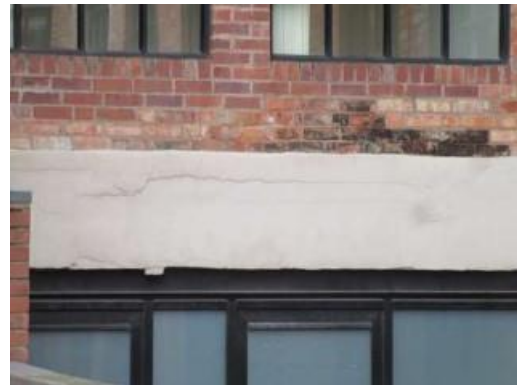
We have noted numerous areas of cracking and apparent live render. This should be attended to in the short term prior to redecoration work. One of the greatest costs associated with the repair to the render will likely be the access equipment and it would be prudent to enquire with the Managing Agent as to whether there are already plans in place for the necessary work.

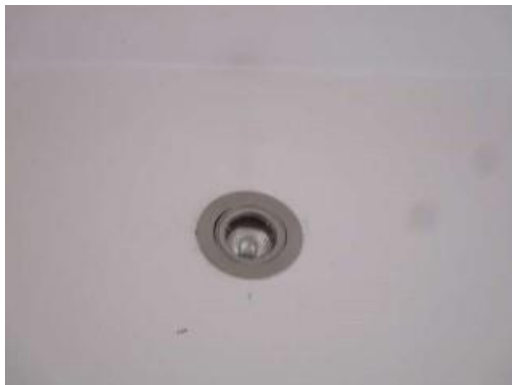
Some of the spotlights are noted to need repair. We also note general heat staining which we would suggest would benefit from isolated cleaning.

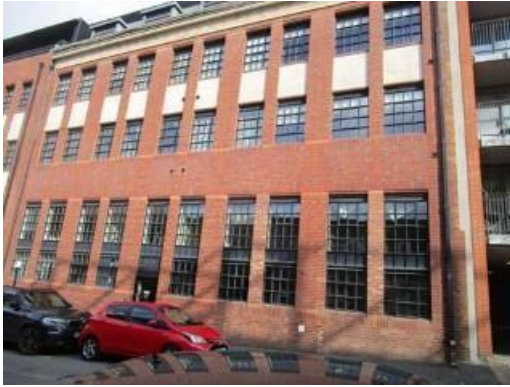
The opening lights do not close fully against the frame and as a result will be draughty and likely allow for issues of water ingress at the junction between the frame and the opening casement.

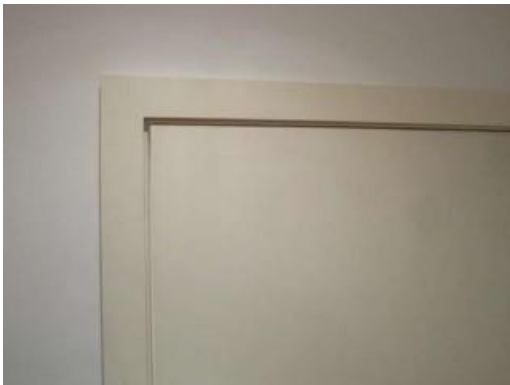
The door leading into the room gives the impression of intumescent strips and door closer and that it has been installed as a fire door however the hinges do not appear to satisfy modern day standard and the door itself is substantially ill-fitting within the frame. Should this be designed as a fire door the door requires complete replacement.

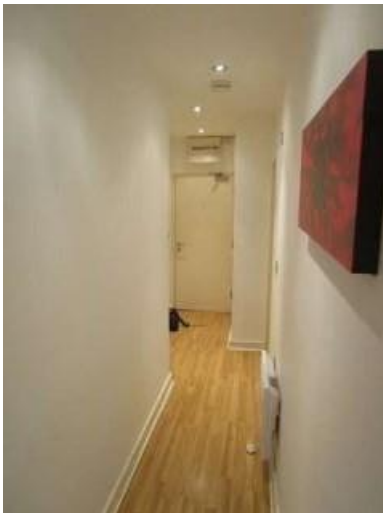
The electric panel heater appeared operational on the day of the survey. We would recommend that you obtain NICEIC approved electrical test certification to confirm that these are in good working order.

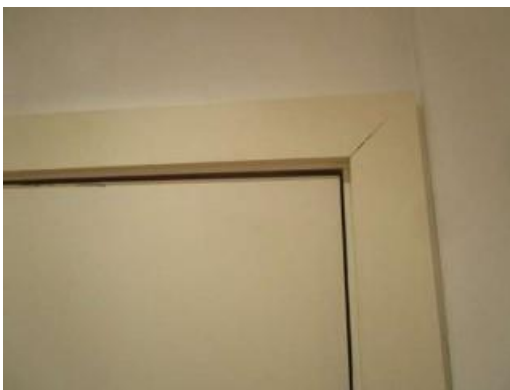
The door to the boiler cupboard appears to have been installed as a fire door although this would not satisfy modern day standards.

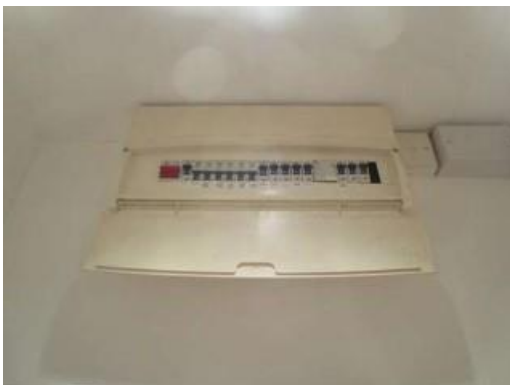
The electrical distribution board is within the room. You should obtain an up-to-date NICEIC electrical test certificate regarding this installation.

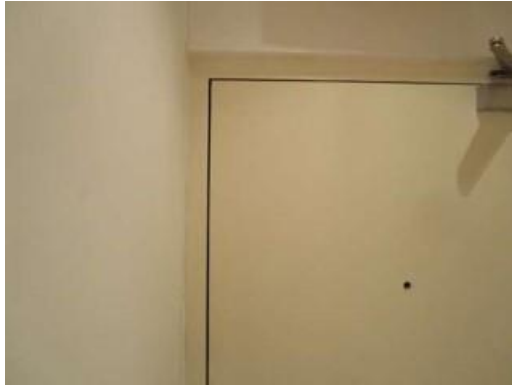
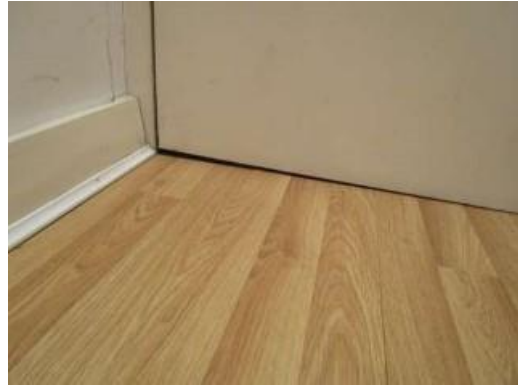
The main entrance door will have been designed as a fire door. The door closer is loose and requires re-fixing. We did note appropriate markings to the door hinges. Separation between the door and frame exceeds the 3mm recommended. We also note unevenness and a comparatively sizeable gap to the underside of the door. By modern day standard we would suggest that this would not be accepted.

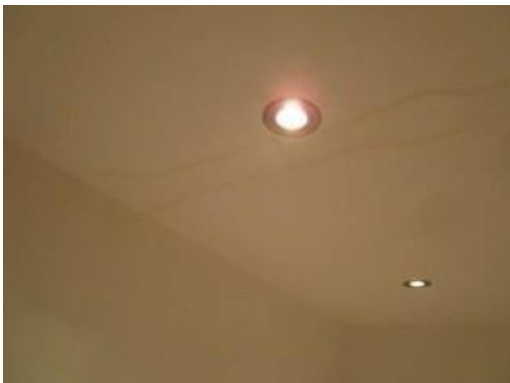
There is clearly dampness to the ceiling. Testing this with a damp meter did not identify any raised levels of dampness suggesting it to be historic and associated with the leaking services from the apartment above.

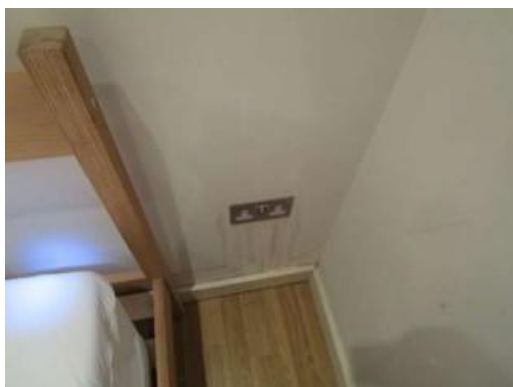
There is further damp staining to the corner of the room adjacent the bed. Testing this with a damp meter did not identify any raised levels of dampness suggesting this to be historic. It may be prudent to enquire as to whether there has been any significant escape of water from the apartment above.

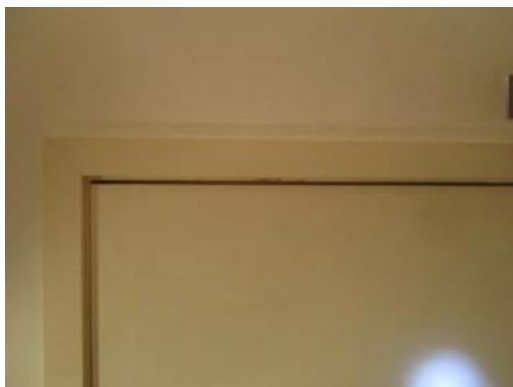
The door leading into the room is installed as a fire door. This is very ill-fitting and would not be accepted by modern day standards.

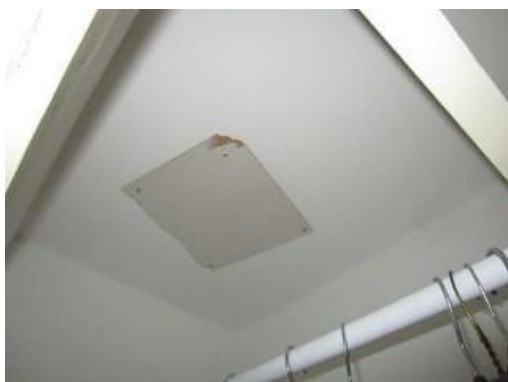
Within the cupboard we note that there are hatches cut within the ceiling. We would suggest that this is associated with some form of repair required and enquiries should be made with the Vendor as to the reason for the hatches.

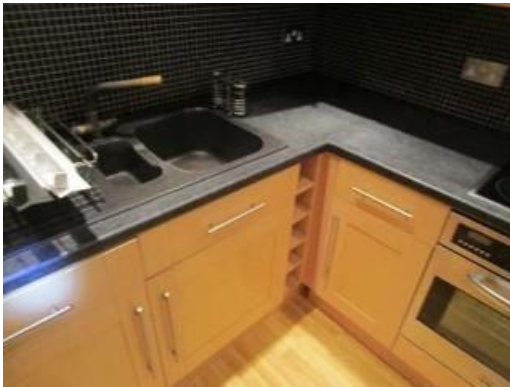
Kitchen units are in a fair condition. They are dated and would benefit from isolated repair in the short term.

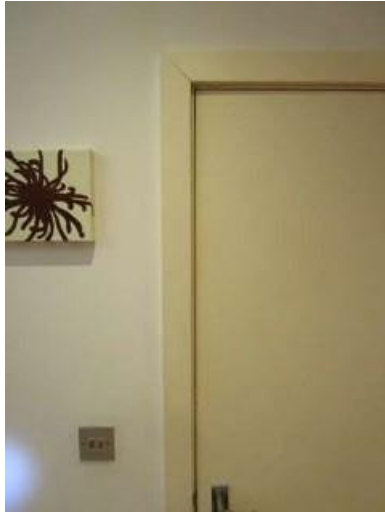
The door leading into the room appears to have been installed as a fire door. The separation between door and frame far exceeds 3mm and this would not be accepted by modern day standards.

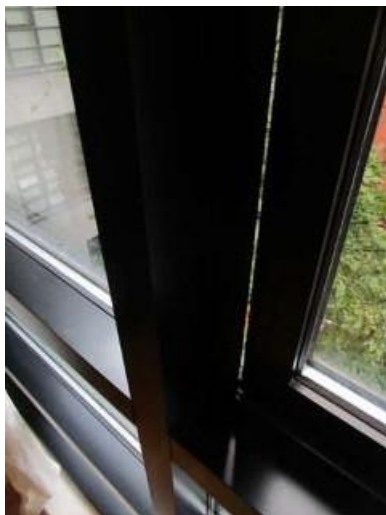
Opening lights to windows are ill-fitting and would be substantially draughty. These should be subject to repair in the immediate term. Should any access be required externally in order to carry out the repair this will attract a substantial cost.

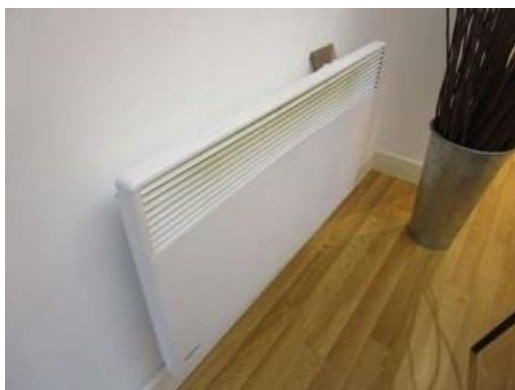
We note impact damage and heat staining to the electric panel heater and would suggest that this is subject to replacement.

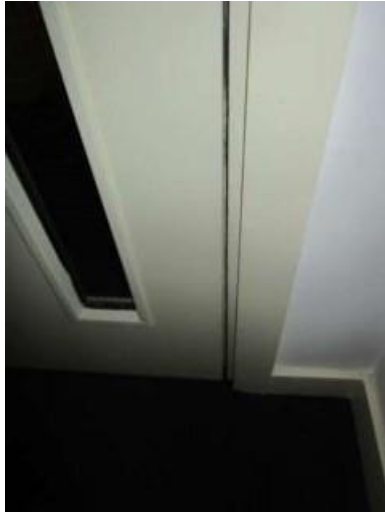
We note separation between fire doors exceeds the 3mm recommended. It may be prudent to enquire with the managing agent as to whether there is any reference to these in the fire risk assessment.

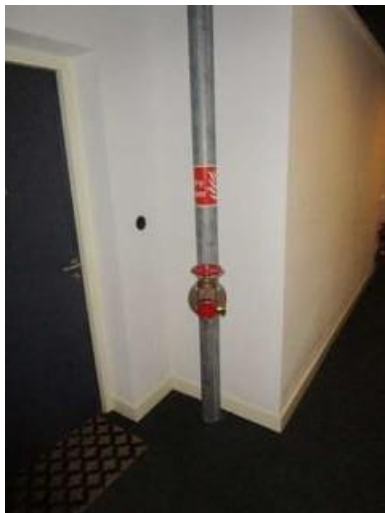
We noted dry riser and would recommend enquiries are made with the managing agent as to whether or not there is any regular servicing or inspection or testing of the dry riser. This should also apply to emergency lighting and the smoke detection installation.
