BUILDING SURVEY

Level 3

21 September 2022

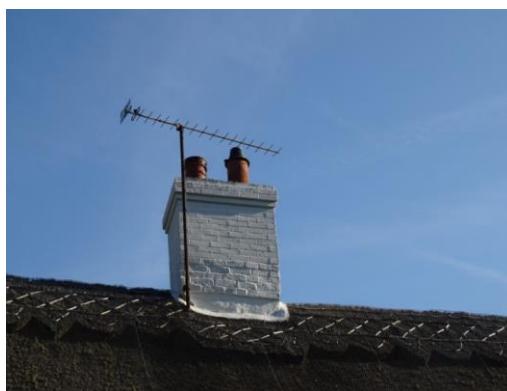
The central brick chimney stack is noted to be in reasonable structural order with no significant deterioration of the mortar pointing noted. Minor perishing of the brickwork was noted due to age related wear and tear, however not considered significant.

The chimney stack has been recently painted. We are unable to confirm whether the paint is breathable. It is recommended that properties of this age and type are decorated with a breathable paint to allow moisture to naturally escape without resulting in premature perishing of the brickwork.

Clay chimney pots are located to the head of the stack with no damage noted. We would advise that the supporting mortar is checked and renewed as necessary when high level access is next provided.

Cement flashings have been installed to the base of the stack with no significant deterioration noted.

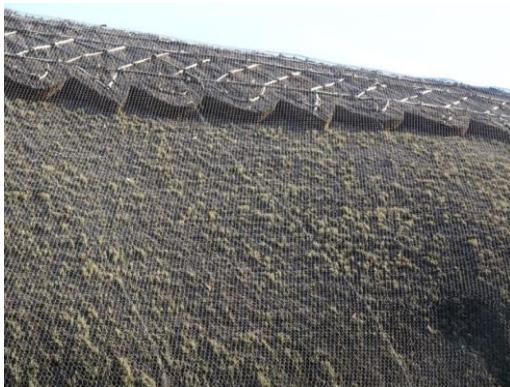
The main roof has been thatched with reed with no significant deterioration of the reed noted.

A general build-up of moss was noted to the thatch, however not considered significant.

A block ridge has been installed to the head of the roof with no significant deterioration noted and we consider has at least ten years life remaining.

Wire netting has been installed to the thatch in accordance with good building practice which was noted to be firmly pulled tight into position.

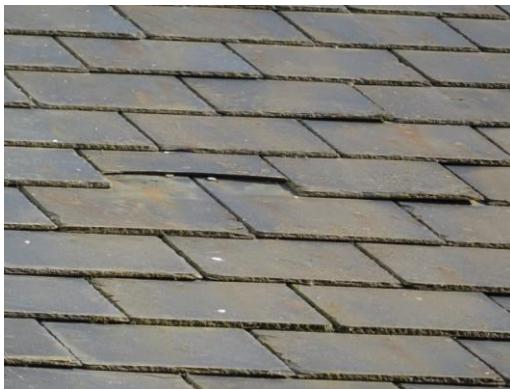
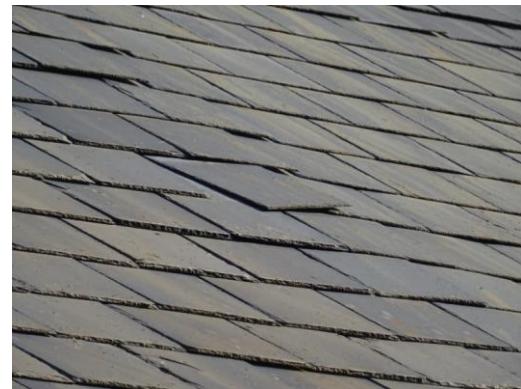
The pitched roof above the right hand single storey extension has been surfaced with natural slate with no significant slippage or delamination of the slates noted. Several slates were noted to be either damaged or to have dislodged requiring replacing or re-setting into position in the immediate term.

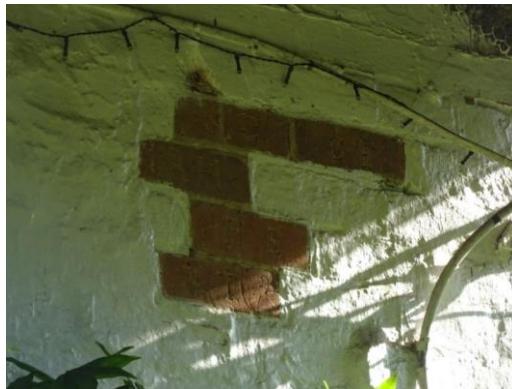
The main elevation has been constructed in a mixture of rubble stone and brick with no structural cracking noted. Various isolated bricks have previously perished which is not considered unusual for the age of the property. We would simply advise that the worst perished bricks are cut out and replaced as part of the pro-active maintenance scheme for the property.

Where brickwork has previously perished, this has been cut out and replaced, however does require decoration.

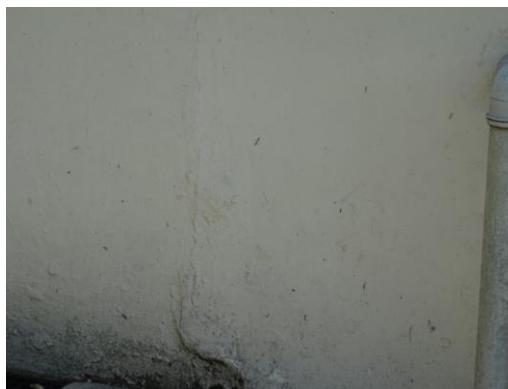
The elevation forming the left hand lean-to has been constructed in solid brick finished with a smooth painted render. Various thermal cracks were evident within the render which is of no significant structural concern with render being susceptible to thermal cracking. We would advise that the cracks are filled with the render then kept regularly decorated with a good quality breathable paint. This is necessary in order to prevent further hairline cracks forming which in the winter months will allow rainwater to enter behind the cracks which will then freeze and expand, causing progressive deterioration of the render.

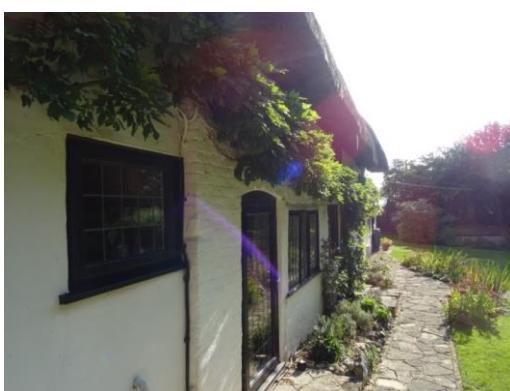
A vine was growing across the elevation which is not currently considered to be of any significant concern, however we would advise that it is cut back and controlled and maintained in due course in order to prevent becoming a nuisance.

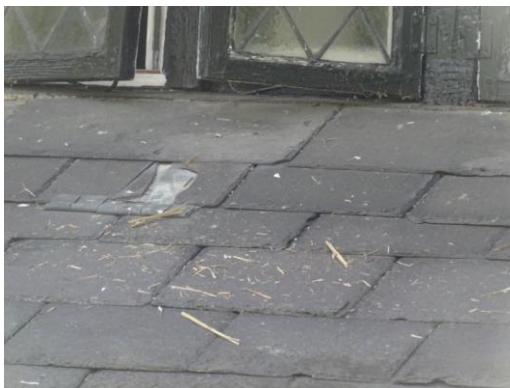
The extension roof is mono pitched and surfaced with natural slate. A number of slates have delaminated requiring replacing in the immediate term. At this time we consider approximately twenty slates to require replacing.

Although we do not consider the roof to require replacing at this time until such time that the mono pitch roof is eventually re-covered, it will require above average maintenance in order to keep it weather tight.

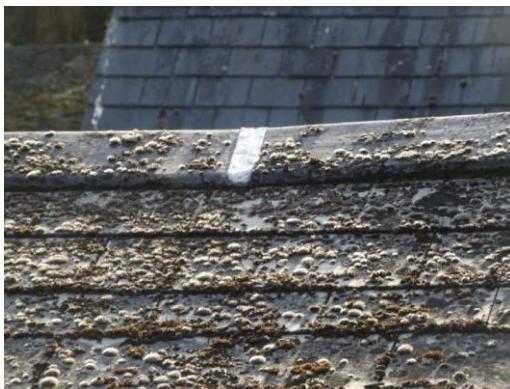
Flash band repairs have been carried out to the ridge tiles suggesting that this is an area subject to previous water ingress. Flash banding should only be considered a temporary waterproofing solution therefore we would advise that this is removed with the ridge tiles repointed.

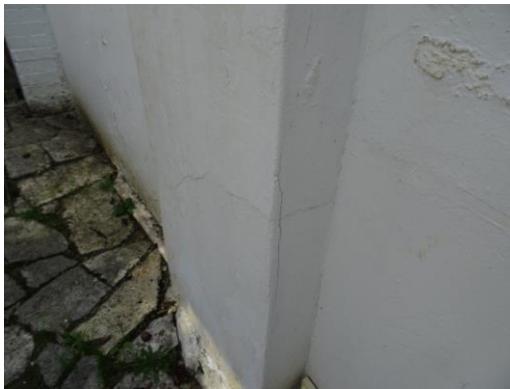
The extension elevation has been constructed in solid brick finished with a smooth painted render. Various thermal cracks were evident within the render, however of no significant structural concern. We would advise that the render is decorated with a good quality breathable masonry paint in order to prevent its progressive deterioration throughout the winter months.

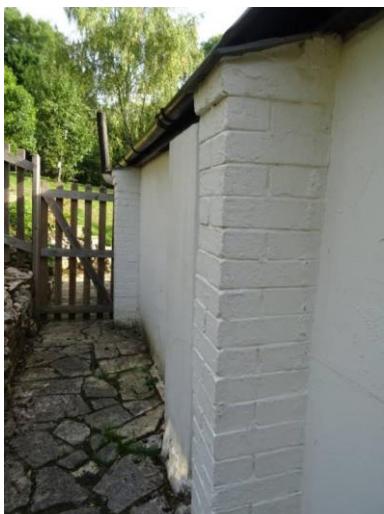
The elevation was noted to have slightly bowed, however retrospective brick buttressing has been installed which we consider to be providing adequate lateral restraint with no evidence of further recent bowing noted to the elevation.

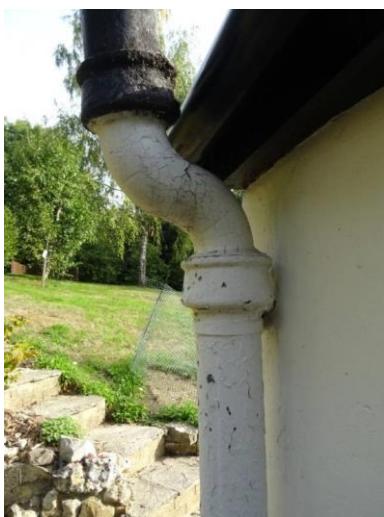
A dated soil and vent pipe is located to the left hand side of the elevation with no evidence of leaking joints noted. The soil pipe appears to have been formed in asbestos cement however no significant damage was noted. Should you decide to disturb the soil pipe then we would advise that it is tested with specialist precautions taken if necessary. Until such time as the soil pipe is replaced, we would advise that it is painted with a good quality paint in order to prevent a release of fibres which will be a health hazard.

Until such time that the soil pipe is replaced, we would advise that a bird cage is installed to the head of the pipe in order to prevent vermin ingress.

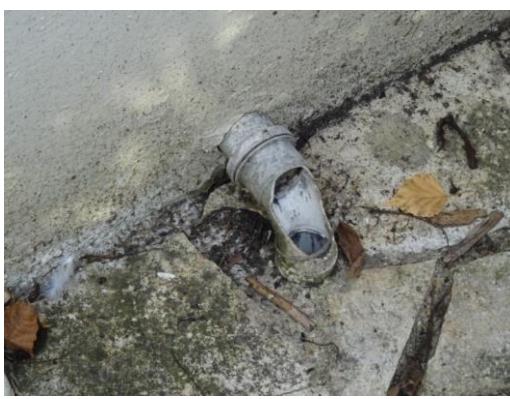
A uPVC waste pipe is located at the left hand side of the elevation at low level which was noted to be damaged requiring repair in the immediate term.

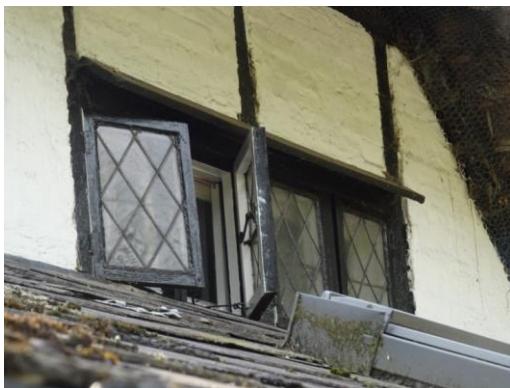
The window within the main body of the property is timber framed incorporating leaded lights which is of significant age, however is currently considered fit for purpose and in keeping with the age and character of the property. It should be noted that due to the extent of the single glazing the windows will be inefficient allowing heat loss. You may wish to consider replacing the windows with double glazed units, however this will require conservation consent, which will attract increased costs.

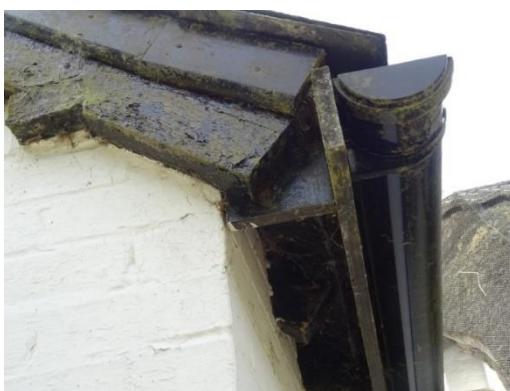
Where the rafters are evident to the underside of the left hand extension roof overhang, they are relatively tired and worn requiring decoration in the immediate term.

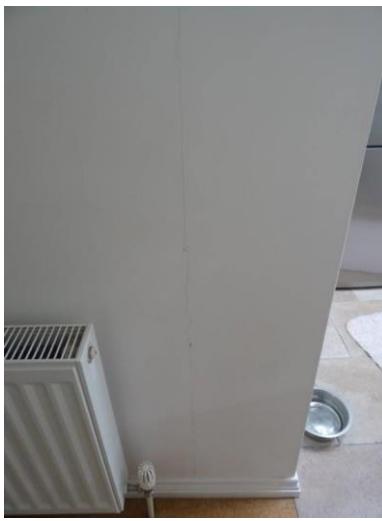
General board cracking was noted to the rear wall where solid masonry abuts studwork which is of no structural concern and requires filling prior to decoration. It should be noted that repairing of the board cracking may be an ongoing maintenance issue.

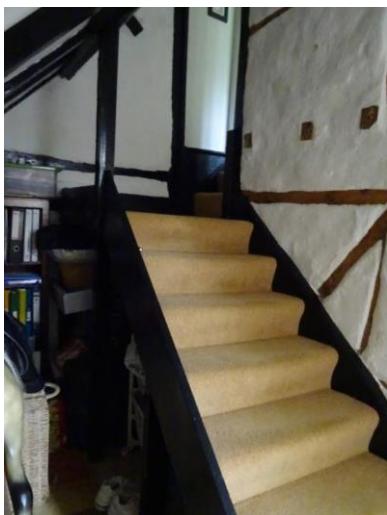
Worm holes were evident to the exposed timbers around the room, however when tested with a damp detection gauge the timbers were found to be dry confirming the infestation is dormant.

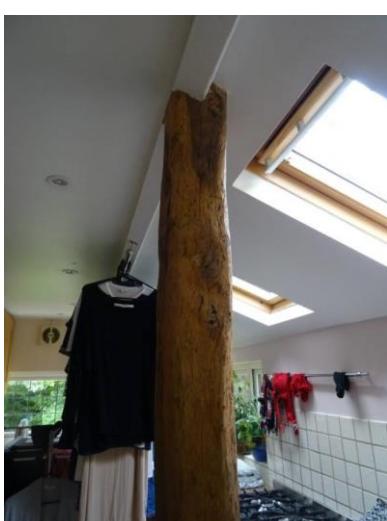
Worm holes were noted to the timber post however when tested with a damp detection gauge the timbers were noted to be dry confirming the infestation is dormant.

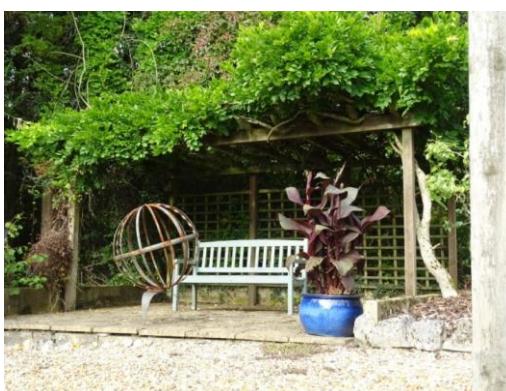
Reconstituted stone paving slabs have been laid beneath the timber pergola which are relatively level however a number of slabs require re-bedding.

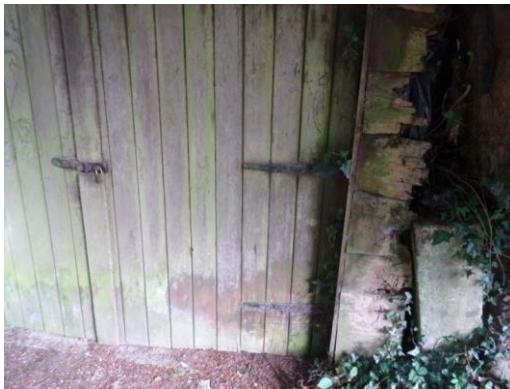
We consider the garage to be at the end of its useable life and would advise that it is demolished and removed. Until such time that the garage is demolished and removed it will require above average maintenance in order to keep it weather tight and structurally sound.
