BUILDING SURVEY

Level 3

ALLCOTT
RESIDENTIAL

Somewhere Street, Anywhere, Everyplace,
EV1 1WX

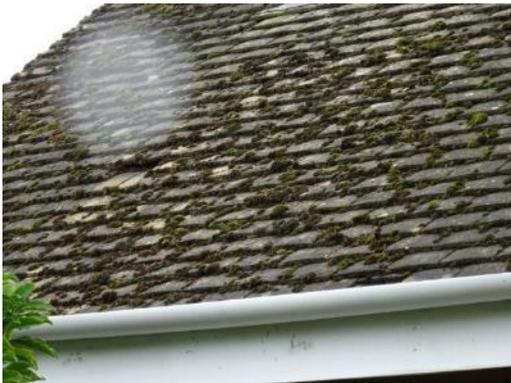
The roof covering is in a serviceable condition with no significant slippage or deterioration of the tiles noted. Several tiles to the left hand side of the main roof were noted to be damaged, requiring replacing in the immediate term.

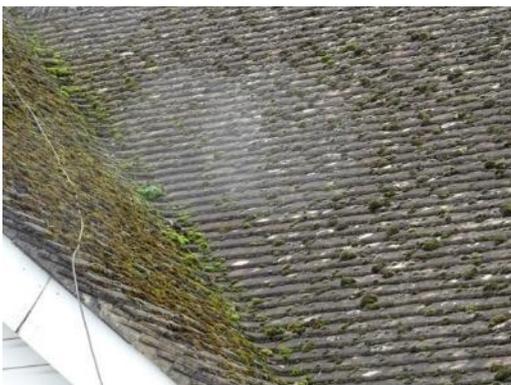
Where the forward facing dormer roofs abuts the main roof, tiled valleys have been formed which are noted to be relatively blocked with vegetation requiring clearing in the immediate term. It should be noted that it is necessary to keep the valleys clear of debris in order to prevent rainwater backing up into the roof void.

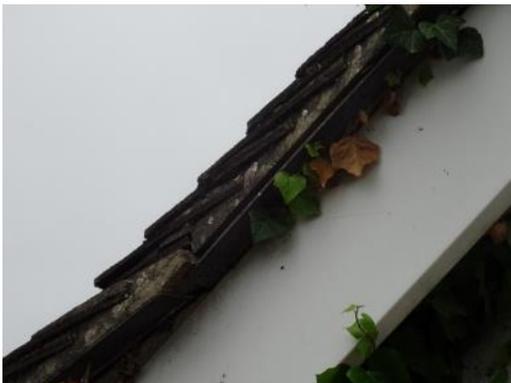
The tile under cloak appears to have been formed in fibrous board. It should be noted that fibrous board in properties of this age and type may contain asbestos. Therefore, should the fibrous board be disturbed, we would advise that it is tested with specialist precautions taken if necessary.

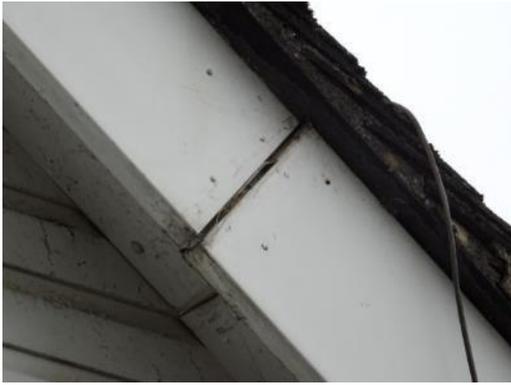
The fascias are uPVC which are noted to be in a serviceable condition having been firmly secured into position however require cleaning down.

The fascias have been relatively amateurishly installed with the junction caps missing and as a result the fascias appeared relatively untidy. You therefore may wish to consider replacing the fascias in a good workmanship fashion.

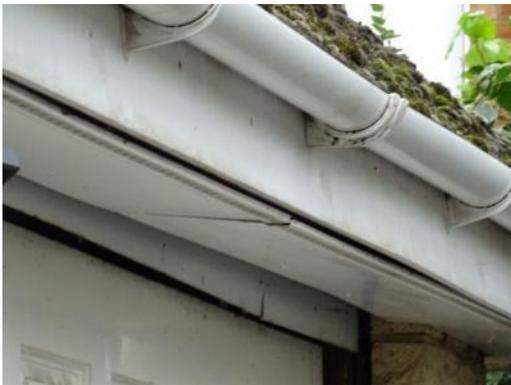
The soffits to the underside of the roofs are uPVC which are noted to be pulling away requiring re-securing into position until such time that the soffits are replaced.

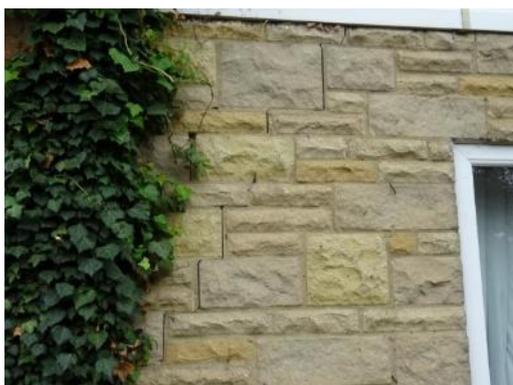
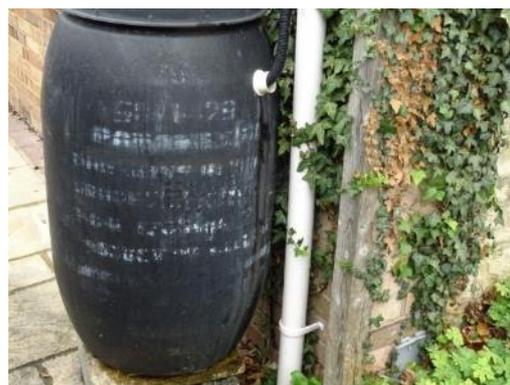
The elevation has been constructed in reconstituted cavity stone. Stepped cracking is noted to the left hand side of the elevation which suggests rotational movement of the front left hand corner of the property. This is where we noted a water butt to be overflowing at the time of our inspection. We consider it is likely that a softening of the subsoils has resulted due to the continuous overflowing of the water butt. Initially we would advise that the water butt is removed with the ground given chance to dry back out to its natural moisture content with the cracked mortar pointing then raked out, with the stonework then repointed with a suitable colour mortar to match with the repair then used as a visual monitor. Should further cracking at this location occur, it will then be necessary to carry out a CCTV survey of the drainage running along the left hand elevation to ensure that there is no below ground defect causing a further softening of the subsoil.

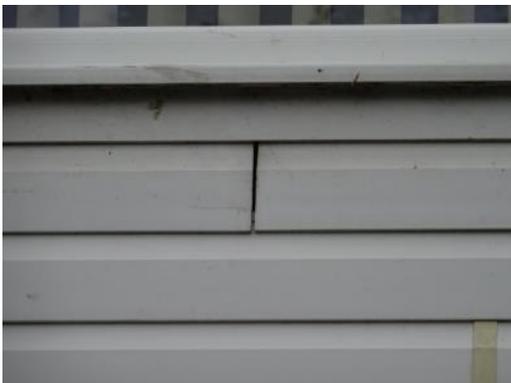
Various junction caps were noted to be missing which we would advise are replaced in the immediate term in order to prevent risk of water ingress in times of wind driven rain.

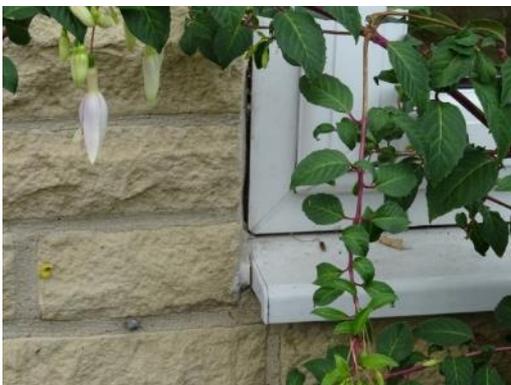
The mastic seal around the edges of the uPVC frames is in a deteriorated condition requiring cutting out and renewing in order to prevent risk of water ingress in times of wind driven rain.

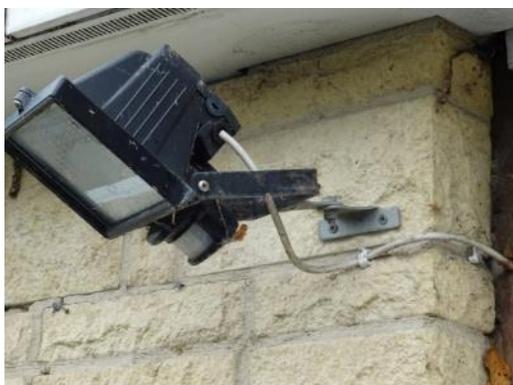
Amateurish alterations have been carried out to the electrical system where we noted external lanterns to have been installed. We would advise that the alterations are inspected by a competent and qualified electrician to ensure that they are safe.

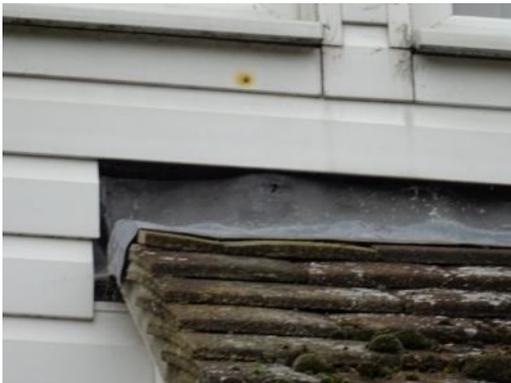
Where the mono-pitched roof above the porch abuts the main body of the property, lead flashings have been installed. The lead was noted to have slightly pulled away, therefore will require re-dressing into position in order to prevent risk of water ingress in times of wind driven rain.

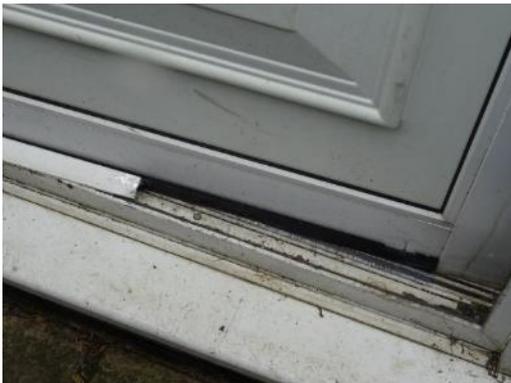
The pedestrian door giving access into the garage was noted to be defective therefore will require replacing in order to improve security.

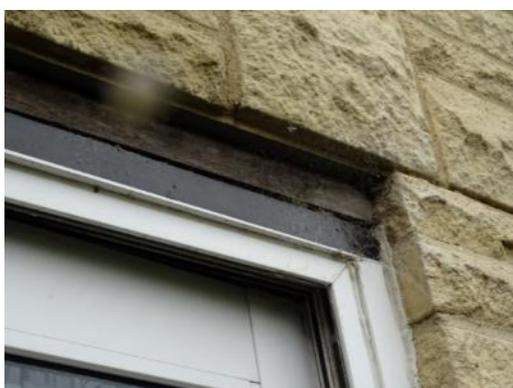
The garage pedestrian door has been amateurishly installed as a result of its poor fitting, a timber infill has been installed above the door. This is amateurish however of no significant concern.

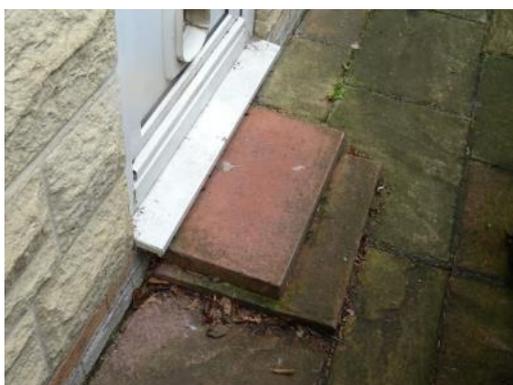
A makeshift step gave access up to the side entrance door. We would advise that this replaced with a permanent solution however until such time that the permanent step has been installed, we would advise that care is taken in order to prevent risk of trips and falls.

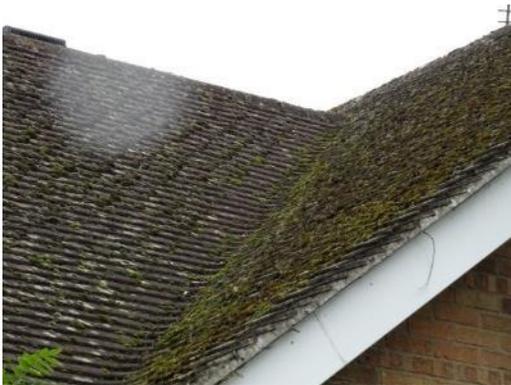
Where the forward facing gable roofs abuts the main roof, tiled valleys have been formed which are noted to be relatively blocked with vegetation requiring clearing in the immediate term.

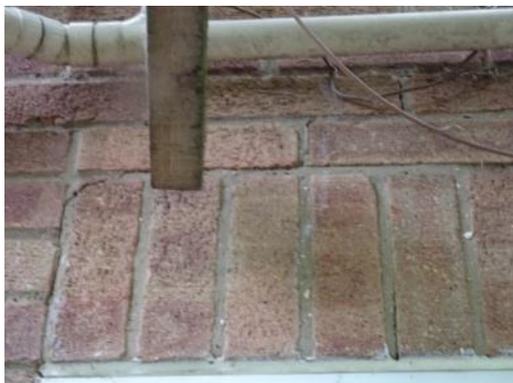
We were unable to identify lintels above the windows. Slight dropping of the brickwork above the windows was noted. Initially we would advise that the cracked mortar pointing is raked out with the brickwork then repointed with a suitable colour mortar to match with the repair then used as a visual monitor. Should further cracking above the windows occur, it will then be necessary to open up the brickwork above the windows to confirm the existence of lintels with lintels then installed if necessary.

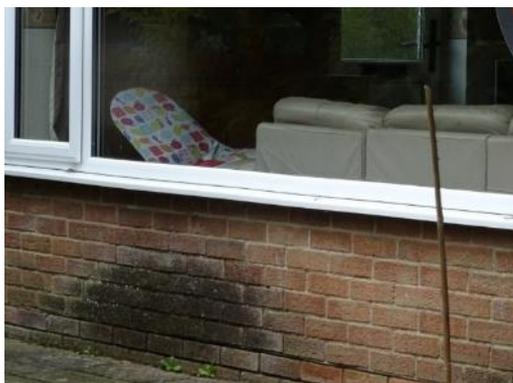
Staining was noted to the brickwork beneath the snug window where the gutters were noted to be overflowing. Once it can be confirmed that the gutters are free flowing, we would then advise that the brickwork is cleaned with a soft wire brush.

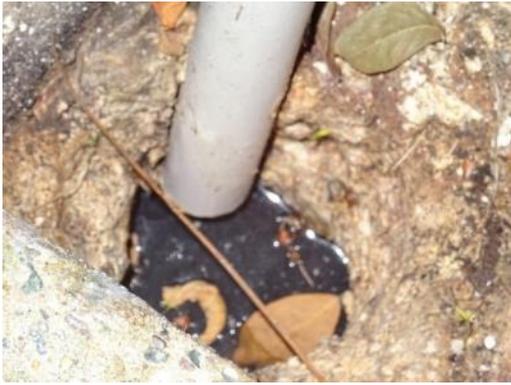
The wastepipe serving the kitchen discharged over an open gulley which was noted to be defective. We would advise that the open gulley is replaced with a proprietary unit in order to prevent risk of escape of water around the gulley.

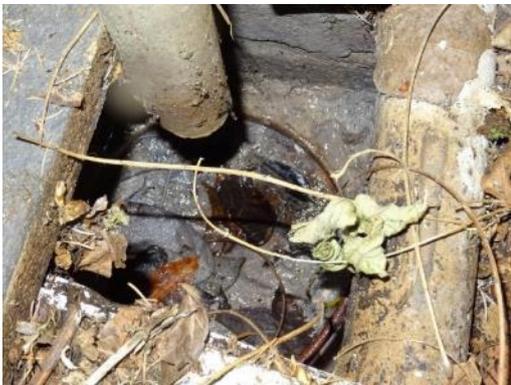
The left hand wastepipe discharged over an open clay gully which was noted to be heavily blocked at the time of our inspection requiring clearing in the immediate term.

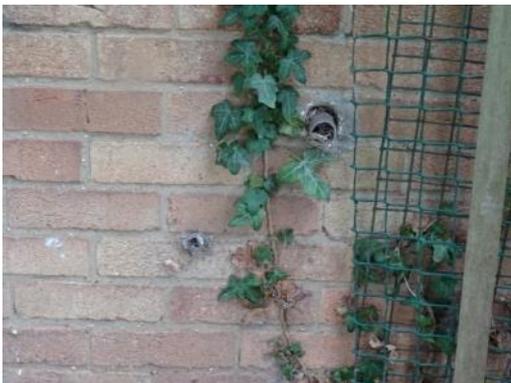
A redundant wastepipe is located to the right hand side of the elevation which we would advise is removed with the opening then filled in order to prevent risk of vermin ingress.

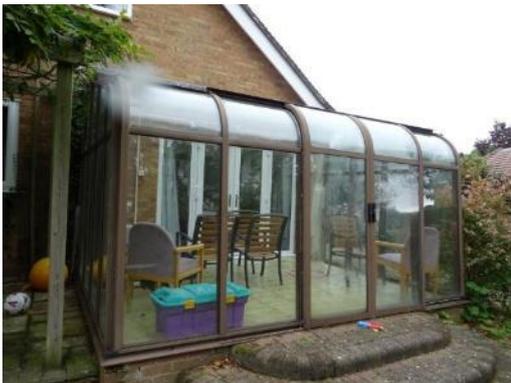
An aluminium framed conservatory incorporating full height double glazing has been installed to the right hand side of the elevation. The conservatory is dated and at the end of its serviceable life, therefore we consider it would be more economical to demolish and remove rather than to continuously maintain and repair. Until such time that the conservatory has been replaced, it will require ongoing maintenance and repair in order to keep it weathertight.

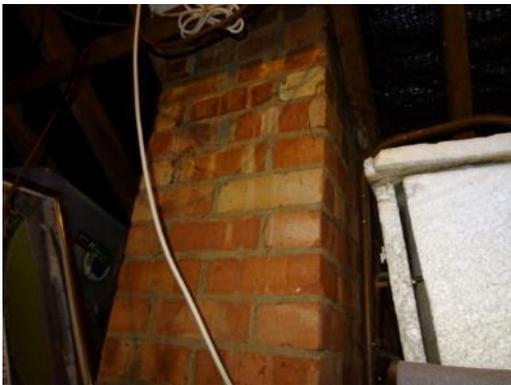
The cold water tanks are located within the roof void which are dated with the lids noted to be missing. Until such time that the cold water tanks are replaced, we would advise that the lids are reinstated in order to prevent vermin entering the tanks.

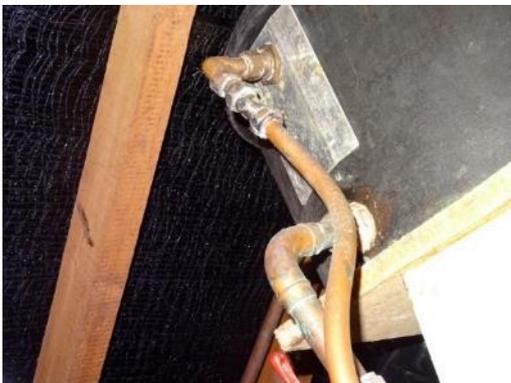
Wasps' nests are evident within the roof void which although no active, we would advise that these are removed.

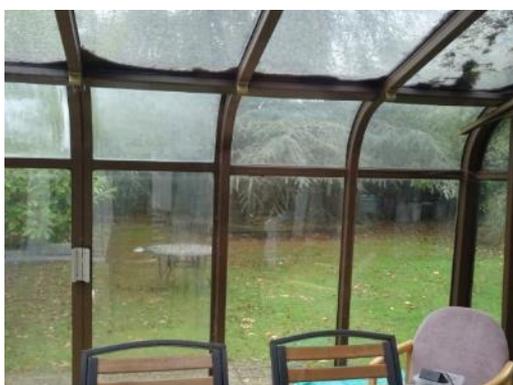
Localised damp staining was noted to the underside of the skylights where we consider the seals to have failed.

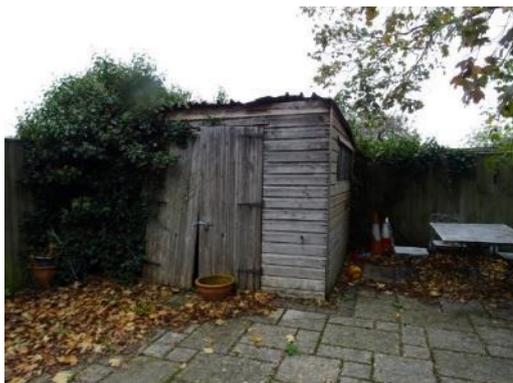
The boundaries around the garden are denoted by timber featheredge board with no significant damage noted. The fencing running along the left hand side of the garden was noted to be leaning over suggesting that the supports require replacing.
