# Building Survey

# Project Preface

**Document prepared by:** Matthew Baker BSc (Hons) MRICS

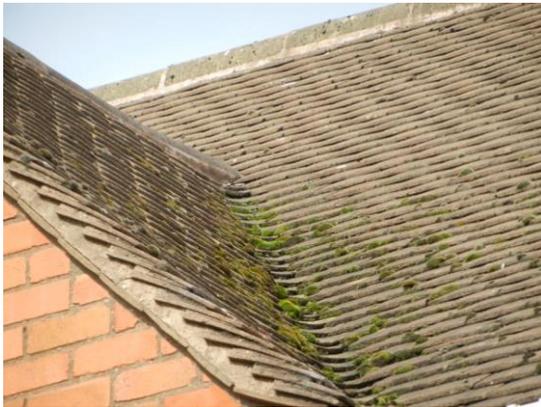
Roof areas appear to be in generally satisfactory condition. We note that there is a build up of moss to the valleys either side of the gable and we would recommend that these be cleared in the short term to prevent water penetration at this point.

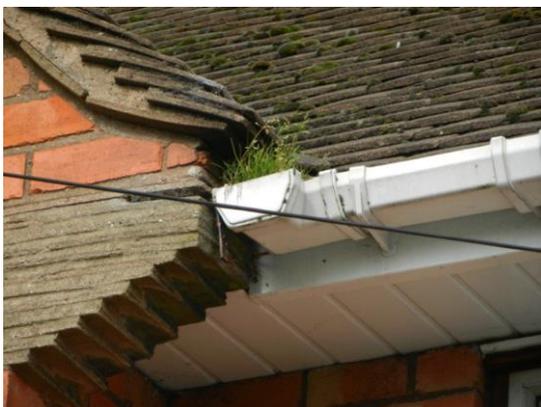
The rainwater goods to the property appear to be in a generally fair condition. Again these are noted to be blocked in a number of places and we would recommend that these be cleared in the immediate term to prevent saturation of the building fabric beneath.

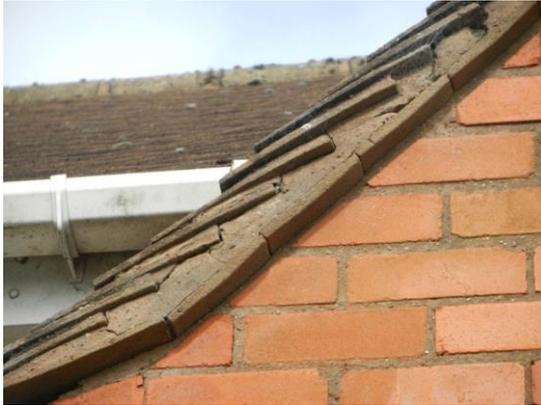
Brickwork to the property appears to be in generally fair condition. There are no significant defects noted with the mortar pointing to the property. We would anticipate some minor re-pointing will be required to brickwork at low level in the short term although this is not deemed to be significant and should be incorporated within a pro active maintenance plan for the property.

There is some minor cracking to the verge pointing although this is not significant and again should be incorporated within a pro active maintenance plan for the property.

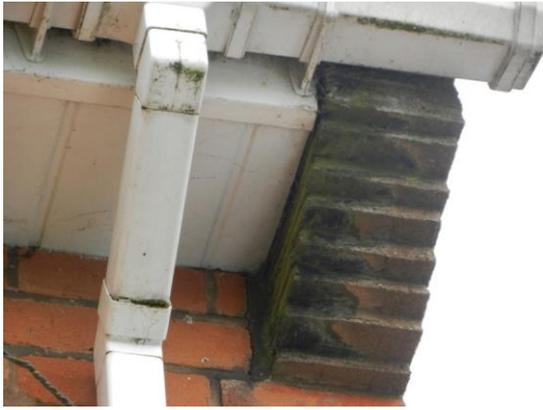
The decorative finish to the timber frames to the windows is in a fair condition although we would anticipate that this will require re-decoration in the short term. At the same time we would anticipate that the mastic bead between the timber frame and the brickwork will require raking out and re-pointing as it is showing signs of degradation in places.

There is some staining to the tiled projecting detail to the right hand side of the hopper to the front elevation. This may suggest that the gutter overflows at this point and again we would recommend that this be inspected and cleared appropriately at high level.

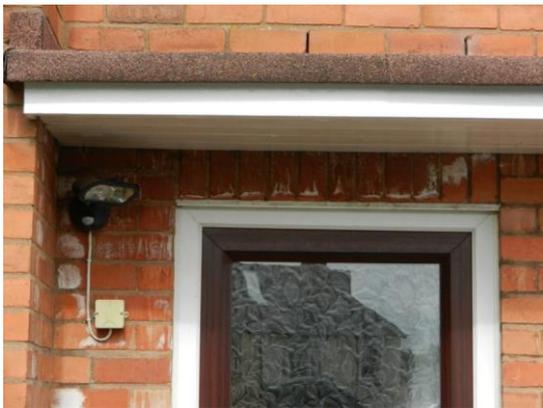
There is efflorescence and damp staining to the brickwork surrounding the main entrance door. We would assume that this is an historic damp issue as a result of a previously defective canopy. The canopy currently looks to have been relatively recently replaced and therefore we would assume that this dampness has been resolved.

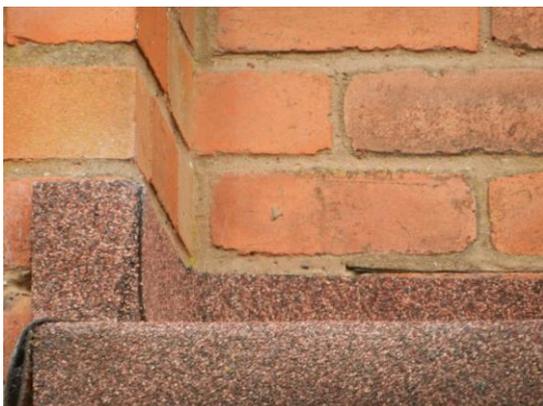
Traditionally a lead skirt detail would have been placed over the top of the upstand to the canopy to act as an additional barrier to prevent water passing between the joints with the canopy and the main brick wall. This may be of benefit to install as part of a pro active maintenance plan for the property.

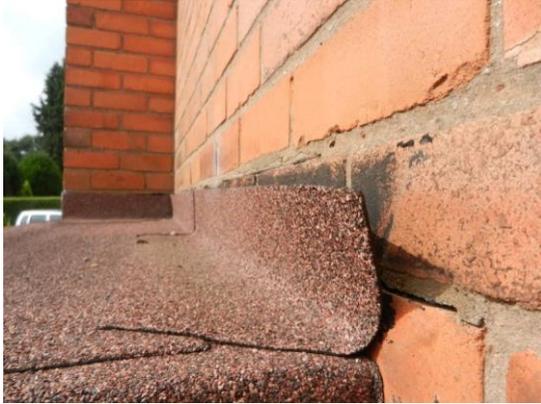
The felt work above the canopy is noted to be loose and has not been bonded correctly to the brickwork. Again we would recommend that a skirting detail be placed at this point following rectification of this upstand.

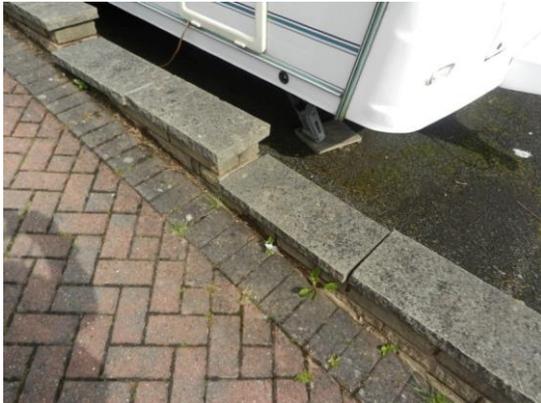
The lower level wall to the right hand boundary will likely require some repair in the short term. We note that a number of the coping stones are loose and require re-pointing.

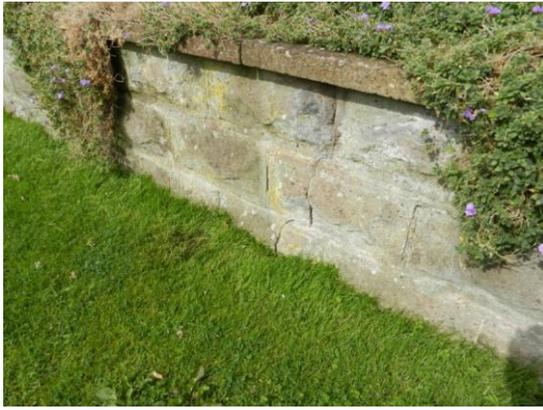
The stone wall to the boundary between this property and the paved areas is noted to be crackled and damaged in a number of places. Generally it is in a fair condition commensurate with its age, however we would anticipate that this will require some repair in the short term.

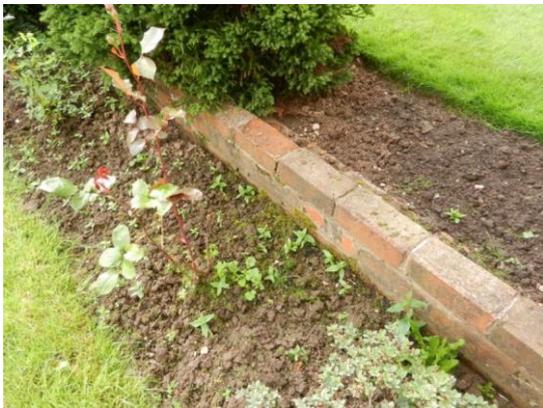
Generally the block paved areas are in a fair condition. There is some settlement in places predominantly where cars are driven or are rested. These are not significant at this time.

The low level brick wall to the left hand boundary is in a fair condition but again we would anticipate that repair will be required in the short term. You are advised to seek guidance from your solicitor as to rights and responsibilities for repair and maintenance of boundaries.

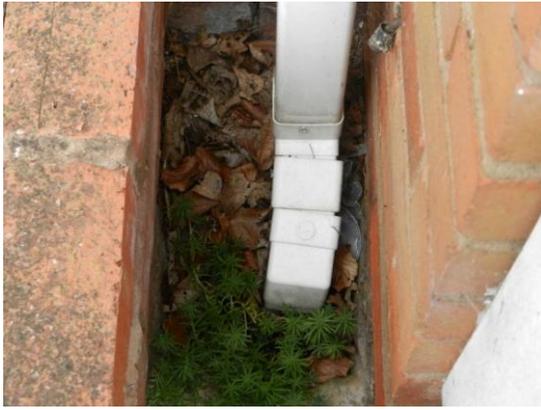
The rainwater gulley to the left hand side of the elevation was noted to be blocked. You are advised to have this cleared in the immediate term and ensure that all below ground drainage is left free flowing.

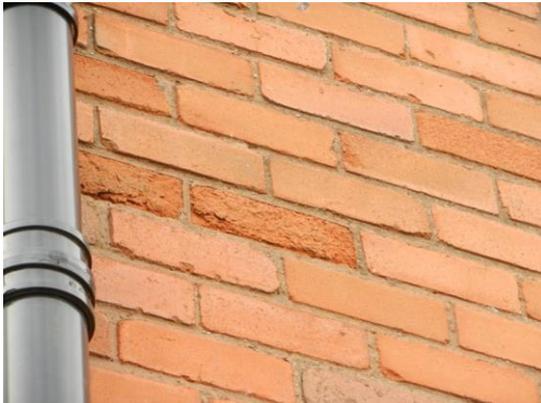
Brickwork and mortar pointing to this elevation are again in a generally fair condition. We note that there are more spalled bricks to this elevation although these are not significant in number at this time. We would recommend as part of a pro active maintenance plan that the spalled bricks be cut out to prevent accelerated damage to surrounding brickwork.

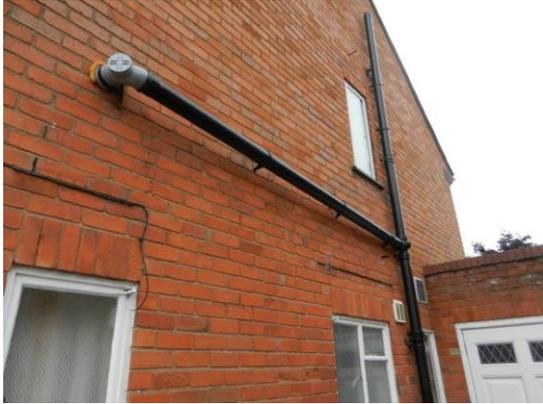
The lower sections of the cast rainwater pipe are in a generally fair condition although will likely benefit from re-decoration in the short term.

The windows to the ground floor are metal casement single glazed units set within timber frames. These are original to the property whereas the window to the first floor is a later replacement glazing, although still of some significant age. We would recommend that the timber elements of these windows be re-decorated in the short term.

The soil pipe to this elevation would appear to have been replaced or added to. We note that the brackets to the soil pipe are not fixed to the wall and we would recommend that this be re-fixed in the short term to prevent sagging of the pipe.

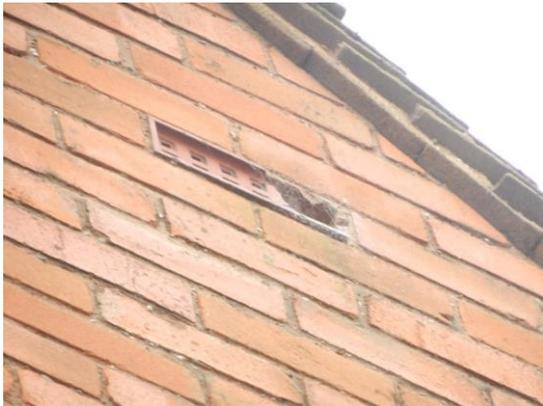
The airbrick to the gable end serving the roof void is noted to be damaged and it may be of benefit to have this replaced to prevent birds accessing the roof areas.

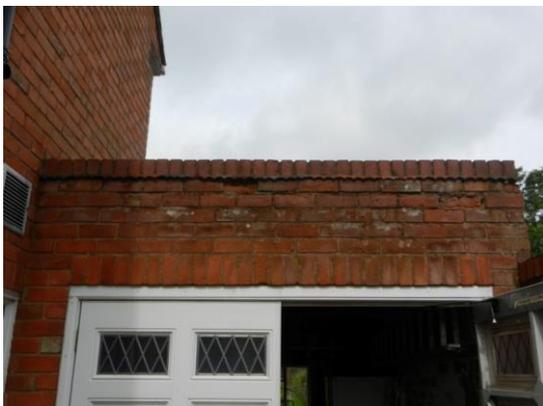
The brickwork to the parapet above the garage doors is noted to be in need of re-pointing and replacement of spalled brickwork in the short term.

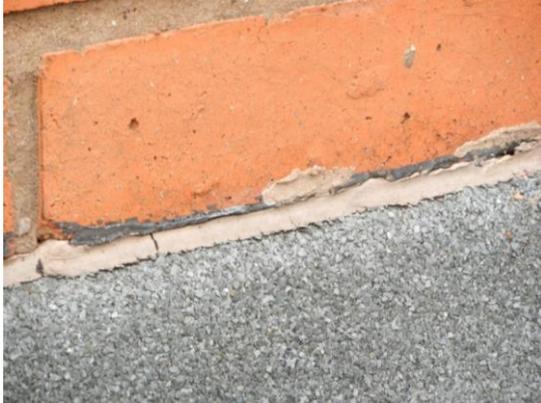
The roof covering to the garage is in a generally fair condition. We note that there are areas of pooling water and that some parts of the felt roof covering have worn more significantly than others. We also note that the detail where the felt is passed into the brickwork either to the parapet or to the main house is poor and should be raked out and renewed in the immediate to short term.

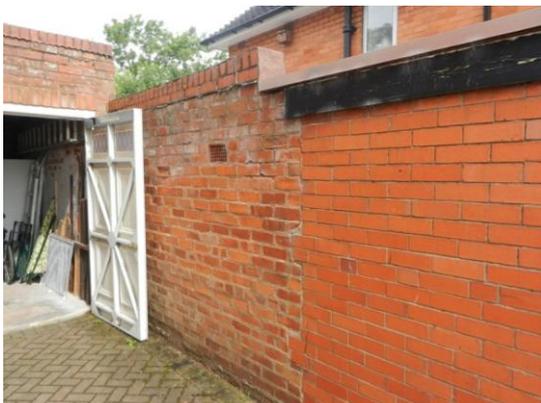
The adjoining owner's garage wall joins the boundary to this elevation. This is noted to be cracked and damaged in a number of places and it may be of benefit to monitor high level brickwork to ensure that debris does not become a falling hazard.

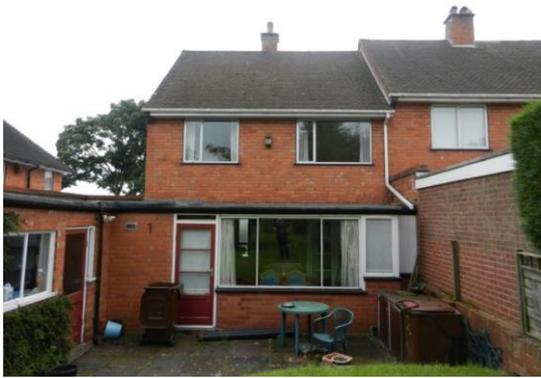
The rainwater goods appear in generally good order. The rainwater goods serving the pitched roof run down the rainwater pipe and in guttering to a single storey addition to the rear. This then runs across the face of the single storey addition into a hopper fixed just outside the door leading to the garage. This is quite a long run and we would anticipate that this may become blocked during heavy wet weather conditions. It is also possible there is a slight back fall to the guttering to the single storey addition which will also contribute to any overflowing of the gutters.

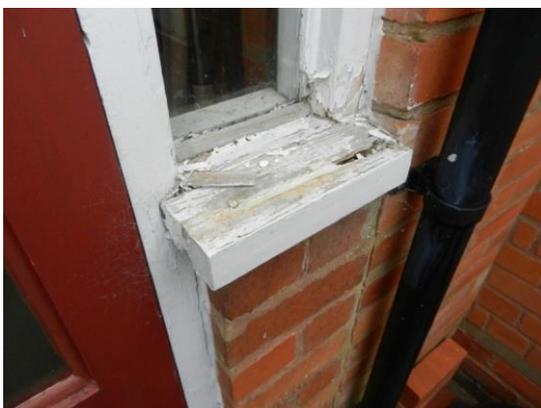
We would recommend that all timber work to windows and doors to the rear elevation be re-decorated in the short term. We note particularly that the timber windows to the garage are in a particularly poor condition and will likely require significant repair as part of the re-decoration work.

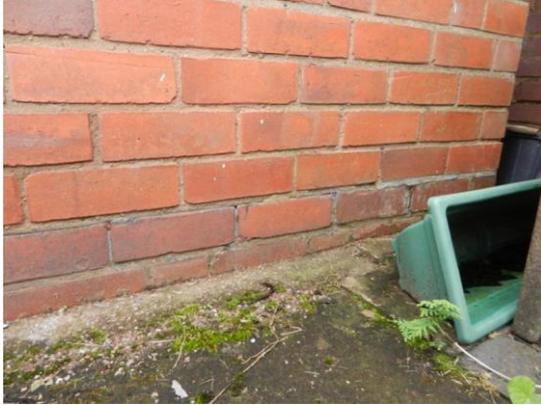
Generally brickwork to the rear elevation is in a satisfactory condition. We note that there is some missing mortar pointing from DPC and brickwork beneath although this is not a significant issue at this time and should be incorporated within a pro active maintenance plan for the property.

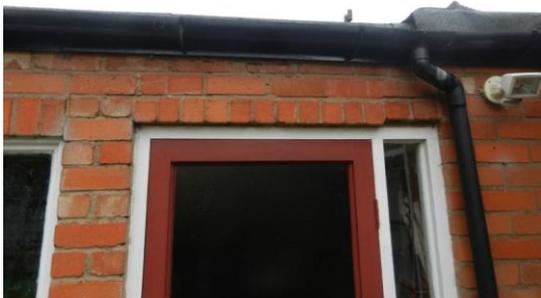
The brick panel to the head of the door leading to the garage would appear to be partially resting on the door frame. Although this gives the appearance that it has dropped it is highly probable that this was just original poor constructional detailing and that in fact the brickwork was built like this. It should be considered that this rear addition is a later extension and given this detail above the garage door is likely to be of a generally poor quality of construction.

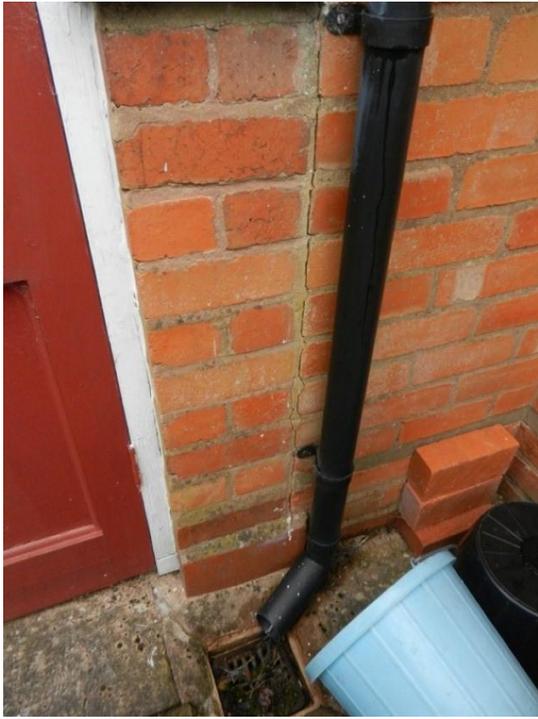
There is cracking to the brick joint between the later addition and the extension. This is not entirely unexpected and is likely a result of differential movement at this point. We would recommend that this be re-pointed in the short term to prevent accelerated damage during freezing weather conditions.

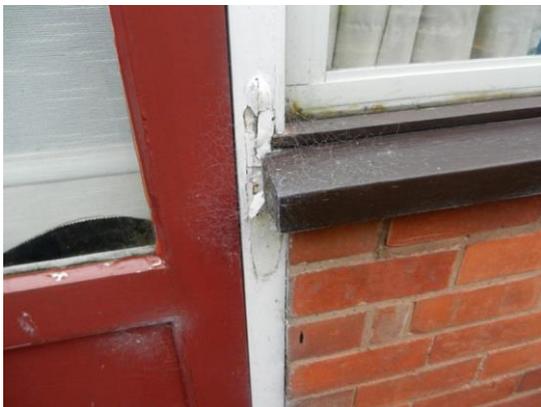
The timber frame to the door leading to the dining area is noted to be in need of significant repair and we would recommend that this be incorporated within the next cyclical re-decoration programme.

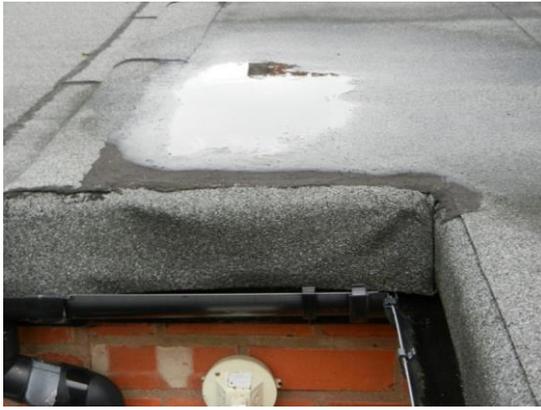
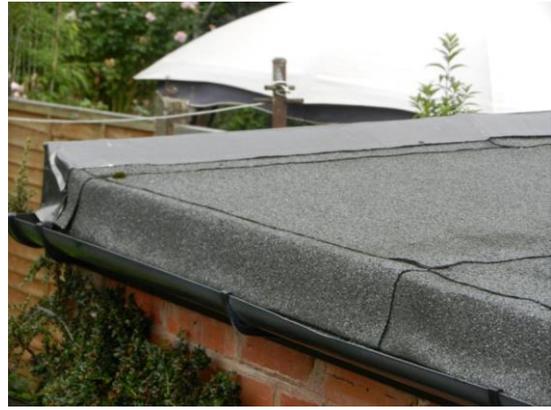
The flat roof areas to the single storey addition again appear to be in a generally fair condition. We do note areas of some poor detailing with regards to the application of bitumin joints and a use of a flashband type material to the garage. We would anticipate that repair will be required to these flat roof areas in the short term with consideration given to their recovering in the short to medium term.

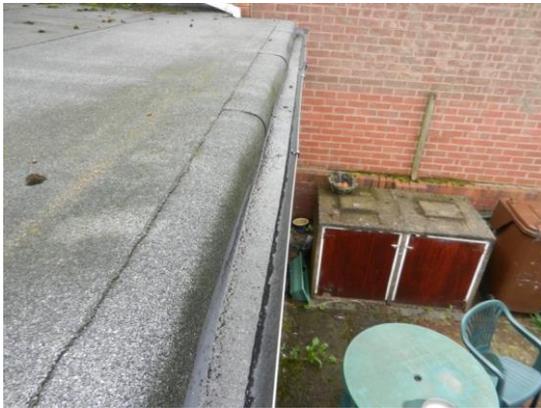
Sediment within the rainwater goods would suggest that, as suspected, there is a back fall and these will likely overflow during heavy wet weather condition.

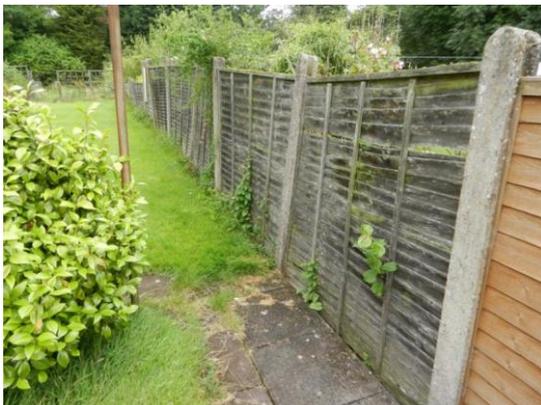
The timber boundary fencing to the right hand side of the property is noted to be in a generally poor condition and will likely require significant repair in the short term. You are advised to seek guidance from your solicitor as to responsibilities for repair and maintenance of boundary fencing.

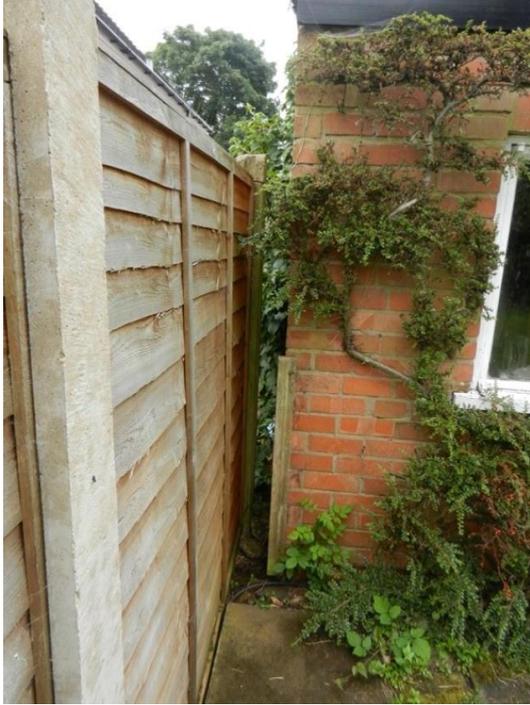
As you face the garage from the rear elevation the rear timber fencing appears to extend further than the outer face of the garage. Again we would recommend that you confirm with your solicitor the precise extent of the boundary associated with this property.

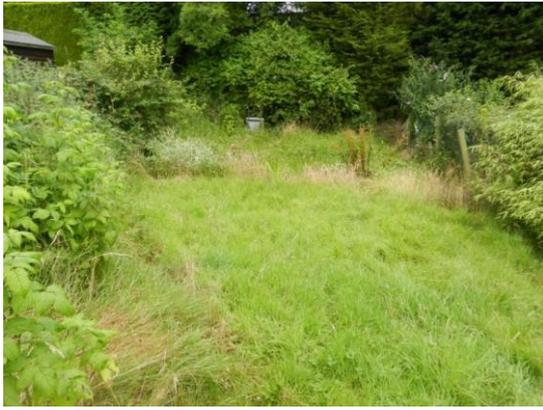
Pavings to the rear garden areas are generally fair although uneven, with damaged paving slabs in a number of places. We would anticipate this will require repair in the short term and would recommend that this be incorporated within a pro active maintenance plan for the property.

There is a section of garden toward the bottom of the garden areas that are clearly not accessed on a frequent basis. These are significantly overgrown which restricted the inspection of these areas. We would anticipate that some repair and maintenance will be required in the immediate to short term in order to utilise this area.

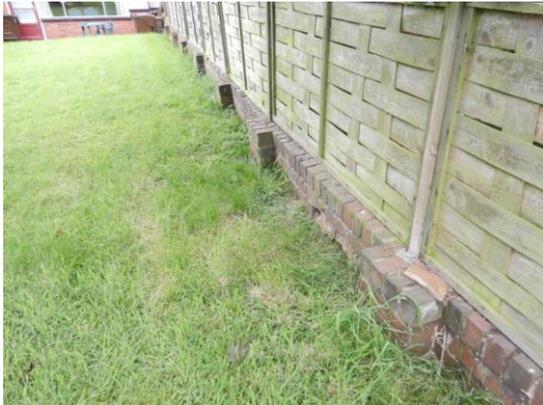
Low level brick walling to the left hand boundary is noted to be damaged and rotating in a number of places. We would anticipate that significant repair will be required to this brick walling in the short term. Again we would recommend that you seek confirmation from your solicitor as to responsibilities for repair and maintenance of perimeter boundaries.

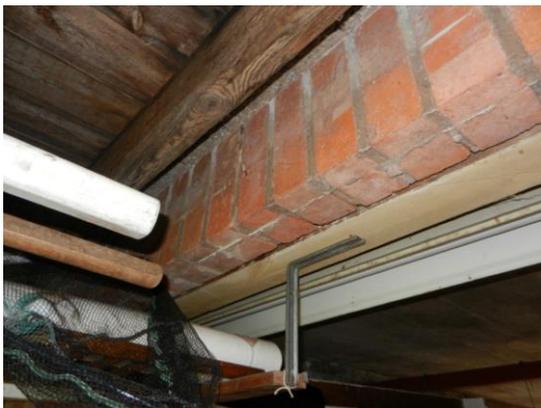
To the junction between the original garage and the later addition the original brickwork and timber lintel remain. It should be noted that the brick soldier course would once have obtained further support from the window frame that would have once have been in this position. Should the mortar pointing deteriorate at this point this soldier course is likely to fail and therefore this should be monitored.

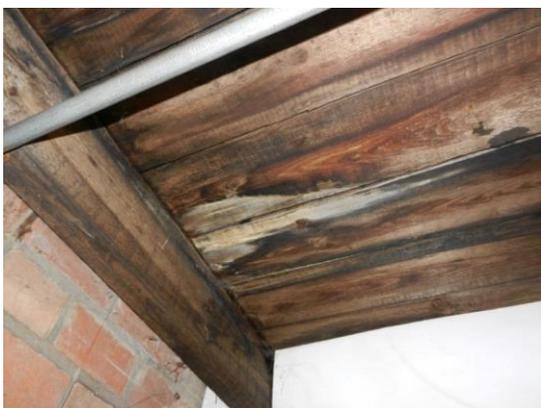
There is some minor evidence of dampness to the timber deck.

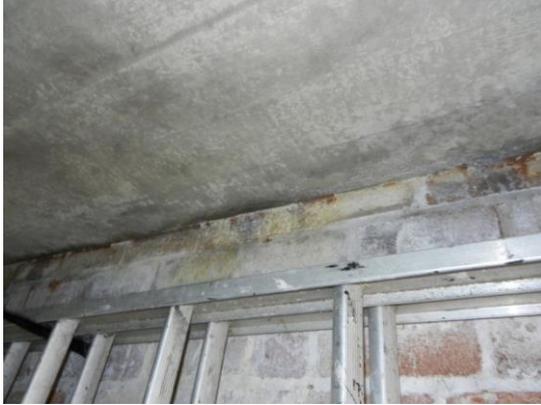
There is evidence of some dampness to the brick wall to the right hand side of the garage. This is likely associated with defects with the upstand, although they appear generally satisfactory on the day of the survey and therefore this may well be historic.

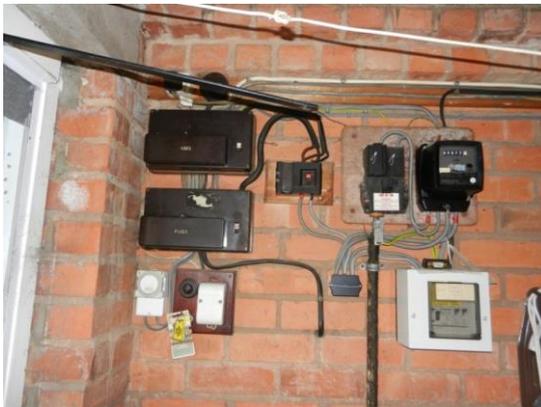
Within the garage is the electrical distribution board for the property. This is of some significant age and we would anticipate it will require some upgrading in the immediate to short term.

We would recommend that you obtain an NICEIC test certificate for the electrical installation.

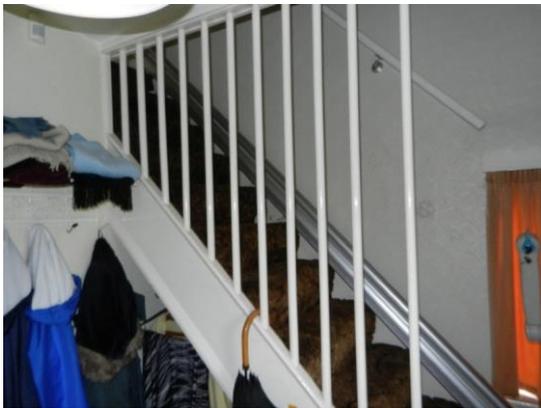
The spindles to the banister meet with current statutory requirements with regards to being less than 100mm apart. However due to the flexibility it is possible to move them slightly further than recommended and therefore it would be of benefit to take care should children be accessing the property.

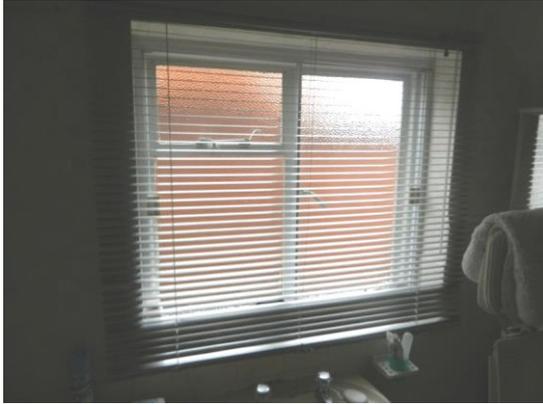
As the bath is also used for a shower. We would deem the glazing to the window to be in a critical location and therefore the glazing should either be a safety glass or have a safety film applied.

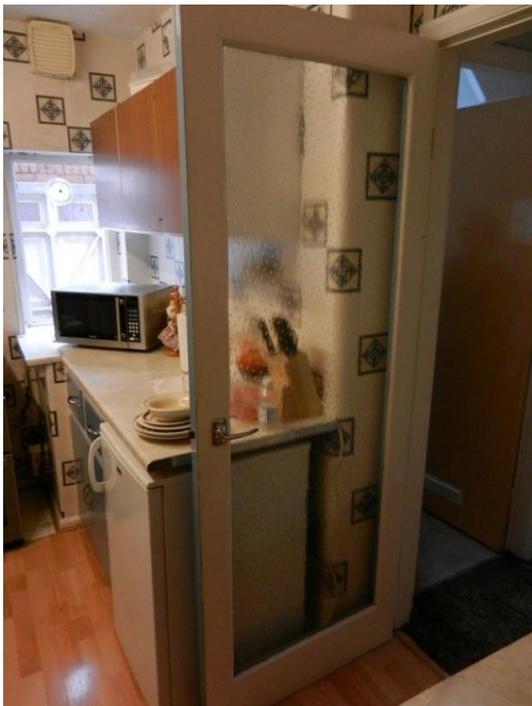
The door leading from the kitchen to the hallway is deemed to be in a critical location and therefore the glass should either be safety glass or have safety film applied.

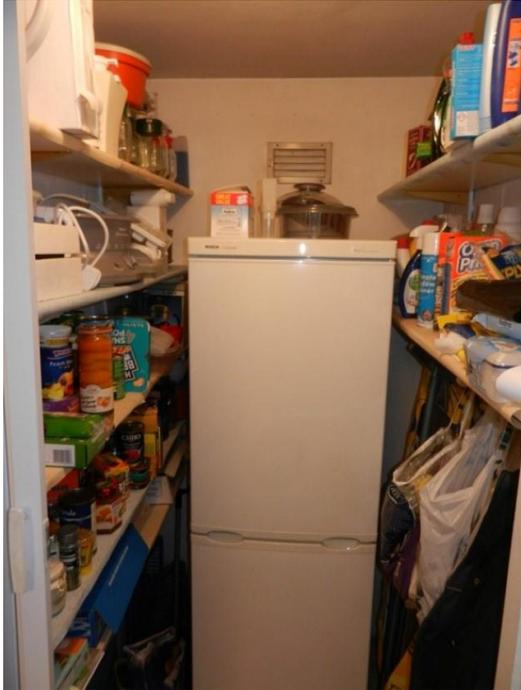
The pantry area is deemed to be in a generally fair condition. A full inspection was restricted due to the quantity of the current occupant's belongings within this area.

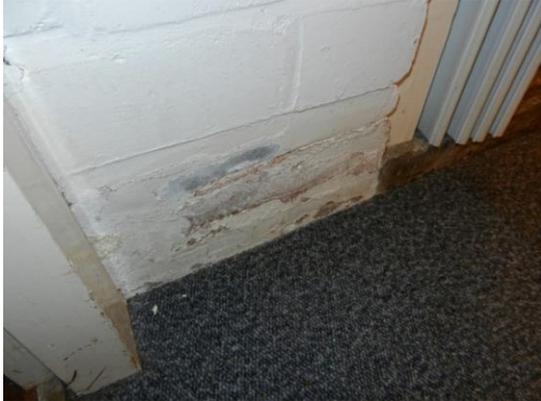
The lobby is in a generally fair condition although again we note low level dampness. This will likely once have been external. Should you wish to refurbish this area to be in keeping with the rest of the property we would anticipate that some further damp proofing works will be required.

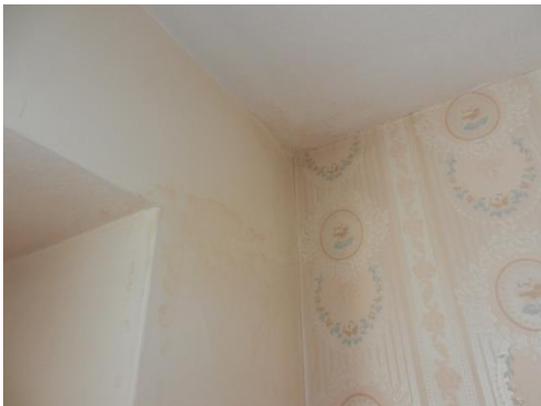
There is damp staining to wall areas to the right hand side of the window. These are likely to be associated with the defects of the valley, possibly as a result of them being blocked which have already been noted externally. We have recommended this be inspected at high level by a competent roofing contractor to identify the source of the defects and carry out all of the works required.

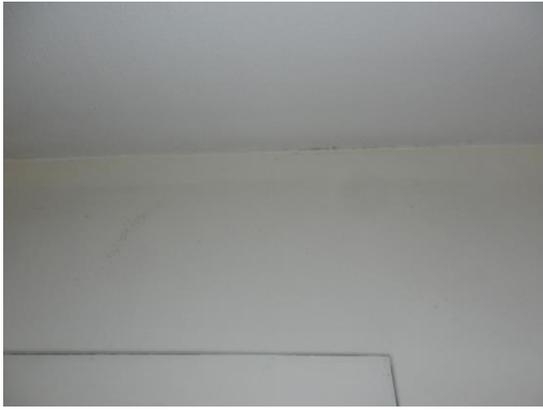
There is again further minor evidence of damp staining to the head of the small window. This is again likely associated with the defect to the valley gutter and we would again recommend that this be inspected at high level.

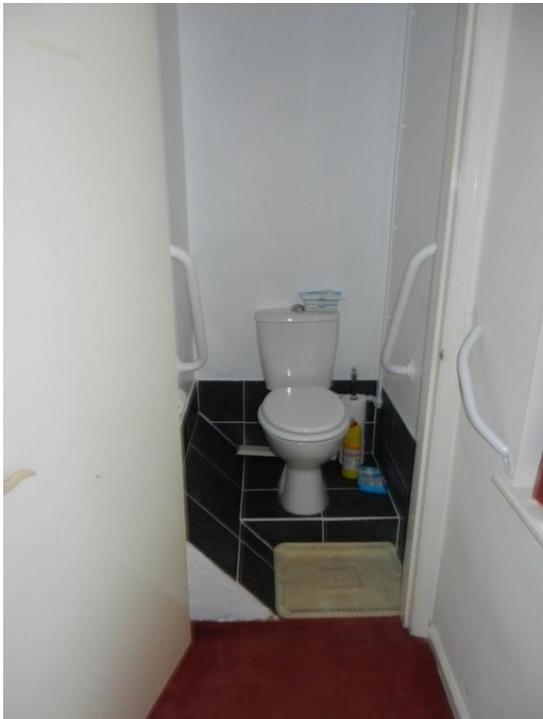
Within the cupboard off of this bedroom a wc has been installed. This appeared to be in generally fair condition on the day of the survey.

It may be of benefit to have an extractor fan installed within this wc area. The facility as it stands would certainly not comply with current regulations however it is clearly has been installed to suit the current occupant.

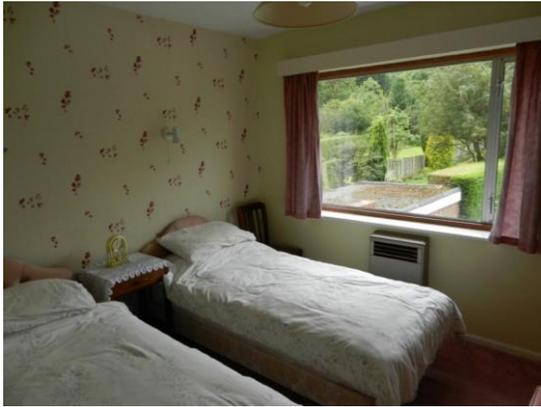
The electric fire within this room is again of some significant age and we would not recommend this be used until it has been appropriately tested.

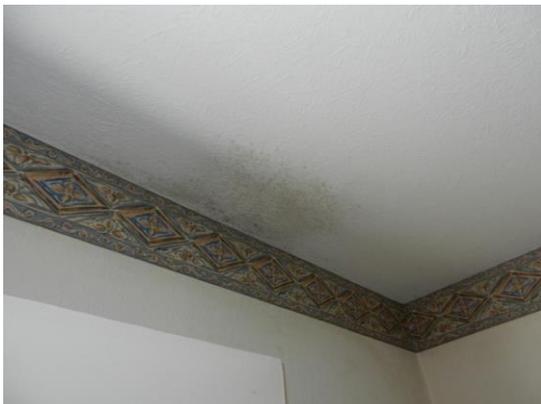
There is some damp staining noted to the ceiling above the windows, as we have already recommended that a roofing contractor carry out an inspection to roof areas to the front of the property we would recommend that inspection be carried out at this point to identify the source of this defect.

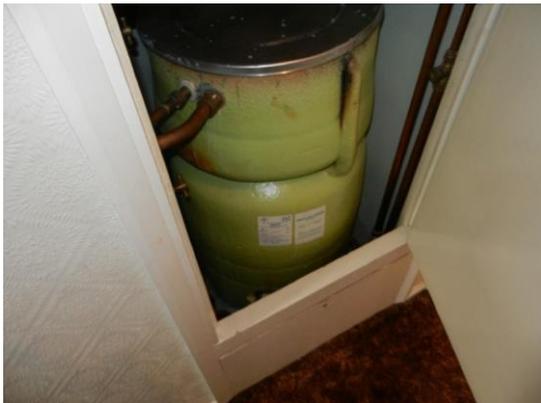
To the cupboard off the landing is the hot water cylinder. We would recommend that you obtain any service records regarding its installation and given the general age of the cylinder, we would anticipate that some upgrading will be required in the short term.

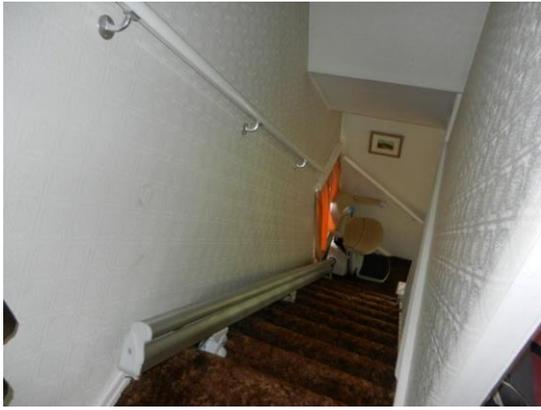
Clearly the staircase has a chair lift installed at the moment. Should this be removed then some alteration will be required in terms of lowering handrails.

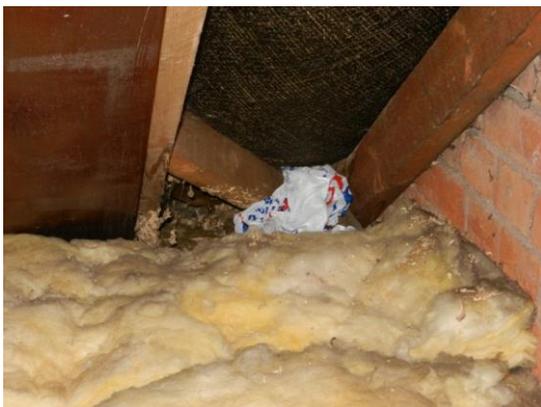
There is evidence of damp staining to timber to the base to the valleys. This would match with the staining noted to the front bedroom and we have already recommended that an inspection be carried out at high level by a competent roofing contractor.
