Structural Feasibility Report

Relating to: Removal of Column and Walls at
XXXX
XXXX
XXXX

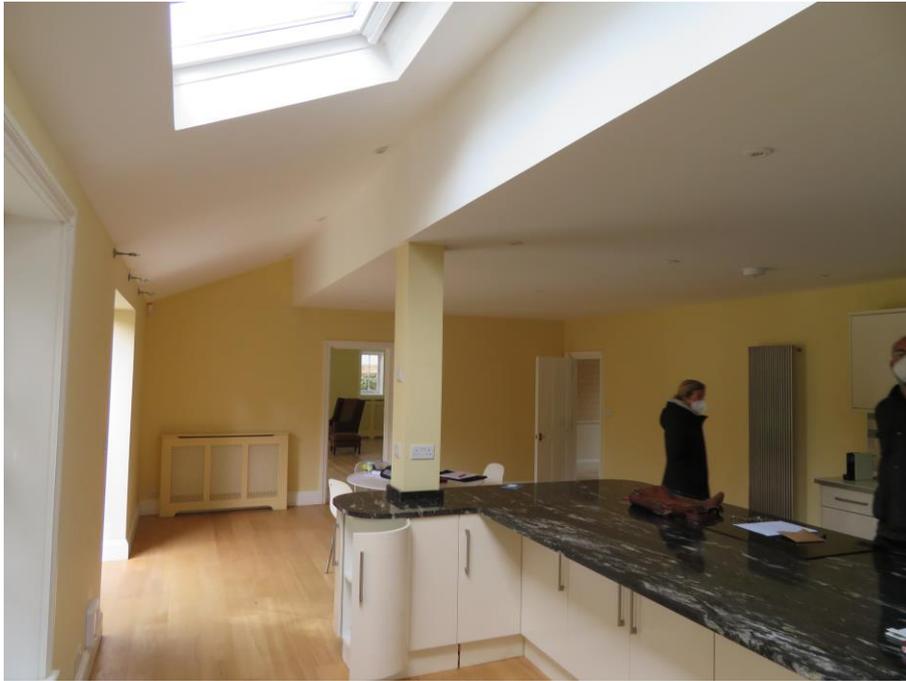
Within the kitchen, a single column labelled P2 is located at the junction beneath the original rear elevation and the wall between the bedrooms above. This is a 139.7x6.3 CHS (circular hollow section) steel column, encased with a plasterboard boxing approximately 230mm x 230mm on plan. This can be seen in the following photograph.

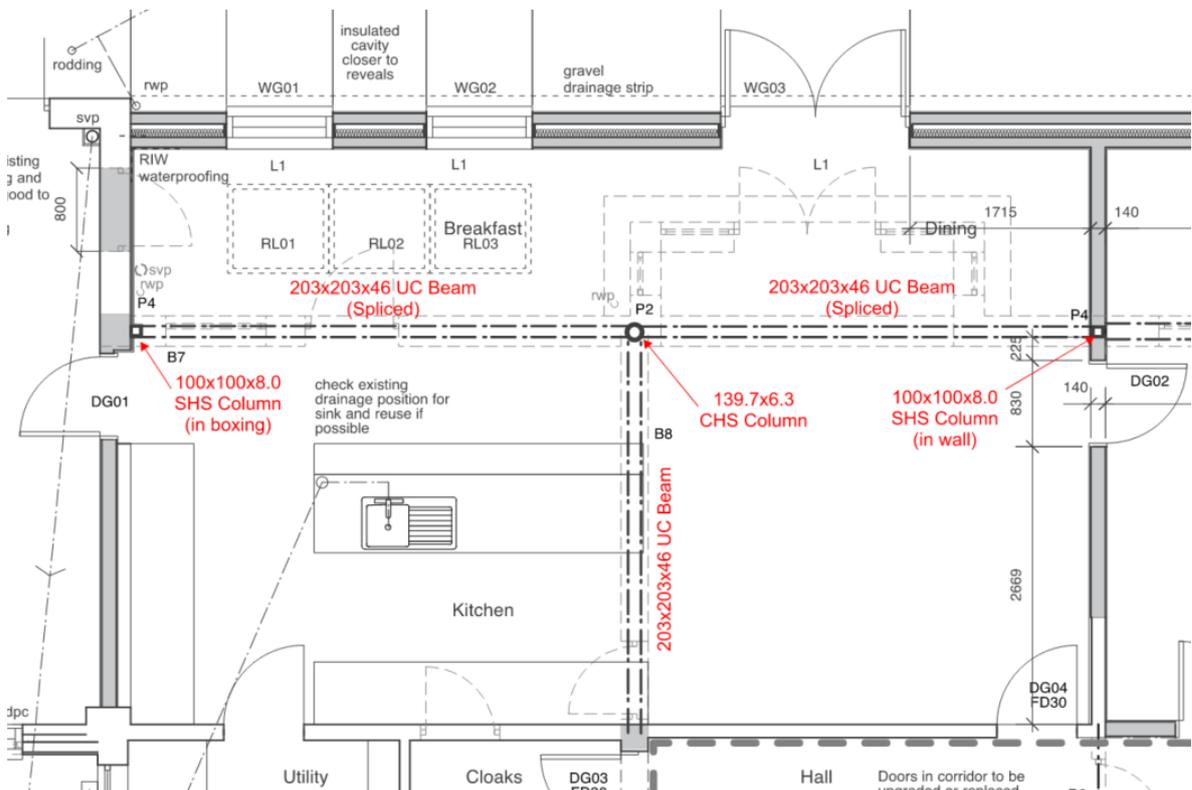
The column supports 203x203x46UC steel beams in two directions in the ceiling above. At either end of the kitchen, the steel beams are supported on 100x100x8 SHS (square hollow section) steel columns. These are indicated on the following extract of the kitchen plan. The structural drawings indicate that the 203x203x46UC beam running parallel to the rear elevation is continuous through into the living room, and that it was spliced into sections approximately 2-3m long to facilitate installation.

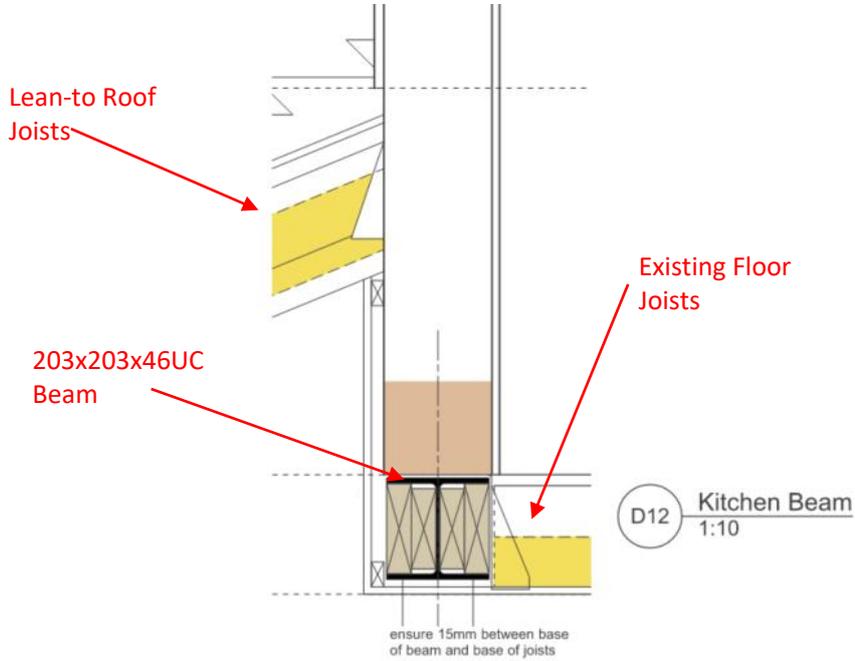
Detail D12 taken from the architectural drawings indicates that this 203x203x46UC beam is positioned within the depth of the existing floor joists, which have been modified to hang off the steel beam via joist hangers. Refer to detail D12 below.

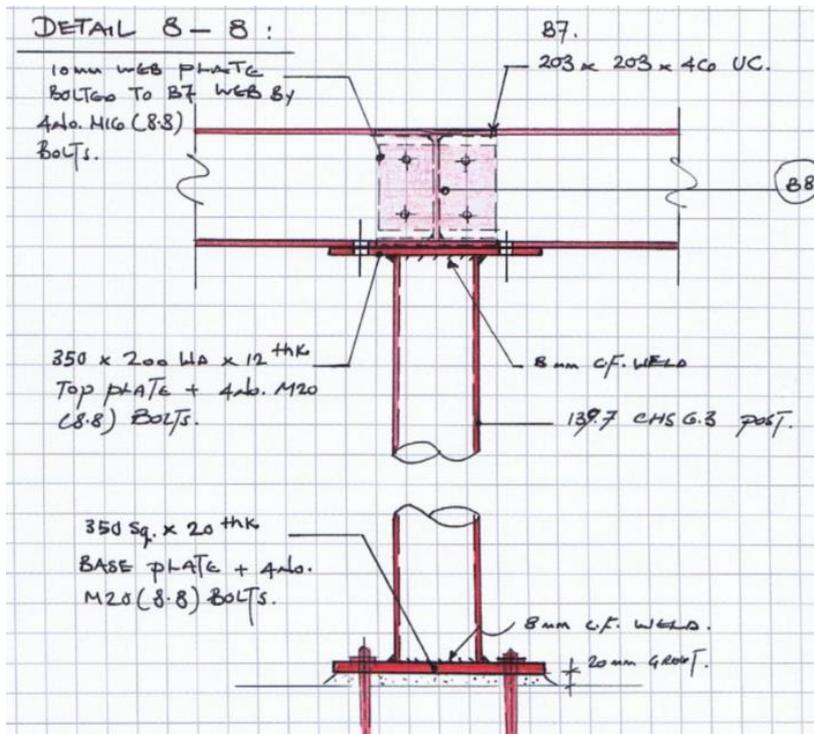
Detail 8-8 from the structural engineer sketches confirms that this 203x203x46UC beam is continuous over the head of the CHS column and can be seen in the extract below.

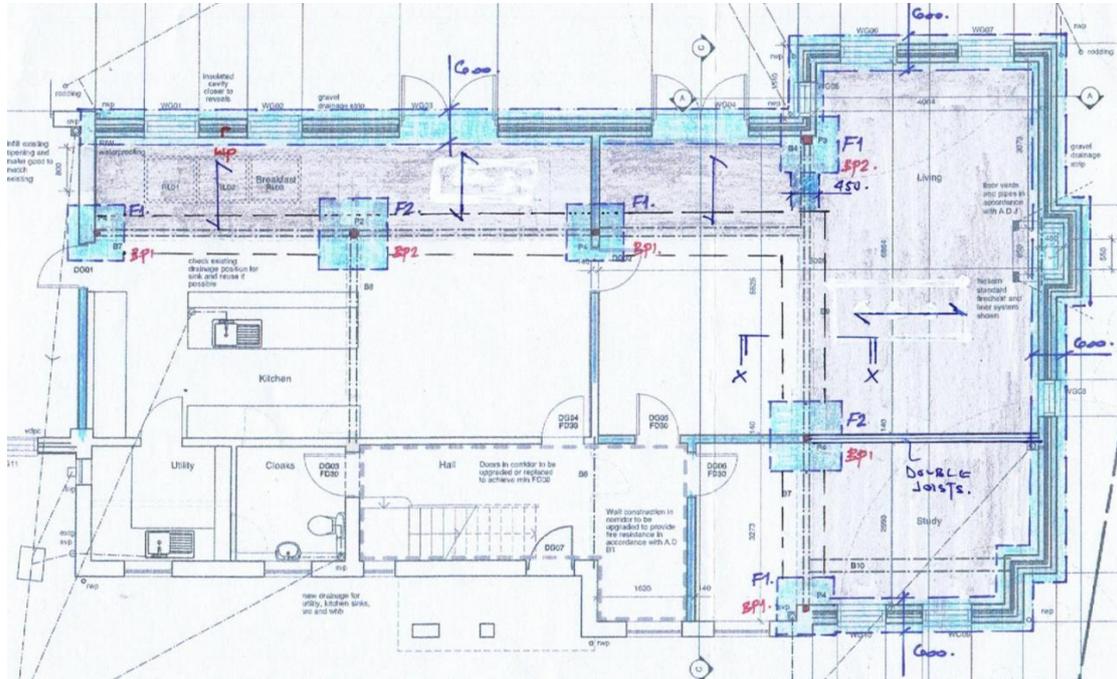
The foundation drawing SK-03 indicates that the CHS column is founded on a 1250x1250 concrete pad footing (reference F2), which the SHS columns at either end of the kitchen are founded on 1000x1000 pad footings (reference F1), as can be seen in the drawing extract below.

The drawing notes that all foundations are to be cast in GEN3 concrete, therefore they are mass concrete (i.e. without steel reinforcement). The depth of the footings is not confirmed on the drawing, however based on the plan dimensions we would assume they are at least 500mm deep.

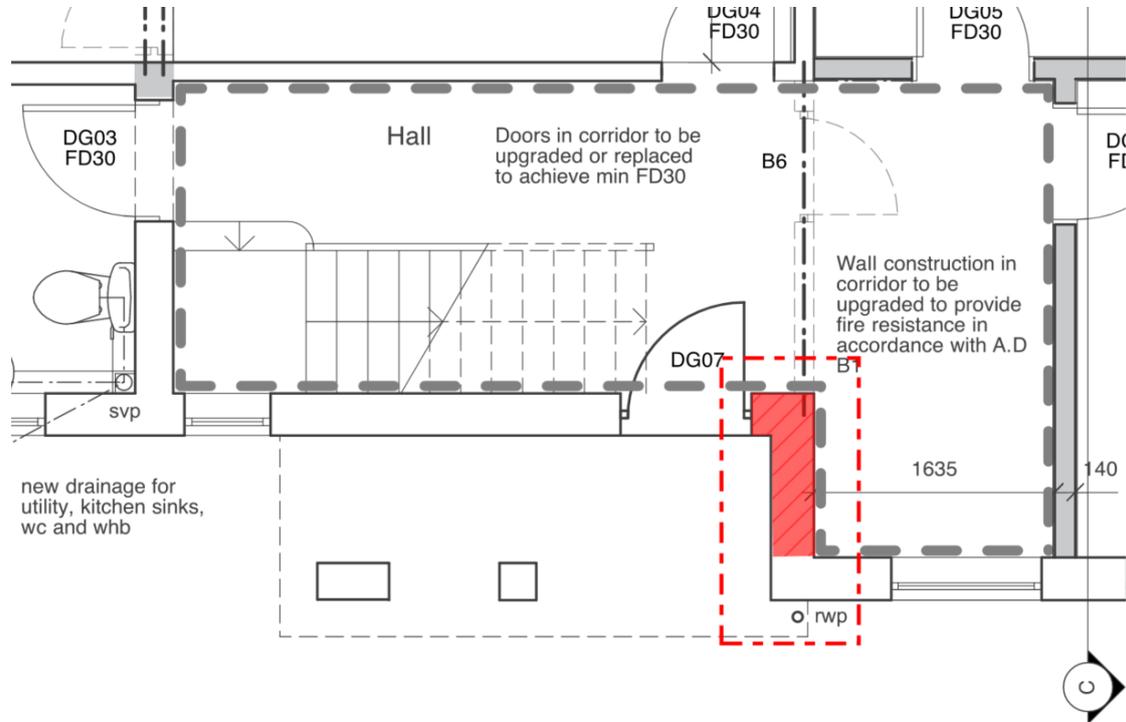
We understand that the client is considering building out beneath the existing porch canopy to the front door, and questioned whether it would be possible to remove the right hand side wall as shaded in red in the ground floor plan extract below.

As can be seen from the plan, an internal wall on this line was removed during the 2012 works and replaced with a steel beam labelled B6 (152x89x16UB section) which bears on to the corner of this wall. The wall will also be providing lateral support to the front elevation.

Given these factors, and the extent of previous wall removal, we recommend that this section of wall is retained to maintain stability to the front elevation.

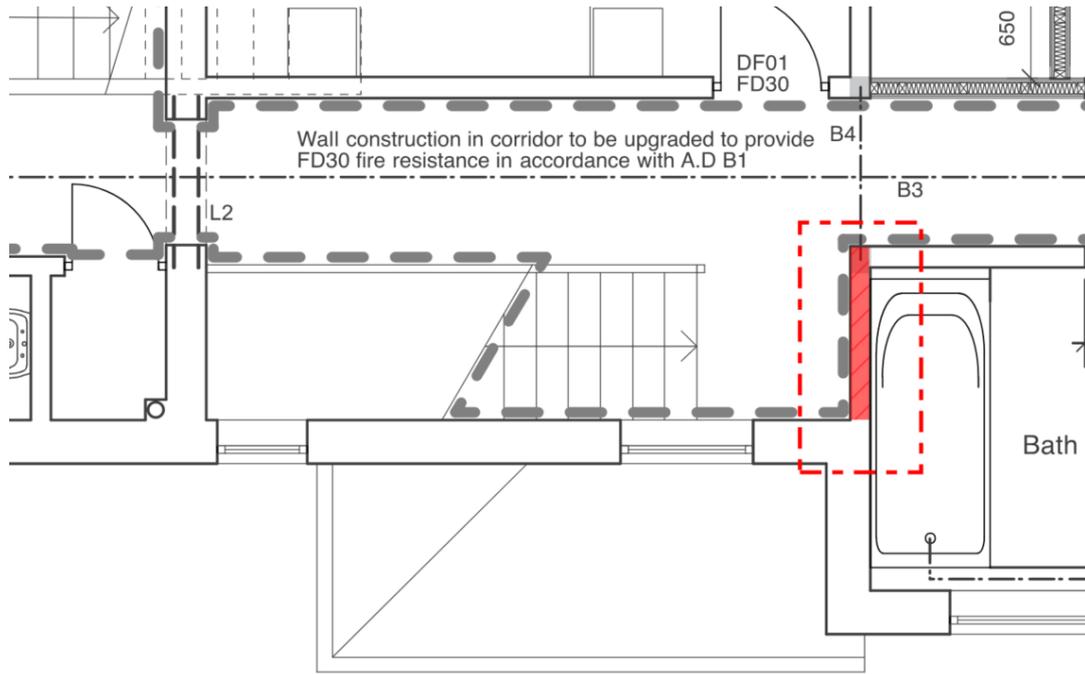
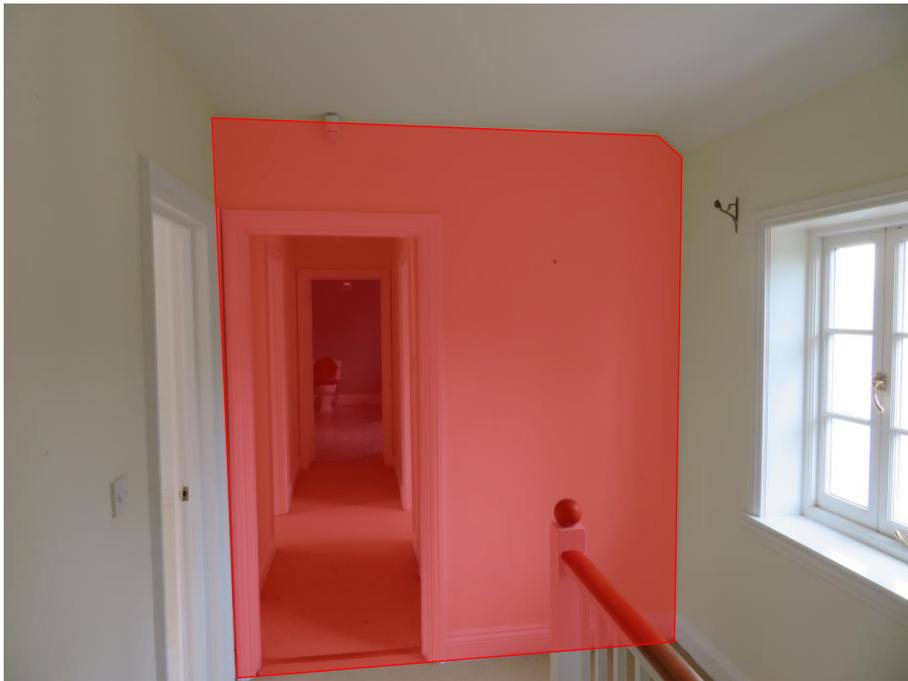
At first floor it was queried whether the wall between the landing and the bathroom could be removed, as shaded in red on the flooring plan extract and photograph. From our inspection on site, it appears that the wall is a combination of studwork and solid masonry. The structural drawings show that a steel beam labelled B4 (100x100x5.0 SHS) is supported on a 440x100x215 padstone to the right hand side of the existing opening. The beam will be supporting the floor to the loft conversion above.

It is feasible to remove this wall without impacting on the stability of the front elevation, as the external wall returns outwards at this location. A new steel beam would be required to be installed over to maintain support to the floor above. We anticipate that a 152x89x16UB similar to that in the same location at ground floor would be sufficient (subject to confirmation through detailed design).

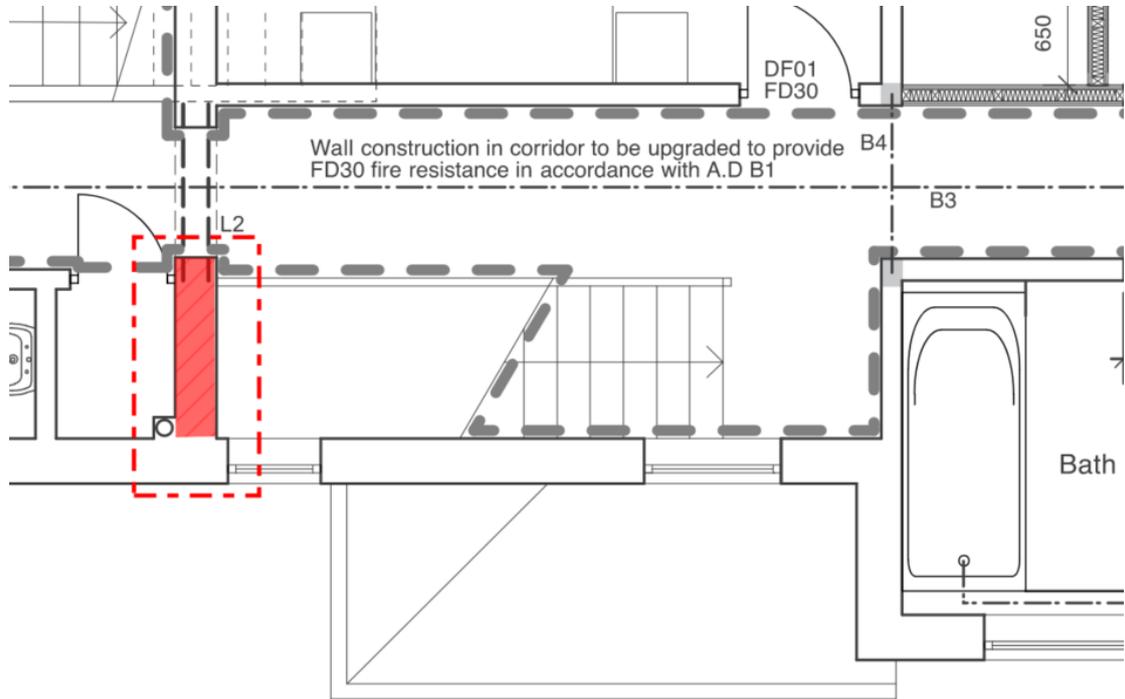
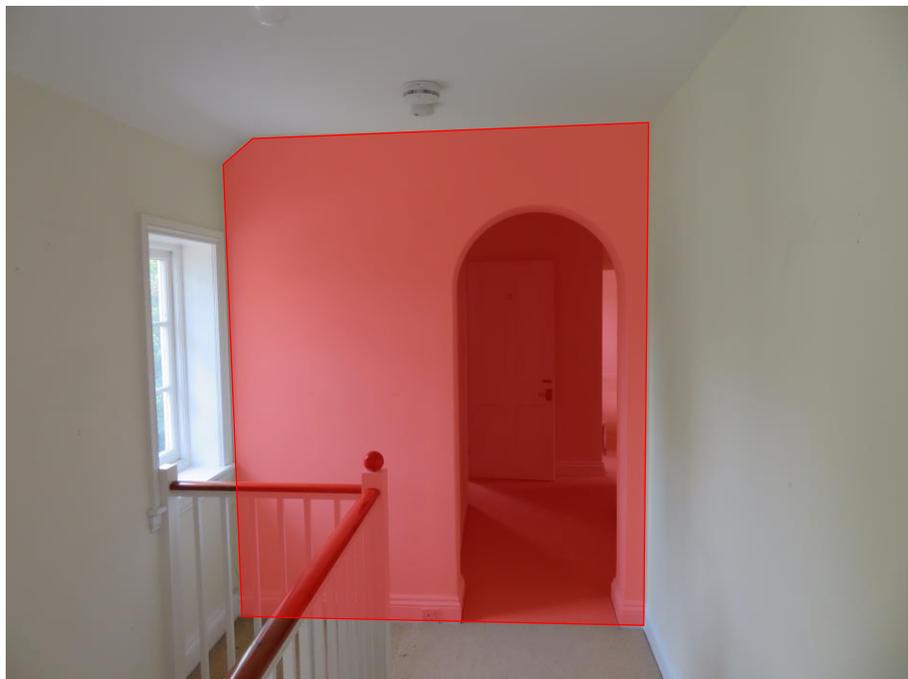
To the other side of the landing as first floor, it was also queried whether the wall between the landing and the water cylinder cupboard could be removed, as shaded in red on the flooring plan extract and photograph.

From our inspection on side, it appears that the wall is solid 225mm thick brickwork. The structural drawings show that a pair of precast concrete lintels labelled L2 (2no. 140mm deep by 100mm wide) are located above the arched opening.

Given the thickness of this wall, it will be providing lateral restraint to the front elevation, which is important as it is directly adjacent to the stair void, therefore the wall is not restrained by the floor in this location.

In light of this, it is possible to cut the wall back to increase the width of the opening, but we would advise against removing it completely. To maintain lateral restraint, in accordance with Building Regulations Approved Document A the minimum length of the wall providing lateral restraint should be at least 3 times the width of the external wall, or 675mm, which means that an internal projection of 450mm should be retained. A new pair of lintels or a shallow beam will need to be installed to maintain support to the floor above.
