Sulfate damage to concrete floors on sulfate-bearing hardcore

Identification and remediation

Ian Longworth, MSc(Eng), CGeol, CSci,
BRE Associate, Materials and Engineering Group,
Building Research Establishment

February 2008
Department for Communities and Local Government

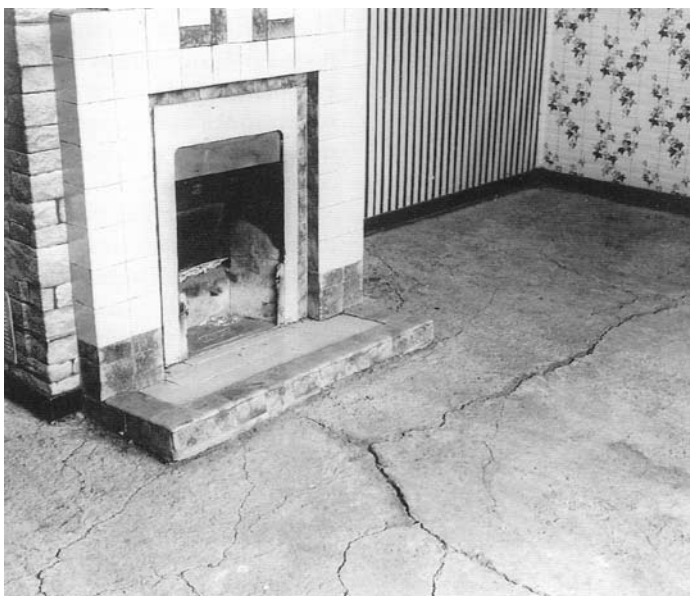
Figure 1: Distortion and cracking of a concrete floor slab caused by sulfate attack. Damage is greatest in front of the fireplace where water, carrying sulfates from underlying hardcore, has been drawn through the slab by heat from the fire.

Sulfate-bearing hardcore, derived from colliery spoil and other industrial by-products, was included in the construction of many thousands of domestic properties in the period 1945–1970, as support for concrete floor slabs, without the use of a separating damp-proof membrane. The legacy has been a continuing occurrence of damage to floor slabs and abutting walls as sulfate from the hardcore has reacted with the overlying concrete resulting in cracking, expansion and deformation. Figure 1 shows typical damage to a floor slab in a house built in the 1950s.

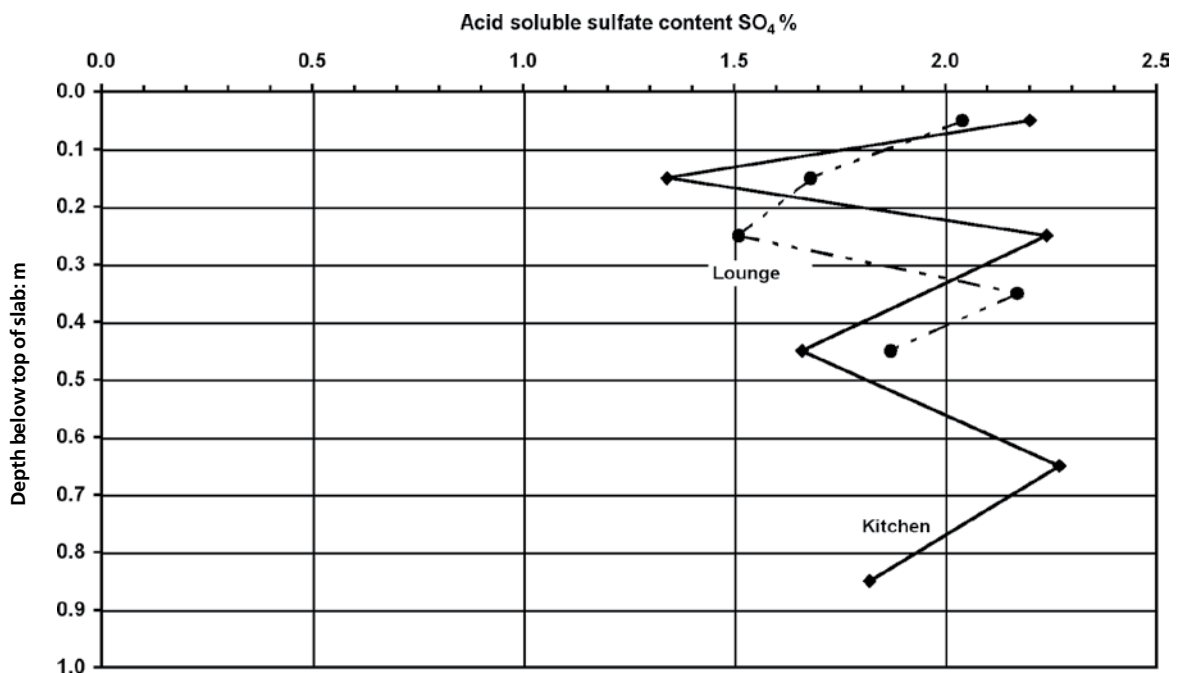
Figure 2: Acid-soluble sulfate contents in burnt colliery spoil (red shale) sampled at depths below a concrete floor slab in a 40 year old house. The values, which represent the total amount of sulfates present in the hardcore, vary erratically with depth from 1.3 to 2.25 per cent SO_4 , reflecting the original variability of the hardcore.

Figures 2 and 3 show sulfate contents measured by the Building Research Establishment (BRE) in burnt colliery spoil (red shale) hardcore sampled at depths below a concrete floor slab in two rooms (kitchen and lounge) of a house in Stoke on Trent. Total amounts

Overall, the variability of results (some 70%), demonstrates the inappropriateness of evaluating the potential for future sulfate attack using just one or two test results on a house as the sole criterion.

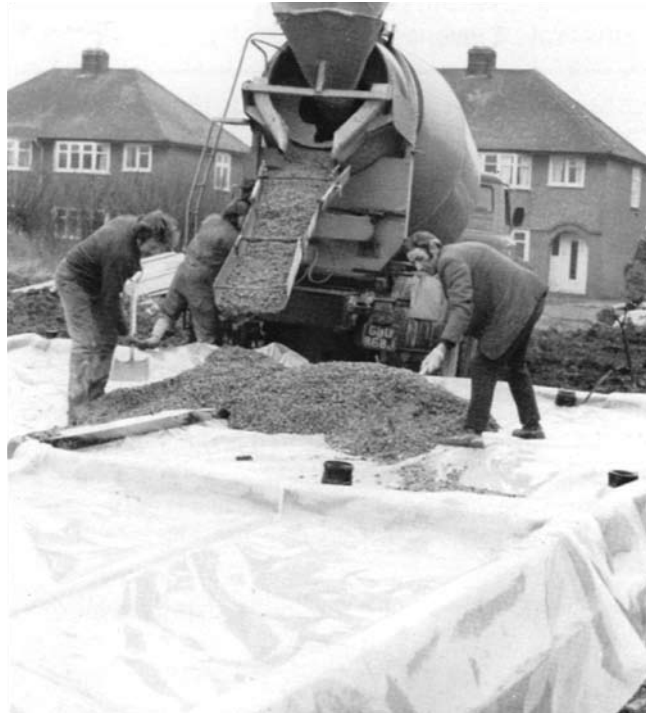
Figure 4: Laying of concrete in the mid 1970s on a 300 micron damp-proof membrane that has been placed over hardcore in the foundations of a house.

- Sulfate migration from hardcore into concrete may be prevented by the use of a separating membrane. Polythene sheets, installed primarily as a damp-proof membranes (DPM), began to serve this purpose from the mid 1960s, and became almost universal for concrete slab construction on sulfate-bearing hardcore by the early 1970s. DPMs installed in the 1960s were typically only 500 gauge (125 micron) thick, and doubts have been cast by some practitioners on their effectiveness as a barrier to sulfate migration. However, no case of deleterious sulfate attack where such a membrane was installed has been brought to the attention of BRE. Thicker membranes that are more resistant to perforation during installation were installed in later decades (eg Figure 4), the current standard being 300 micron.

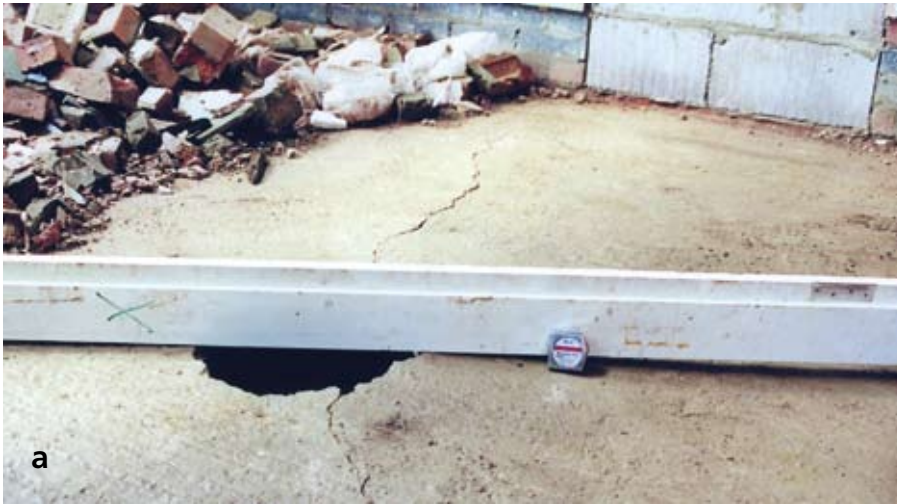
Figures 7(a, b & c): Sulfate-attacked oversite concrete that was laid over plaster contaminated brick rubble beneath a suspended wooden floor (here removed together with the sleeper walls).
 (a) An improvised straight edge shows some 50 mm doming of the oversite concrete that lifted brick sleeper walls and wooden floors.

Figures 7(a) to 7(c) show sulfate attacked oversite concrete that was laid over plaster contaminated brick rubble beneath a suspended wooden floor of a bungalow in the West Midlands. The concrete, much softened as result of TSA, domed upwards in several rooms lifting the sleeper walls that supported the floor. The doming was accompanied by radiating and map pattern cracks.

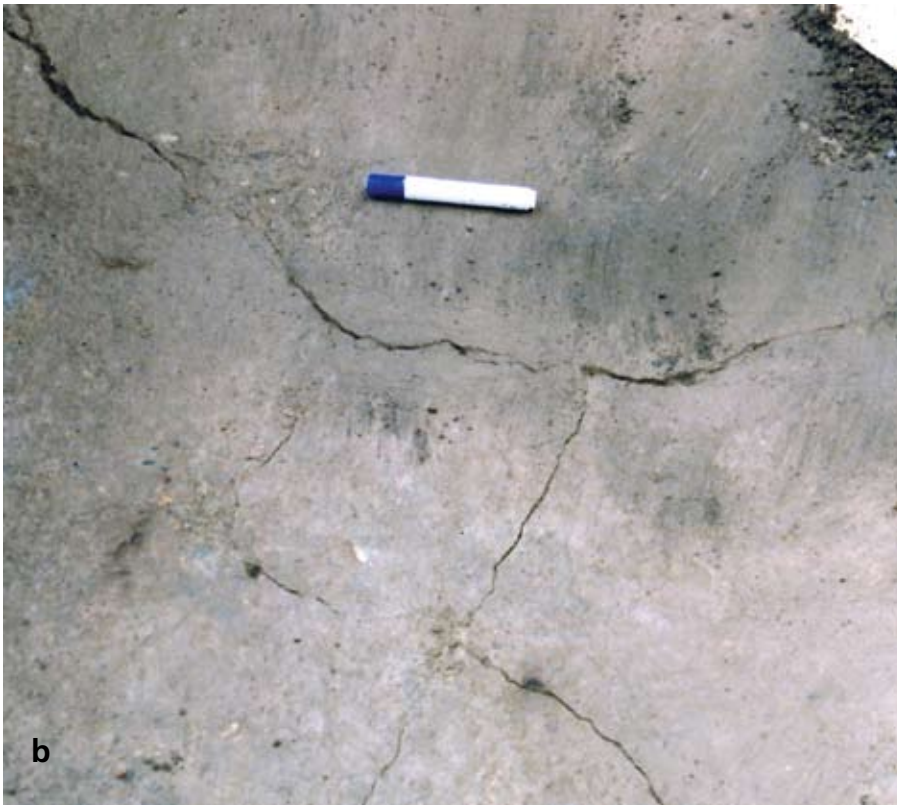
(b) Map pattern cracks in sulfate-attacked oversite concrete beneath a suspended wooden floor of an adjacent room.

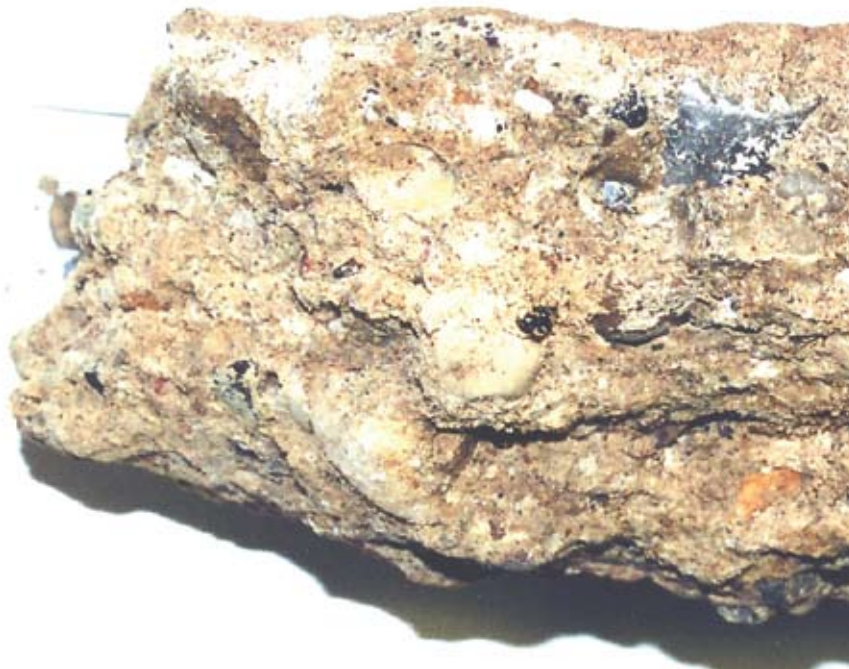
c

(c) 70 mm thick sample of oversite concrete affected by TSA. The concrete has been softened and discoloured white and yellow-brown. Much white thaumasite can be seen in the upper part of the section. Concrete missing from the bottom of the section was so friable it fell away during sampling.

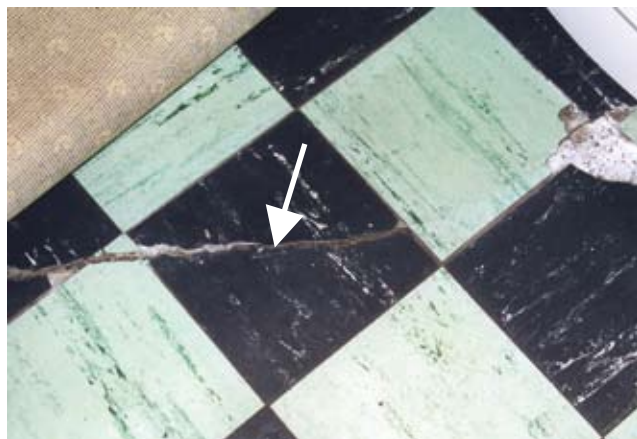
Figure 9: Stepped crack in floor of 1950s house that may indicate sulfate attack. The unevenness could be felt through the (rolled back) carpet.

The first visible sign of sulfate attack to a concrete floor slab is usually some unevenness in the floor. This may be accompanied by appearance of cracks in the concrete screed and floor finish that are at first narrow, but which widen with time (eg Figure 9). The unevenness of the floor will typically progress into an obvious heave and there may be increasing difficulty in using internal doors as a result of the lower edge

fouling the floor. However, lifting is generally highest in the centre of the room resulting in a doming in the floor that is detectable with an adequately long straight edge. The doming is commonly accompanied by a radiating or map pattern of cracking, with some cracks making vertical steps in the floor of the order of several millimetres.
