Sulfate damage to concrete floors on
sulfate-bearing hardcore
Identification and remediation

Ian Longworth, MSc(Eng), CGeol, CSci,
BRE Associate, Materials and Engineering Group,
Building Research Establishment

February 2008
Department for Communities and Local Government

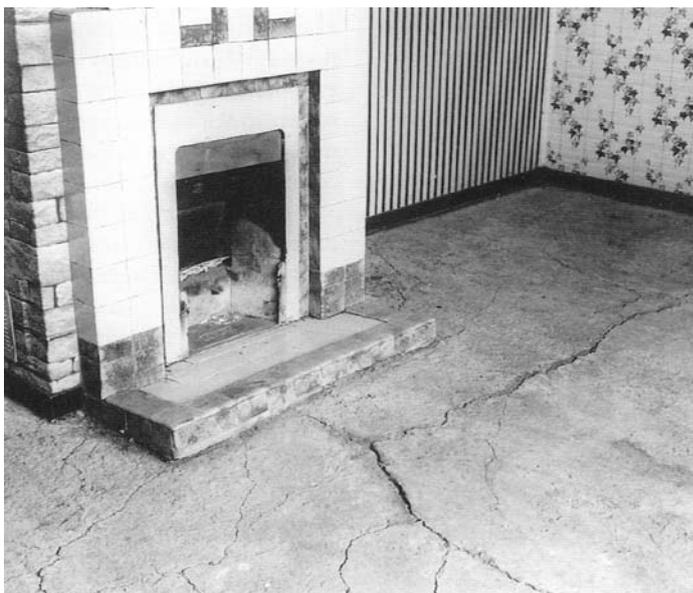
Figure 1: Distortion and cracking of a concrete floor slab caused by sulfate attack. Damage is greatest in front of the fireplace where water, carrying sulfates from underlying hardcore, has been drawn through the slab by heat from the fire.

Sulfate-bearing hardcore, derived from colliery spoil and other industrial by-products, was included in the construction of many thousands of domestic properties in the period 1945–1970, as support for concrete floor slabs, without the use of a separating damp-proof membrane. The legacy has been a continuing occurrence of damage to floor slabs and abutting walls as sulfate from the hardcore has reacted with the overlying concrete resulting in cracking, expansion and deformation. Figure 1 shows typical damage to a floor slab in a house built in the 1950s.

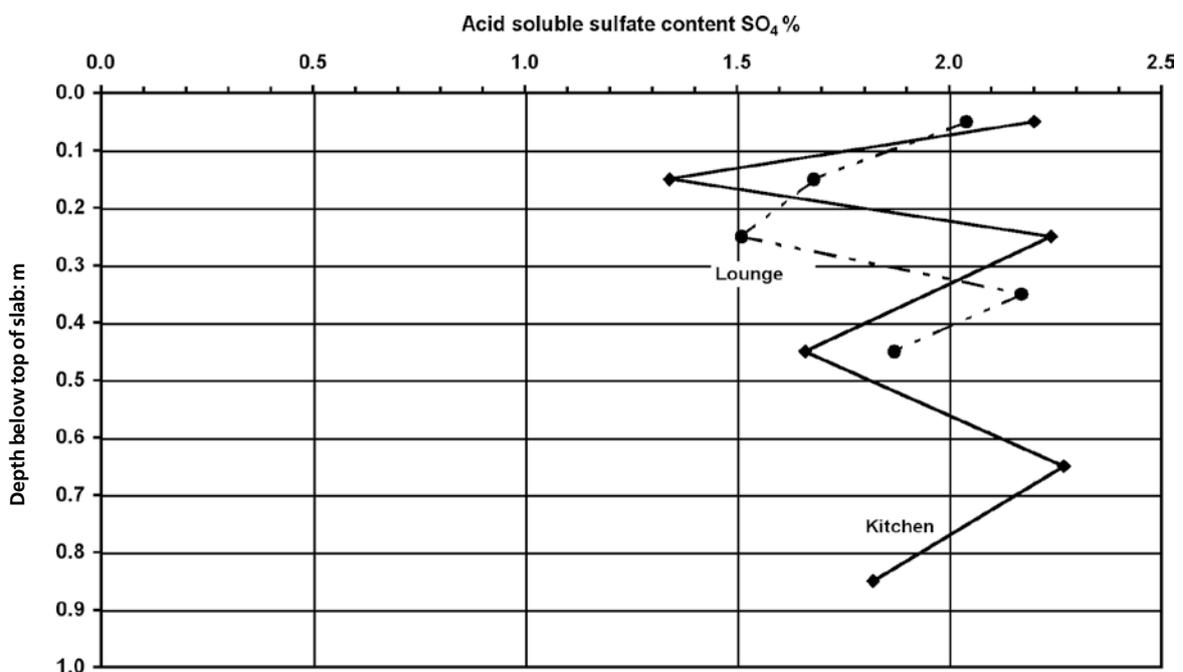
Figure 2: Acid-soluble sulfate contents in burnt colliery spoil (red shale) sampled at depths below a concrete floor slab in a 40 year old house. The values, which represent the total amount of sulfates present in the hardcore, vary erratically with depth from 1.3 to 2.25 per cent SO_4 , reflecting the original variability of the hardcore.

Figures 2 and 3 show sulfate contents measured by the Building Research Establishment (BRE) in burnt colliery spoil (red shale) hardcore sampled at depths below a concrete floor slab in two rooms (kitchen and lounge) of a house in Stoke on Trent. Total amounts

Overall, the variability of results (some 70%), demonstrates the inappropriateness of evaluating the potential for future sulfate attack using just one or two test results on a house as the sole criterion.

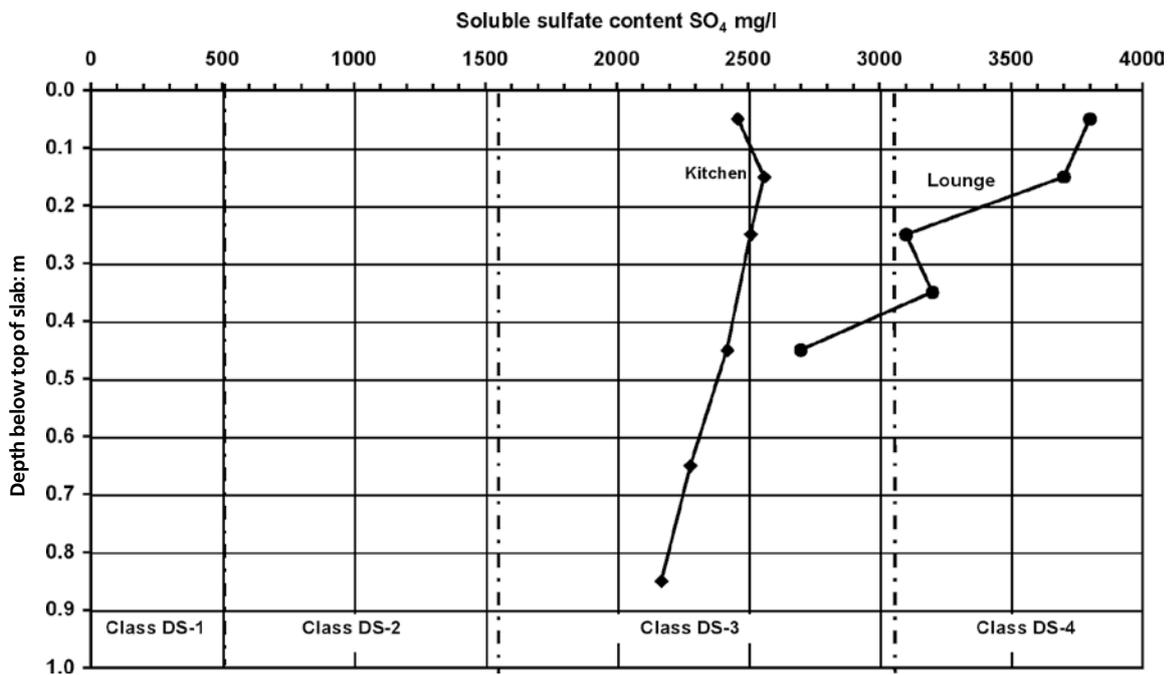
Figure 3: Water-soluble sulfate contents in burnt colliery spoil (red shale) sampled at depths below a concrete floor slab in a 40 year old house. Also shown are the Sulfate Class Limits from BRE SD1:2005. The profiles show values of sulfate which increase upwards. This is likely to be due to these soluble sulfates being drawn upwards by water passing through the slab to the warm rooms above.

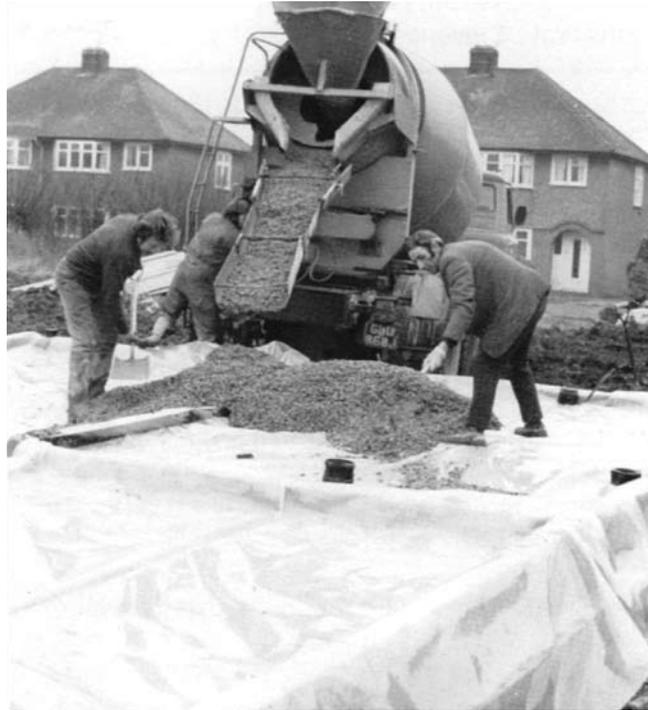
Figure 4: Laying of concrete in the mid 1970s on a 300 micron damp-proof membrane that has been placed over hardcore in the foundations of a house.

- Sulfate migration from hardcore into concrete may be prevented by the use of a separating membrane. Polythene sheets, installed primarily as a damp-proof membranes (DPM), began to serve this purpose from the mid 1960s, and became almost universal for concrete slab construction on sulfate-bearing hardcore by the early 1970s. DPMs installed in the 1960s were typically only 500 gauge (125 micron) thick, and doubts have been cast by some practitioners on their effectiveness as a barrier to sulfate migration. However, no case of deleterious sulfate attack where such a membrane was installed has been brought to the attention of BRE. Thicker membranes that are more resistant to perforation during installation were installed in later decades (eg Figure 4), the current standard being 300 micron.

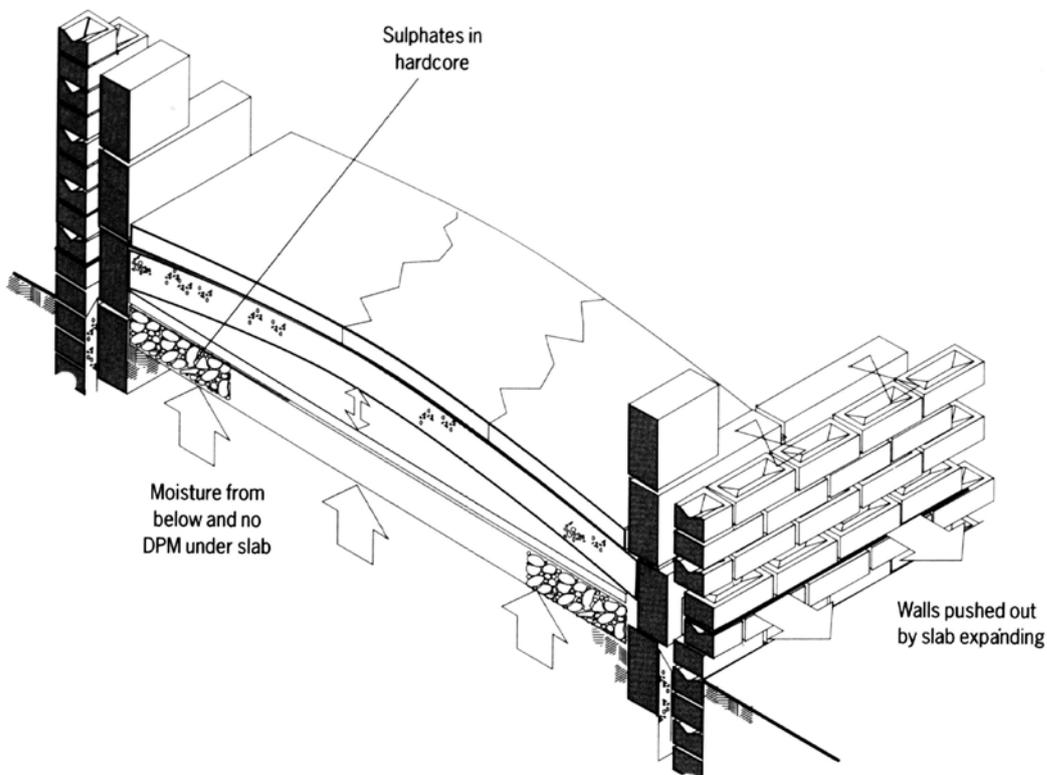
Figure 6: Doming and cracking of floor slab and outward displacement of walls resulting from expansion of concrete due to sulfate attack.

An excellent account of damage caused to buildings by sulfate attack is included in Chapter 3 of the BRE Building Elements book: *Floors and flooring, performance, diagnosis, maintenance, repair and the avoidance of defects*, (BR 460)^[22], and from which Figure 6 (below) is taken.

Expansive sulfate reaction within the concrete floor slabs will tend to produce horizontal expansion of the floor slab or oversite concrete. However, these are generally constrained at the perimeter, where the concrete abuts external and internal walls. As a result the slab or oversite concrete is typically uplifted into a dome shape which, with time, may achieve a deflection of several centimetres. The doming will put the upper part of the concrete element into tension, leading to a map pattern of cracking (Figure 1). This cracking may penetrate through floor slabs, or be confined to the topmost 'screed' layer, which often comprises a much weaker mix of sand and cement, 25–35 mm thick.

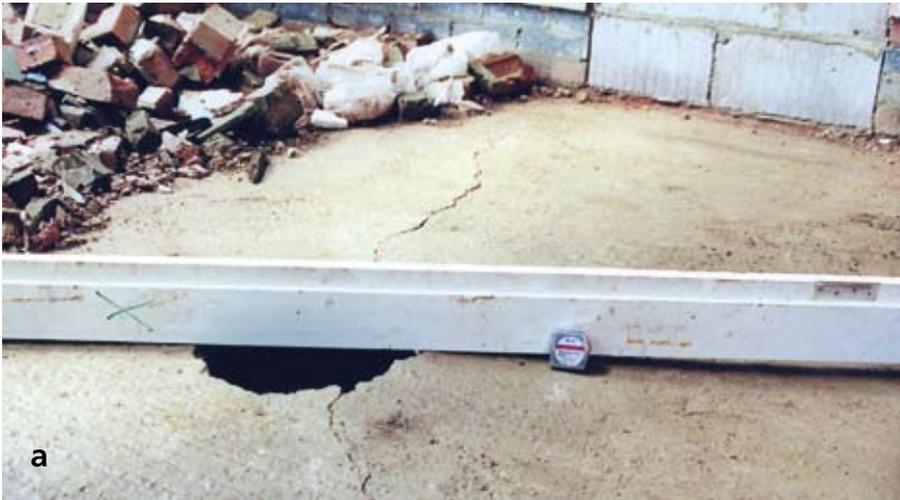
Figures 7(a, b & c): Sulfate-attacked oversite concrete that was laid over plaster contaminated brick rubble beneath a suspended wooden floor (here removed together with the sleeper walls).
(a) An improvised straight edge shows some 50 mm doming of the oversite concrete that lifted brick sleeper walls and wooden floors.

Figures 7(a) to 7(c) show sulfate attacked oversite concrete that was laid over plaster contaminated brick rubble beneath a suspended wooden floor of a bungalow in the West Midlands. The concrete, much softened as result of TSA, domed upwards in several rooms lifting the sleeper walls that supported the floor. The doming was accompanied by radiating and map pattern cracks.

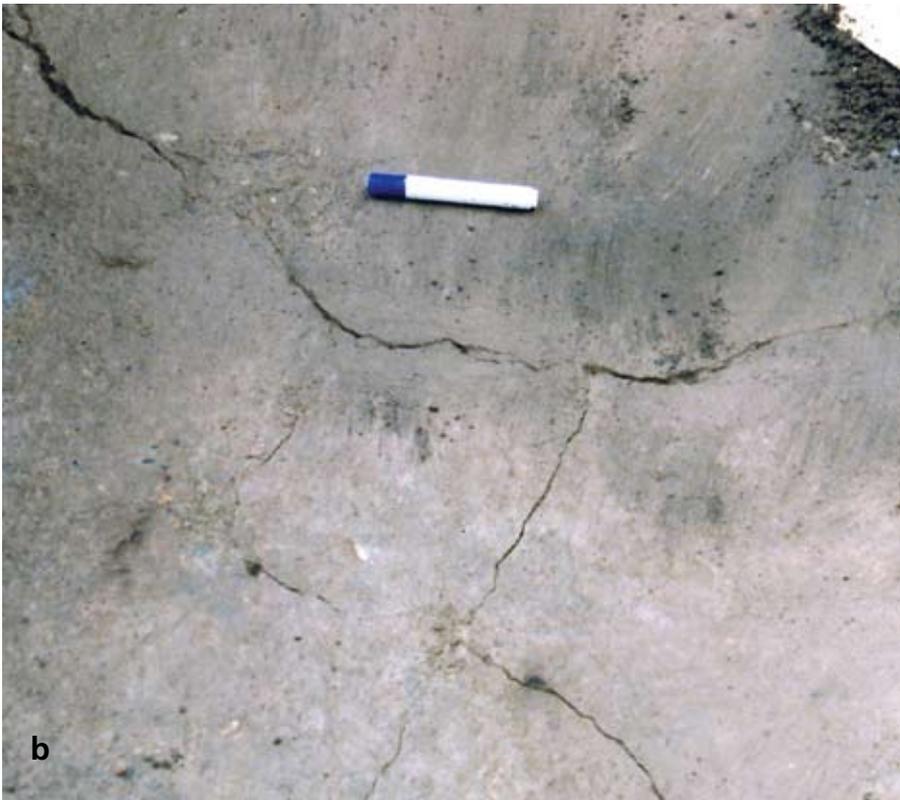
(b) Map pattern cracks in sulfate-attacked oversite concrete beneath a suspended wooden floor of an adjacent room.

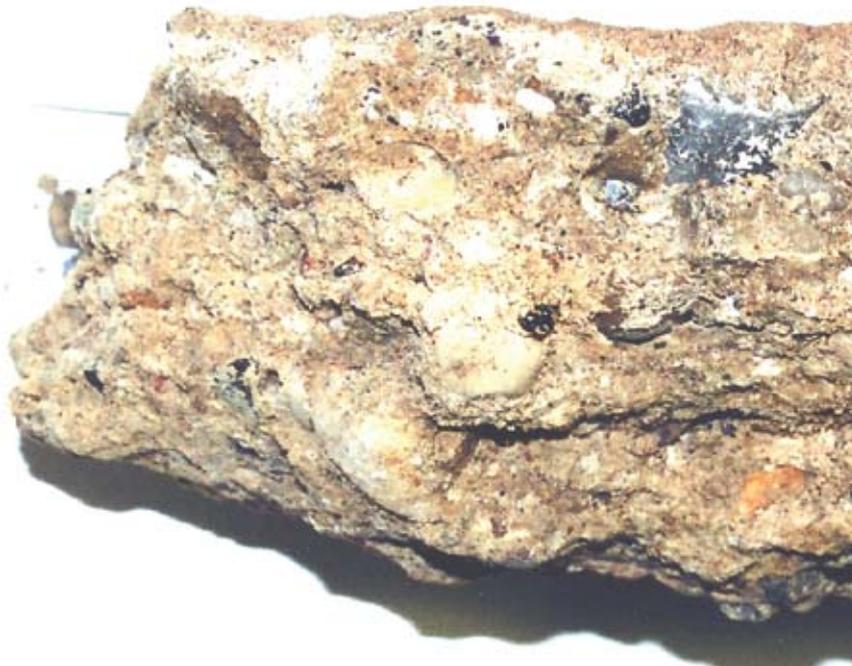
c

(c) 70 mm thick sample of oversite concrete affected by TSA. The concrete has been softened and discoloured white and yellow-brown. Much white thaumasite can be seen in the upper part of the section. Concrete missing from the bottom of the section was so friable it fell away during sampling.

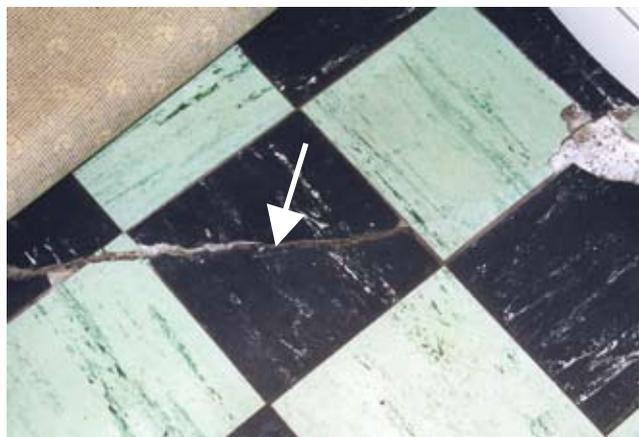
Figure 9: Stepped crack in floor of 1950s house that may indicate sulfate attack. The unevenness could be felt through the (rolled back) carpet.

The first visible sign of sulfate attack to a concrete floor slab is usually some unevenness in the floor. This may be accompanied by appearance of cracks in the concrete screed and floor finish that are at first narrow, but which widen with time (eg Figure 9). The unevenness of the floor will typically progress into an obvious heave and there may be increasing difficulty in using internal doors as a result of the lower edge

fouling the floor. However, lifting is generally highest in the centre of the room resulting in a doming in the floor that is detectable with an adequately long straight edge. The doming is commonly accompanied by a radiating or map pattern of cracking, with some cracks making vertical steps in the floor of the order of several millimetres.

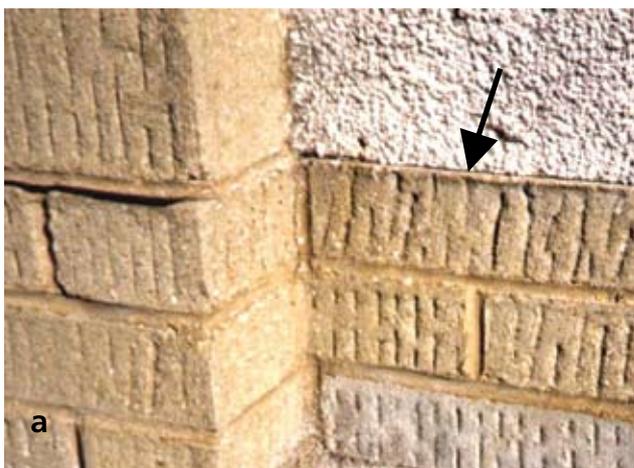
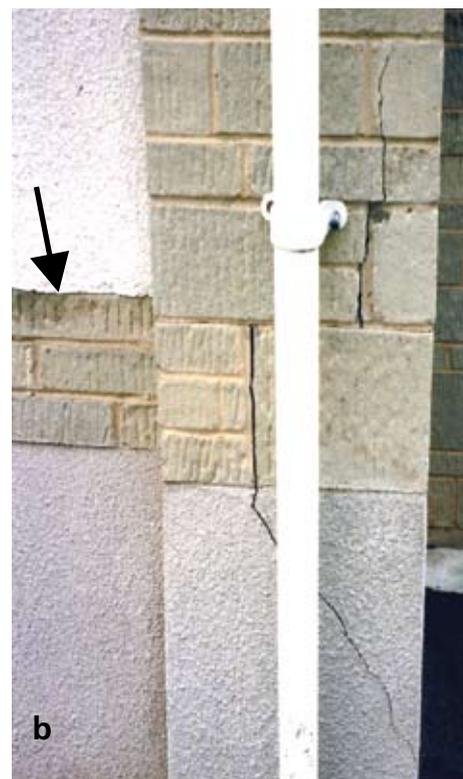
Figures 8(a & b): Exterior of a bungalow affected by sulfate attack in South Wales. The worst damage is on the downslope side where there is about 1 m of exposed masonry below internal floor level.

- (a) Wall below DPC level (arrowed) has been thrust outward by 5 mm by sideways expansion of the floor slab.
- (b) Masonry at a corner, above and below DPC level, has been disrupted by outward thrusting of floor slab.

Externally, the pushing out of walls by the sideways expansion initially causes horizontal cracks to appear in mortar courses at or near to DPC level. With time these typically show a horizontal step in the masonry with the courses above being thrust out (oversailing) relative to the courses below. There may also be irregular displacement of blocks of the wall adjacent to the DPC particularly near to corners, as in Figures 8(a) and 8(b).

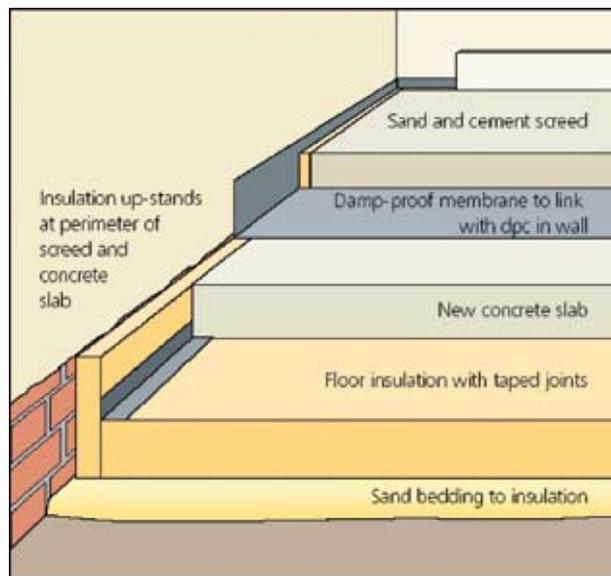
Figure 10: Floor slab construction with insulation conforming to Building Regulations Approved Document L1B (from CE 184).

Figure 10 shows typical construction for a replacement floor slab. This has a DPM situated above the concrete slab; whereas for floor insulation over sulfate-bearing hardcore that is left in place, a DPM over the hardcore is generally the more appropriate location.
