Sulfate damage to concrete floors on
sulfate-bearing hardcore
Identification and remediation

Ian Longworth, MSc(Eng), CGeol, CSci,
BRE Associate, Materials and Engineering Group,
Building Research Establishment

February 2008
Department for Communities and Local Government

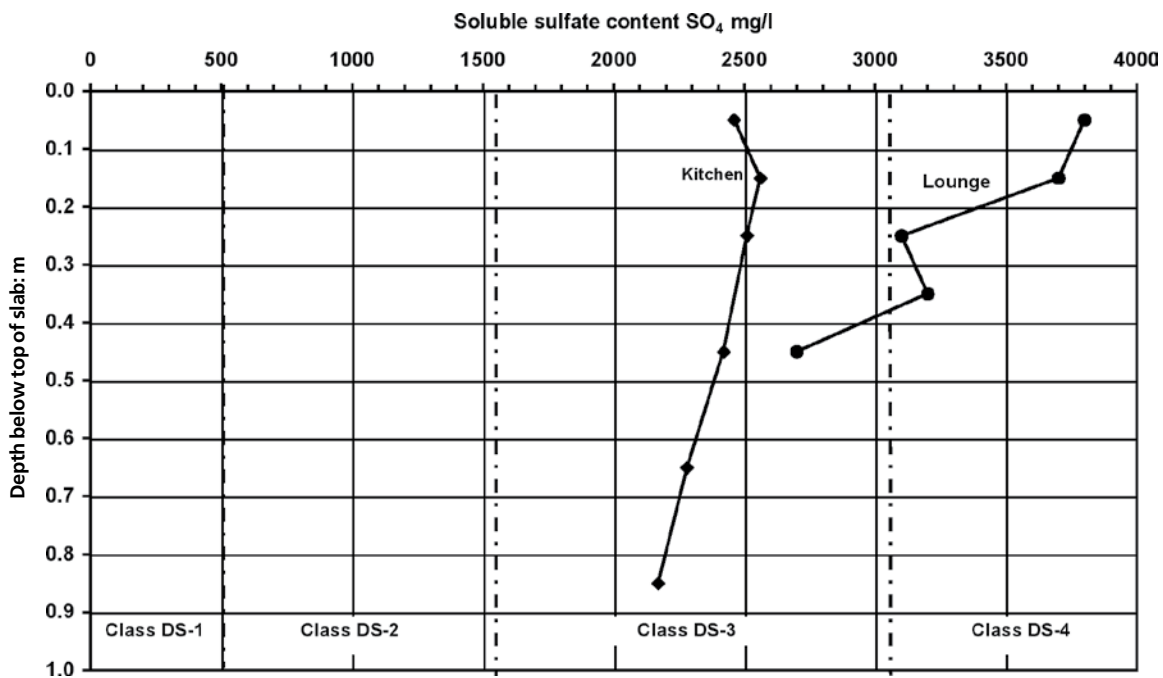
Figure 3: Water-soluble sulfate contents in burnt colliery spoil (red shale) sampled at depths below a concrete floor slab in a 40 year old house. Also shown are the Sulfate Class Limits from BRE SD1:2005. The profiles show values of sulfate which increase upwards. This is likely to be due to these soluble sulfates being drawn upwards by water passing through the slab to the warm rooms above.

Figures 2 and 3 show sulfate contents measured by the Building Research Establishment (BRE) in burnt colliery spoil (red shale) hardcore sampled at depths below a concrete floor slab in two rooms (kitchen and lounge) of a house in Stoke on Trent. Total amounts

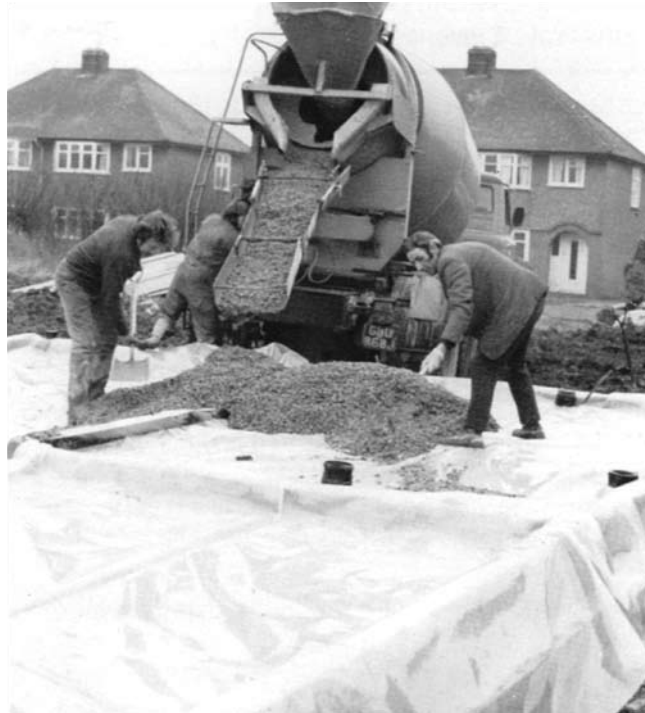
Figure 4: Laying of concrete in the mid 1970s on a 300 micron damp-proof membrane that has been placed over hardcore in the foundations of a house.

- Sulfate migration from hardcore into concrete may be prevented by the use of a separating membrane. Polythene sheets, installed primarily as a damp-proof membranes (DPM), began to serve this purpose from the mid 1960s, and became almost universal for concrete slab construction on sulfate-bearing hardcore by the early 1970s. DPMs installed in the 1960s were typically only 500 gauge (125 micron) thick, and doubts have been cast by some practitioners on their effectiveness as a barrier to sulfate migration. However, no case of deleterious sulfate attack where such a membrane was installed has been brought to the attention of BRE. Thicker membranes that are more resistant to perforation during installation were installed in later decades (eg Figure 4), the current standard being 300 micron.

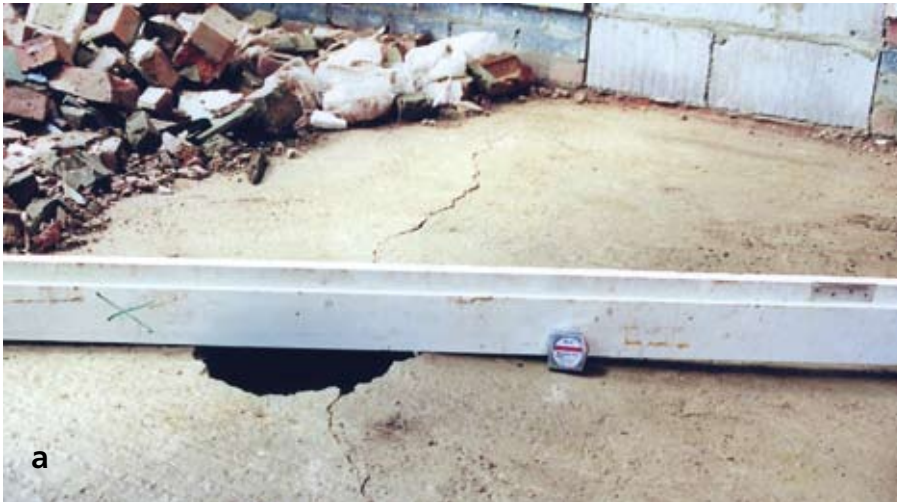
Figures 7(a, b & c): Sulfate-attacked oversite concrete that was laid over plaster contaminated brick rubble beneath a suspended wooden floor (here removed together with the sleeper walls).
 (a) An improvised straight edge shows some 50 mm doming of the oversite concrete that lifted brick sleeper walls and wooden floors.

Figures 7(a) to 7(c) show sulfate attacked oversite concrete that was laid over plaster contaminated brick rubble beneath a suspended wooden floor of a bungalow in the West Midlands. The concrete, much softened as result of TSA, domed upwards in several rooms lifting the sleeper walls that supported the floor. The doming was accompanied by radiating and map pattern cracks.

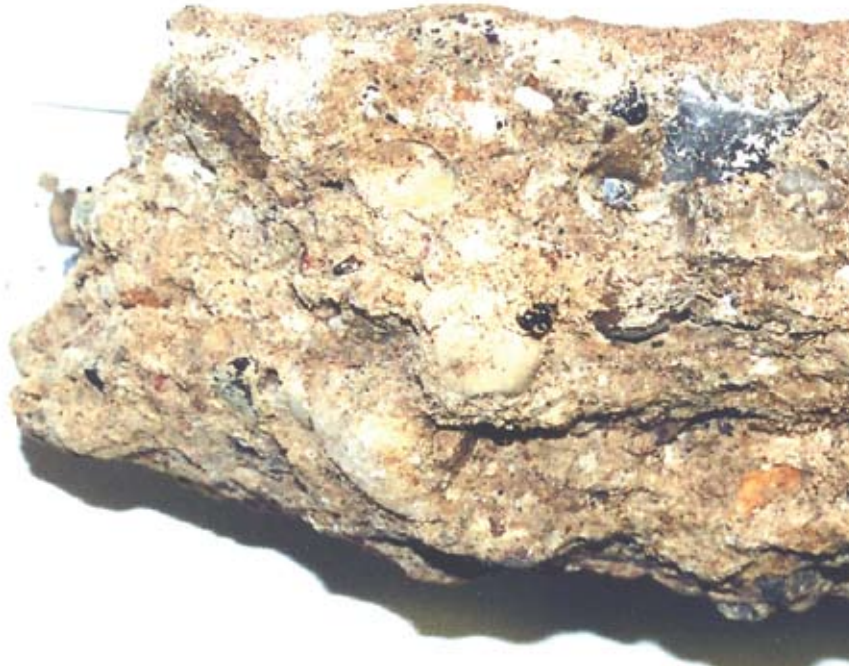
c

(c) 70 mm thick sample of oversite concrete affected by TSA. The concrete has been softened and discoloured white and yellow-brown. Much white thaumasite can be seen in the upper part of the section. Concrete missing from the bottom of the section was so friable it fell away during sampling.

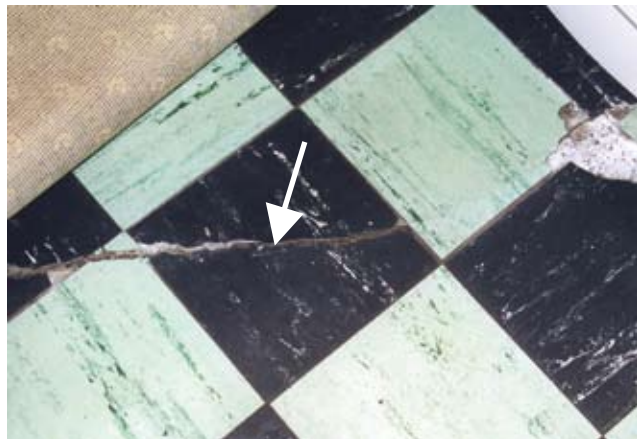
Figure 9: Stepped crack in floor of 1950s house that may indicate sulfate attack. The unevenness could be felt through the (rolled back) carpet.

The first visible sign of sulfate attack to a concrete floor slab is usually some unevenness in the floor. This may be accompanied by appearance of cracks in the concrete screed and floor finish that are at first narrow, but which widen with time (eg Figure 9). The unevenness of the floor will typically progress into an obvious heave and there may be increasing difficulty in using internal doors as a result of the lower edge

fouling the floor. However, lifting is generally highest in the centre of the room resulting in a doming in the floor that is detectable with an adequately long straight edge. The doming is commonly accompanied by a radiating or map pattern of cracking, with some cracks making vertical steps in the floor of the order of several millimetres.
