# Building Survey

XXXXXXXXXXXX  
XXXXXXXXXXXX

**Date of Inspection:** 12/09/2011

**Job reference:** AA0000

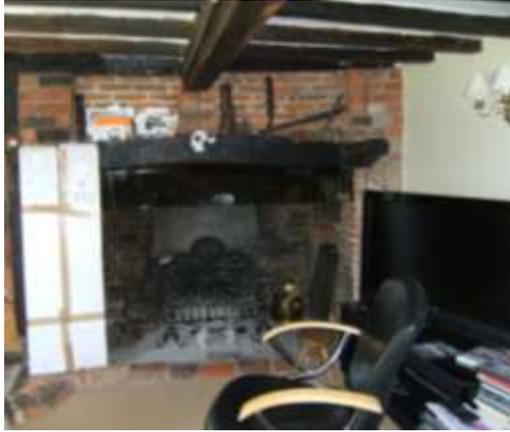
Figure 14: Lounge fireplace

A lounge is accessed off the right-hand side of the hallway, the floor of which is even lower than the hall by approximately 150mm, with two steps down. Therefore the lounge floor is approximately 300mm below ground level. A large inglenook fireplace with brick surround is on the left-hand wall (fig. 14). The lounge has an original beamed ceiling (fig. 15). The timberwork of the ceiling appears to be in reasonable condition, with woodchip paper on the plaster between the beams. With the exception of the inglenook area, the walls are finished with a painted lining paper. The paper is lifting to the right-hand side of the front wall, indicating damp is present (fig. 16). There is a hole within the inglenook fireplace within the floor, where the grate appears to have been dislodged, which we consider is an air hole (fig. 17). This requires resetting. The floor is solid and feels relatively level. It is not original. Exposed cables were noted within the lounge area which by current electric regulations should be ducted.

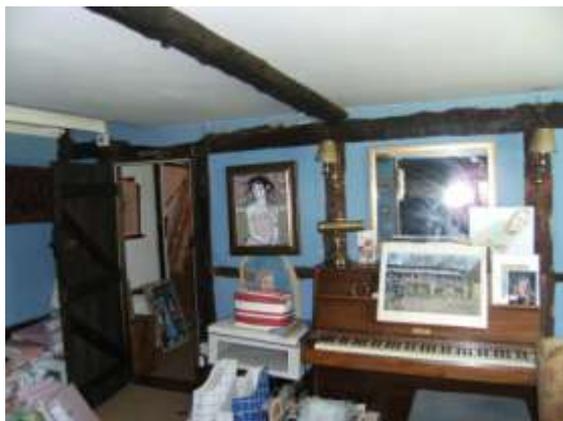
**Figure 19: The music room**

The right-hand room, the music room, leads off the lounge and has original beams on both the wall and the ceiling (fig. 19). An old distortion is evident in the timber beam above the doorway into the room however this beam has been in this position for many years. There are also old distortions on the ceiling and on the plain painted plaster infill between the wall beams. Extensive exposed cables were noted, nailed to the walls, which contravenes current regulations and are considered dangerous (fig. 20). The floor again is solid and feels reasonably level. The rear wall is finished with Artex, which appears to be of some age.

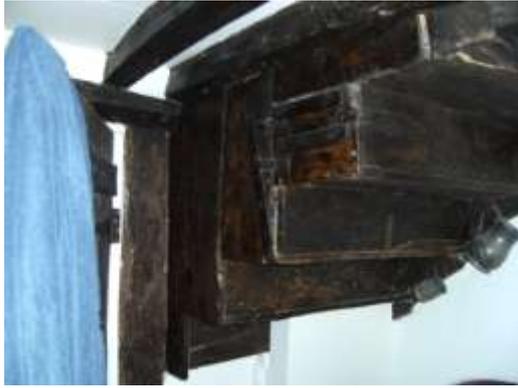
Figure 21: Right-hand staircase

The first room in the original right-hand cottage is accessed through the right-hand beamed wall of the left-hand cottage. There is also a further stairway up to first floor to the rear of the room. The stairway is showing within the room and has been repaired with a metal strap around the stairway (fig. 22). There is movement on one of the treads where it appears the wood had been eaten by a beetle (fig. 23). Again, walls and ceiling are finished with timber beams, with plain painted plaster infill. Extensive exposed cables are again present (fig. 24). The floor feels reasonably level and firm.

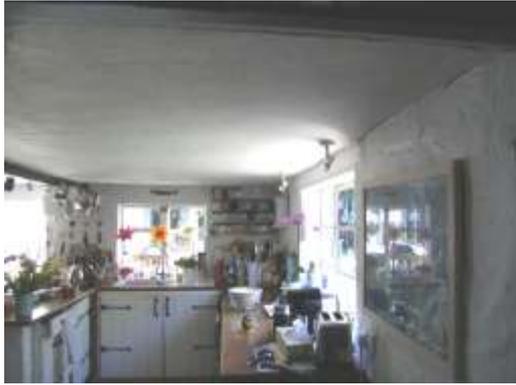
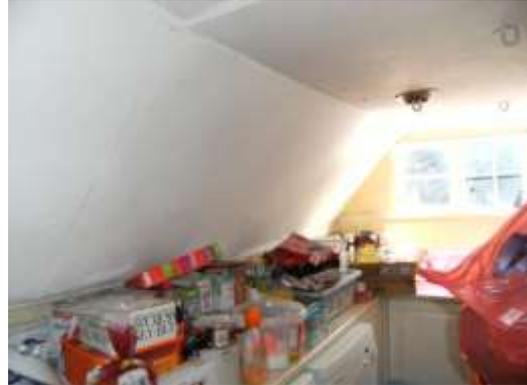
**Figure 24: The kitchen**

The kitchen is accessed off the front right-hand side of the right-hand room, and has a heavy Artex finish to both walls and ceiling. The walls are relatively roughly plastered and distortions are showing within the ceiling. The ceiling appears to be lath and plaster, with plaster having de-bonded. There is an exposed timber beam extending from left to right within the middle of the ceiling. The kitchen units are relatively old, with doors of timber planking (fig. 25). There is a further inglenook fireplace with a brick surround on the left-hand wall. Again, exposed cables and surface plugs are evident. The floor is relatively level and firm.

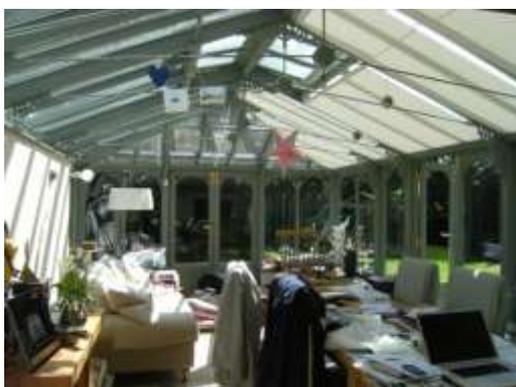
**Figure 25: The conservatory**

The conservatory is accessed off the right-hand side of the kitchen and is a proprietary construction of reasonable quality (fig. 26). The windows and roof consist of double-glazed units, with steel tie rods to prevent the upper part of the wall spreading, which is a normal form of construction. The conservatory is of a reasonable quality. The dwarf walls are finished with painted plaster and no distortions are evident. The floor is finished with ceramic tile, and is reasonably level.

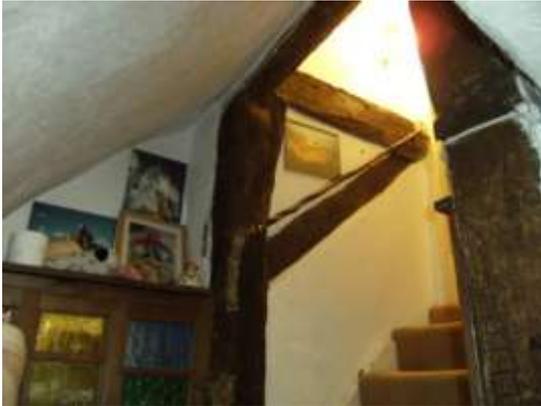
Figure 26: Lobby staircase

Leading off to the rear of the left-hand room, adjacent to the kitchen, is a further lobby, with a staircase to the first floor of the original right-hand cottage (fig. 27). Again, the ceiling is sloping as it is in the extended roofline section of the property, which makes access to first floor relatively difficult. This would not conform to current regulations. The plasterwork is rough and again has the appearance of being lath and plaster onto the original tree branch rafters. There are timber beams with plaster infill within the wall, which appear to be in reasonable condition.

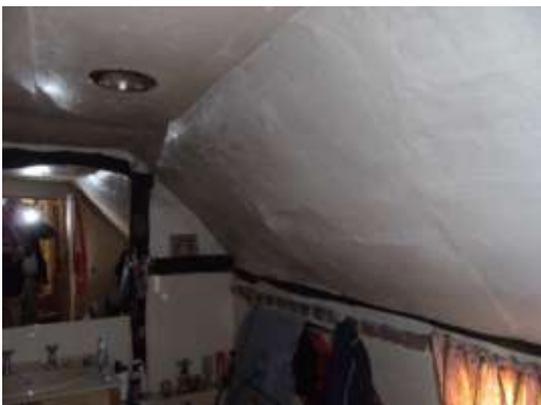
Figure 27: Bathroom off the lobby

Leading off the left-hand side of the lobby is a further bathroom, with a sloping ceiling to the rear section due to it being in the extended roofline section noted to the rear of the property (fig. 28). The bathroom has distortions within the ceiling and walls. There is ceramic tiling around the bath and the walls, which appears free from movement, with no splitting of the tiles or opening of the grouted joints.

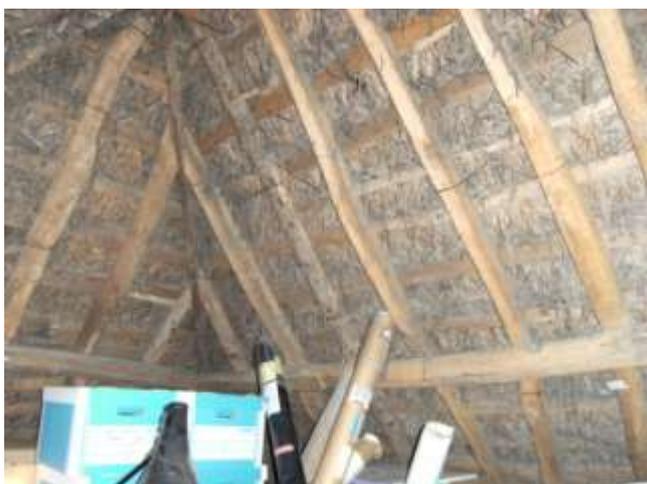
**Figure 36: Roof space**

The roof space of the left-hand side of the property is accessed from the hallway. The rafters consist of original tree trunk purlins and branches (fig. 37). The underside of the thatch can be seen, and looks original. The original branch batons are in poor condition in various areas. The roof section appears original.

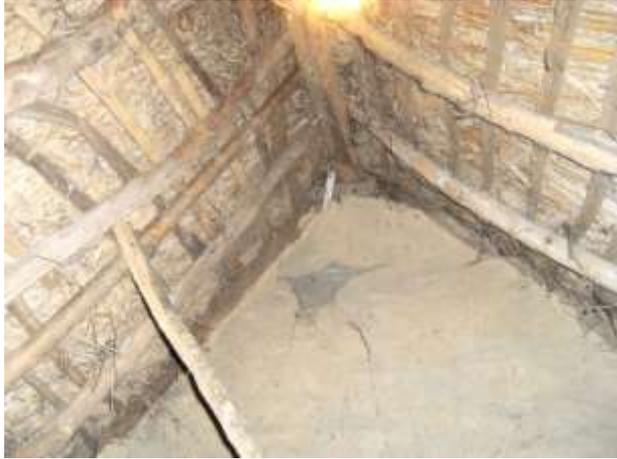
**Figure 38: Reverse of wattle and daub wall**

There is an observation hatch within the master bedroom ceiling which shows the reverse side of the wattle and daub wall (fig. 39). Again tree trunk purlins and branch rafters are present with the battens in reasonable condition.
