Structural Report

The roof at the property known as

In accordance with instructions received from Ms. R. Clive on 25th January 2011 we have been asked to carry out a Specific Structural Inspection on the cracking above windows and around wall heads at first floor level at the property known as 37 Hillyfield Road, Marsh Hill, Birmingham B23 7HB. The inspection was carried out on Wednesday 26th January 2011. All comments are based on visual inspection only and no opening up of areas was carried out.

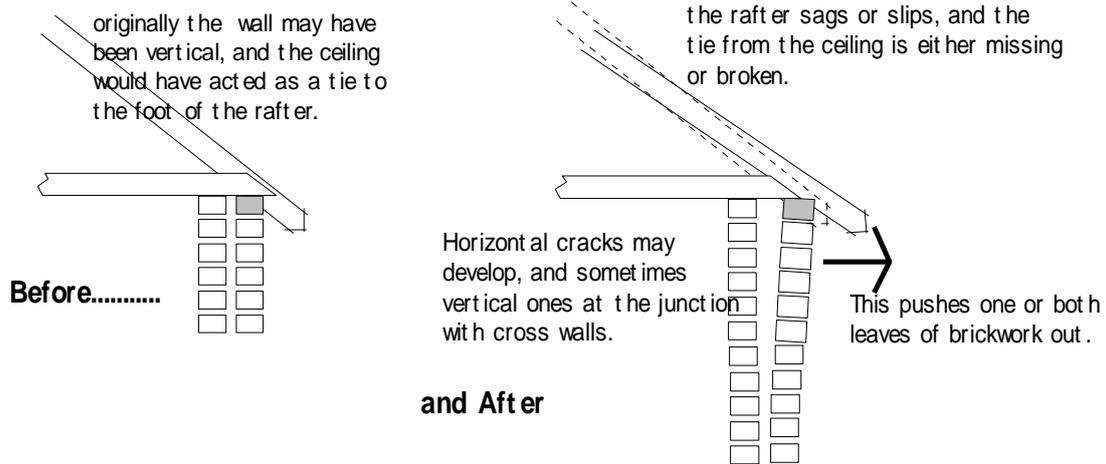
Matters are exacerbated if any of the timbers are rotten or suffering from excessive deflection due to deterioration. Often the bottom of the rafters are not tied, allowing the roof frame to spread outwards as shown above.

We consider the slight cracking has been brought about by installing the new tile covering to the roof as opposed to installing a slate covering. Concrete mono tiles are approximately 2 ½ times heavier than normal slates consequently impose a greater load to the roof surface.

In some cases this can cause serious distortions to a roof however in this particular case the roof structure appeared relatively substantial internally. We consider due to the age of the building there is more than likely a timber lintel over the windows internally and due to the weight of the roof being supported on the inner leaf of the brickwork the additional weight is imposing additional stresses, which is causing a deflection of the timber lintels. This in turn is manifesting itself as minor cracks.

As the cracking is negligible at current times we consider it is the existing structural timbers taking up the additional loading. The timbers appears to be of sufficient size to withstand the additional loadings consequently we would advise that the cracking should cease after a period of time and we would advise a period of 12 months is given for the stresses in the roof to equalize and the cracking to cease.
