# HomeBuyer Report

## Level 2

Property address	Somewhere Street, Anywhere, Everyplace, EV1 1WX
Client's name	John Smith
Date of inspection	1 October 2019

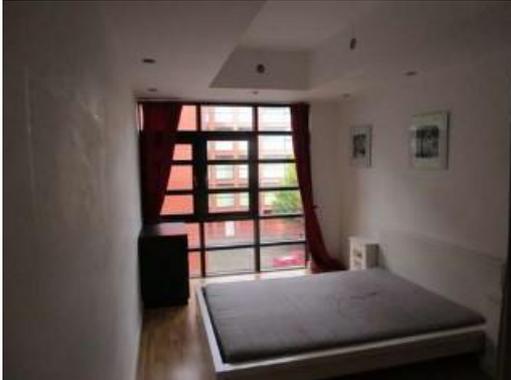
### Master Bedroom

Some of the spotlights are noted to need repair. We also note general heat staining which we would suggest would benefit from isolated cleaning.

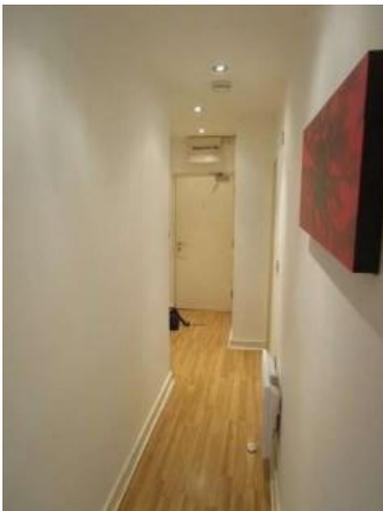
### **Entrance Hallway**

The electric panel heater appeared operational on the day of the survey. We would recommend that you obtain NICEIC approved electrical test certification to confirm that these are in good working order.

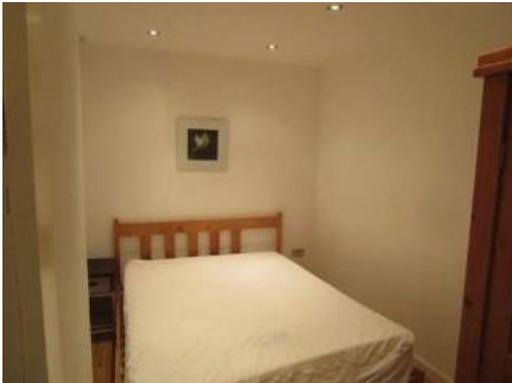
### **Bedroom Two**

There is progressive passive ventilation within the room likely associated with there being no opening window. You should enquire as to any service records or ongoing maintenance required to this passive ventilation.

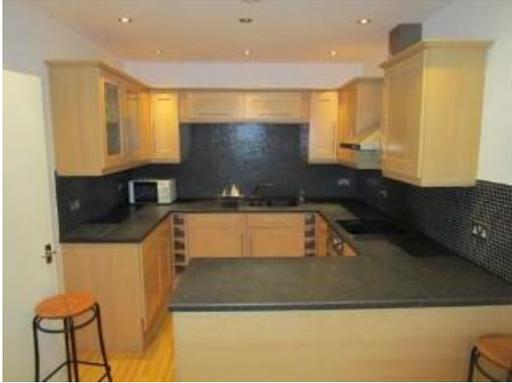
## Kitchen

Kitchen units are in a fair condition. They are dated and would benefit from isolated repair in the short term.

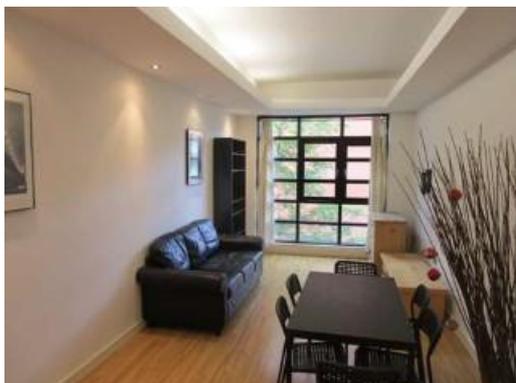
### Sitting Room

Crossing the floor no significant undulation or reverberation noted and it felt solid under foot.

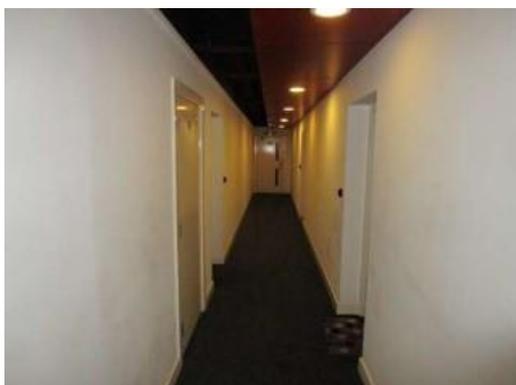
### **Communal Corridors**

We note separation between fire doors exceeds the 3mm recommended. It may be prudent to enquire with the managing agent as to whether there is any reference to these in the fire risk assessment.

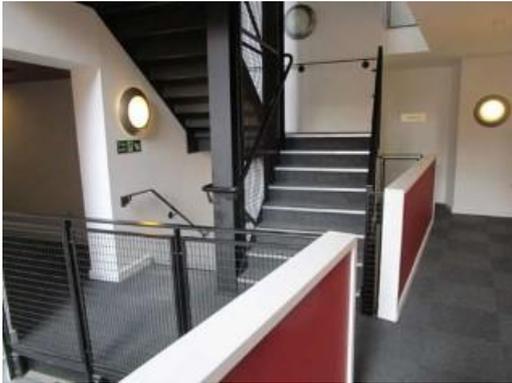
Largely the staircased areas and entrance foyer were in a satisfactory condition commensurate with their age and use.
