HomeBuyer Report

Somewhere Street, Anywhere,
Everyplace, EV1 1WX

1 October 2019

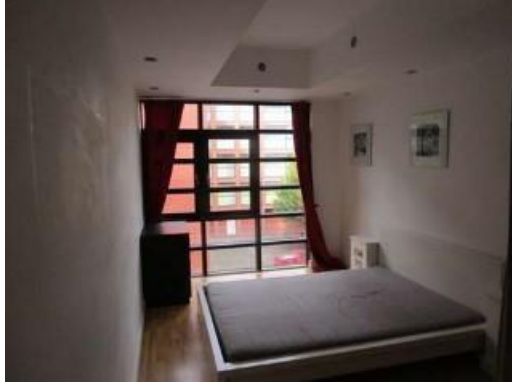
Master Bedroom

Decorative finishes and floor finishes are in a generally satisfactory condition.

Some of the spotlights are noted to need repair. We also note general heat staining which we would suggest would benefit from isolated cleaning.

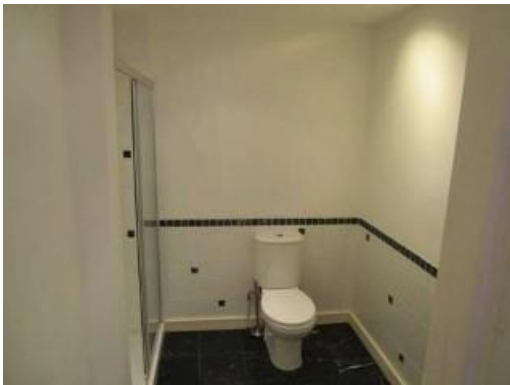
En-Suite Shower Room

Decorative finish and floor finishes are in a fair condition.

Mechanical extract fan is very noisy and we suggest it would benefit from replacement.

The mastic bead to the perimeter of the shower tray will benefit from renewal in the short term.

The spotlight above the shower does not appear to be the IP65 rating recommended and we recommend that it is replaced.

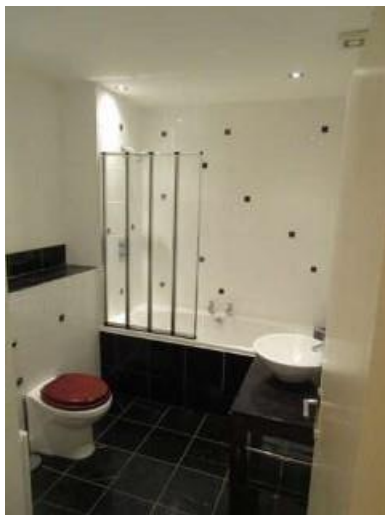
Bathroom

Decorative finishes and floor finishes are in a generally fair condition.

Sanitary ware is in a satisfactory condition commensurate with its age.

The electrical panel heater was not operating on the day of the survey. We note that it is inadequately fixed to the wall and requires re-fixing.

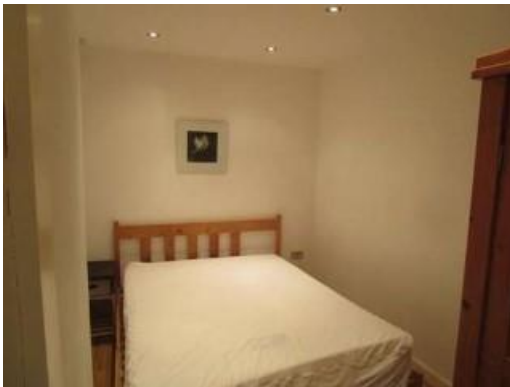
Bedroom Two

Decorative finishes and floor finishes are in a fair condition.

There is progressive passive ventilation within the room likely associated with there being no opening window. You should enquire as to any service records or ongoing maintenance required to this passive ventilation.

There is clearly dampness to the ceiling. Testing this with a damp meter did not identify any raised levels of dampness suggesting it to be historic and associated with the leaking services from the apartment above.

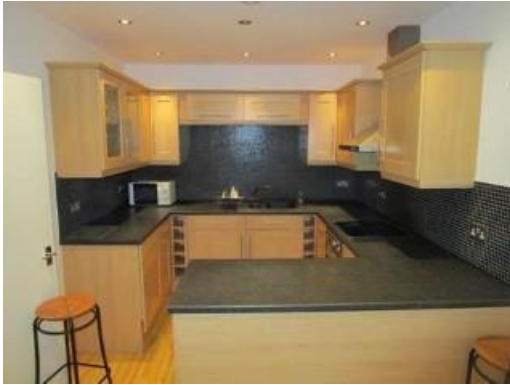
Decorative finish and floor finishes are in a generally satisfactory condition.

Kitchen units are in a fair condition. They are dated and would benefit from isolated repair in the short term.

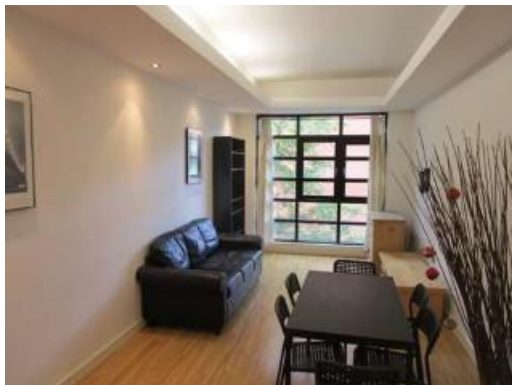
Sitting Room

Decorative finish and floor finishes are in a satisfactory condition.

Crossing the floor no significant undulation or reverberation noted and it felt solid under foot.

The electric panel heater appeared operational on the day of the survey.

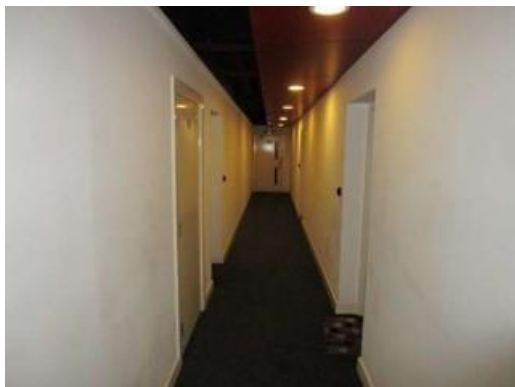
Communal Corridors

Decorative finishes and floor finishes are in a fair condition.

We note separation between fire doors exceeds the 3mm recommended. It may be prudent to enquire with the managing agent as to whether there is any reference to these in the fire risk assessment.

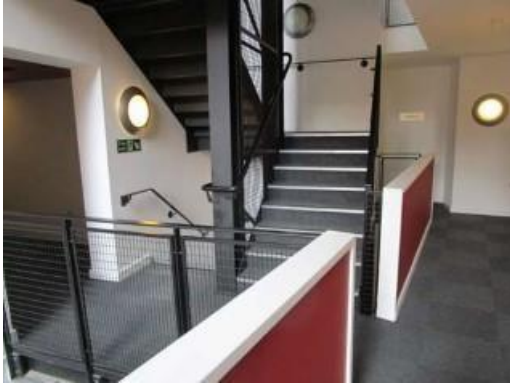
Largely the staircased areas and entrance foyer were in a satisfactory condition commensurate with their age and use.
