BUILDING SURVEY

Level 3

21 September 2022

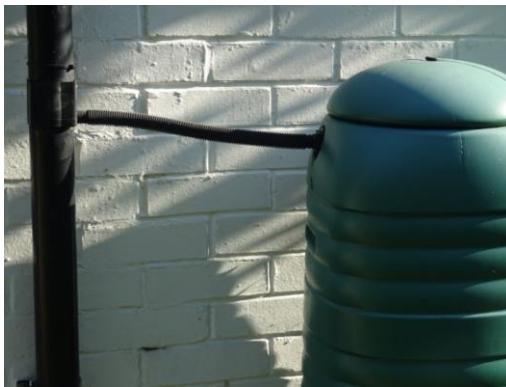
The down water pipe adjacent the utility window also discharged into a water butt which we would advise is periodically inspected to ensure that it is not left to overflow.

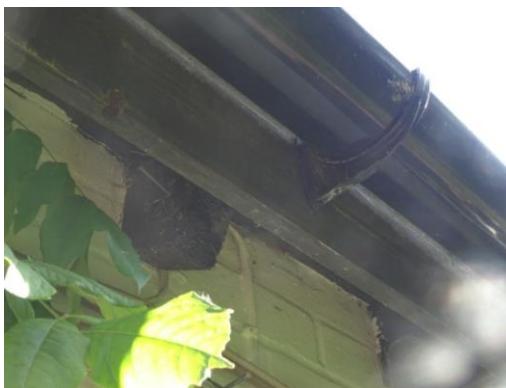
The fascias and rafter legs were evident to the underside of the pitched roof with no rot or infestation noted but would benefit from decoration in the short term.

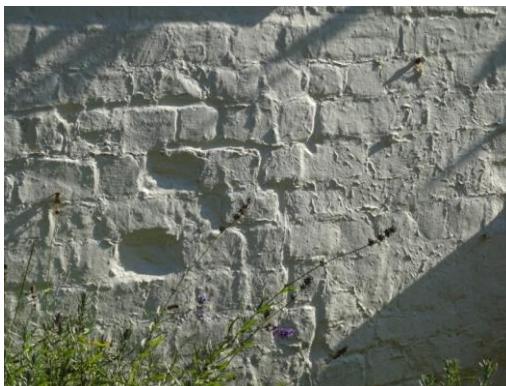
The main elevation has been constructed in a mixture of rubble stone and brick with no structural cracking noted. Various isolated bricks have previously perished which is not considered unusual for the age of the property. We would simply advise that the worst perished bricks are cut out and replaced as part of the pro-active maintenance scheme for the property.

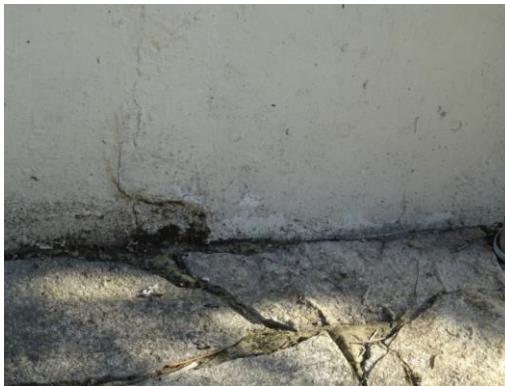
Due to the render finish we are unable to identify a damp proof course at the base of the left hand extension. Due to the age of the extension it is possible that a slate damp proof course has been installed, however this cannot be confirmed. In either case the external ground levels are again raised above the internal floor level which will increase the risk of damp ingress.

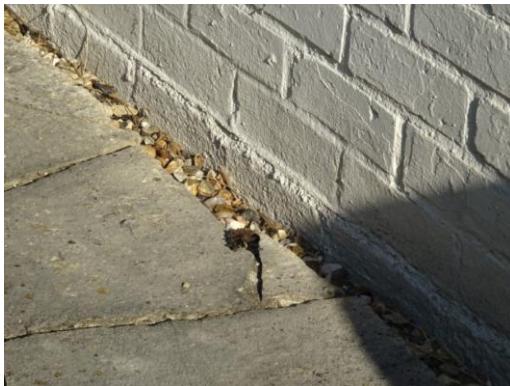
A mixture of bitumen and plastic damp proof coursing is located at the base of the right hand single storey extension which has been slightly compromised by the height of the adjacent ground level. In an attempt to prevent rainwater splashing up above the damp proof course a small gravel channel has been installed. The width of the gravel channel would benefit from being increased in order to improve its effectiveness.

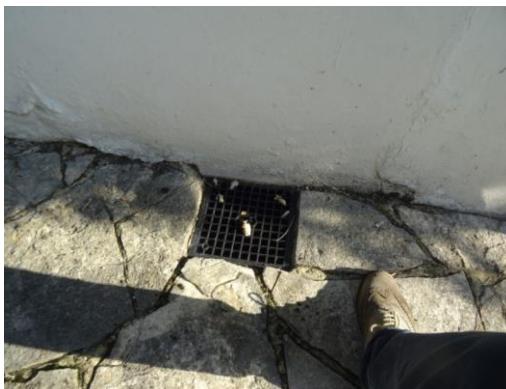
A uPVC waste pipe serving the kitchen discharged into a closed gully which we assume connects directly to the adjacent modern polycarbonate gully which was noted to be clear of blockage at the time of our inspection.

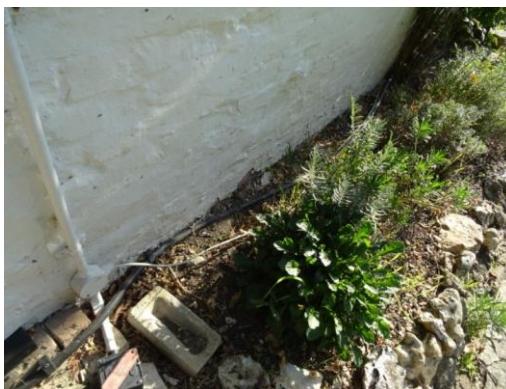
The earthing rod is located adjacent the left hand door which was noted to be firmly secured into position. The associated earthing cable was noted to drape across the flowerbeds which we would advise is secured into position.

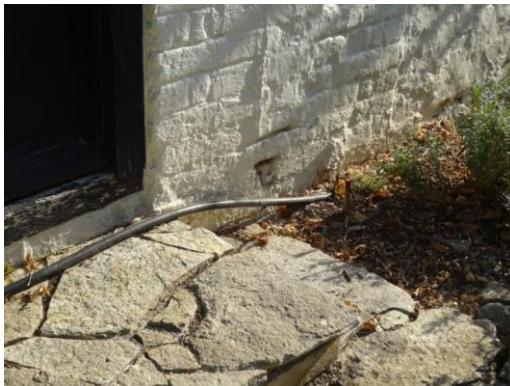
An armoured electrical cable passed along the base of the elevation which we would advise is concealed within the ground in order to prevent being a trip hazard adjacent the main entrance door.

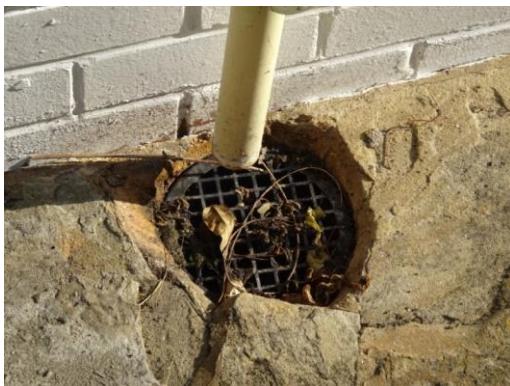
A uPVC waste pipe serving the kitchen discharged over a modern polycarbonate gully which was noted to be in a satisfactory condition and clear of blockages at the time of our inspection.

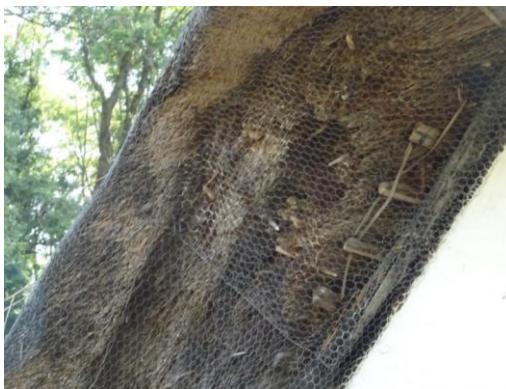
There is evidence that the roof has been over thatched at least three times throughout its life. We would advise against any further over thatching as this will increase the loadings on the original roof structure. Therefore when the time comes to eventually re-thatch the roof we would advise that the thatching is stripped prior to renewal.

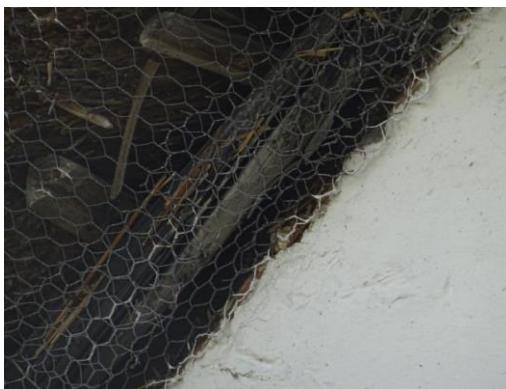
Where a limited inspection of the rafters could be carried out localised rot was noted, however this appears historic. We would advise that the exposed timbers are decorated in the short term.

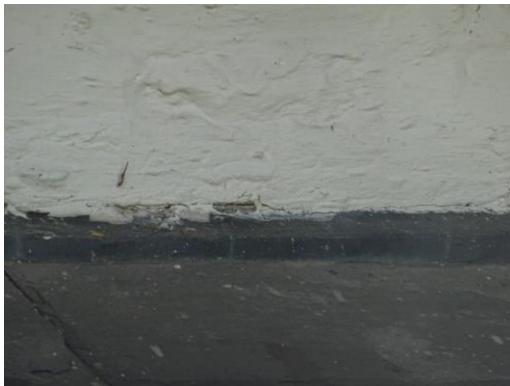
Where the mono pitched roof abuts the main body of the property a small cement flashing detail has been installed with no significant deterioration noted. When the time comes to eventually re-cover the mono pitch roof we would advise that the flashing detail in this location is improved in order to prevent damp ingress.

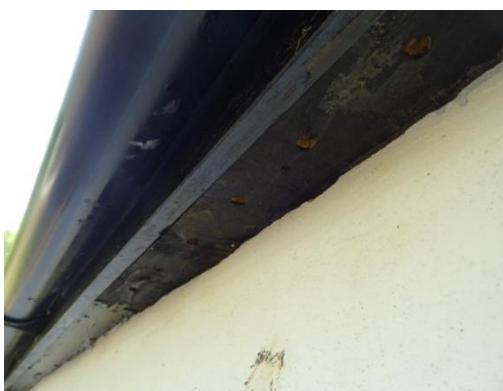
Ventilation holes have been drilled within the soffits. The ventilation would benefit from being increased in order to increase the risk of condensation building up within the roof void.

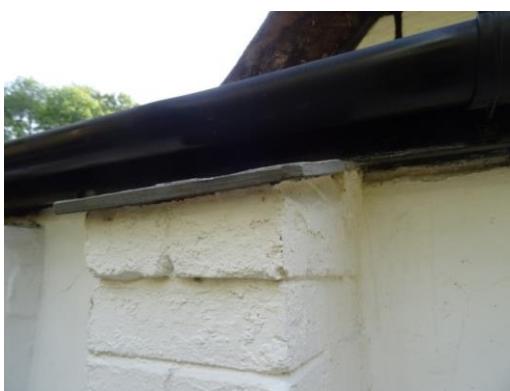
Slate has been installed to the head of the buttressing in order to prevent deterioration of the brickwork and is noted to be firmly secured in to position.

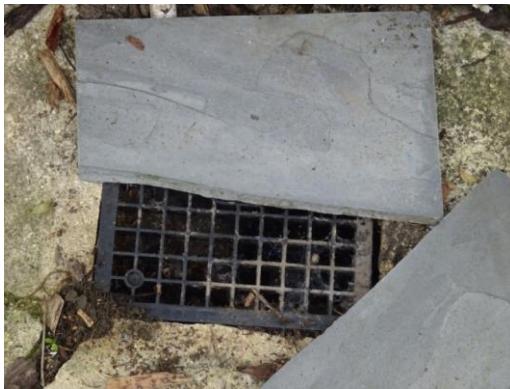
An open polycarbonate gully is located to the left hand side of the elevation which was noted to be clear of blockage at the time of our inspection.

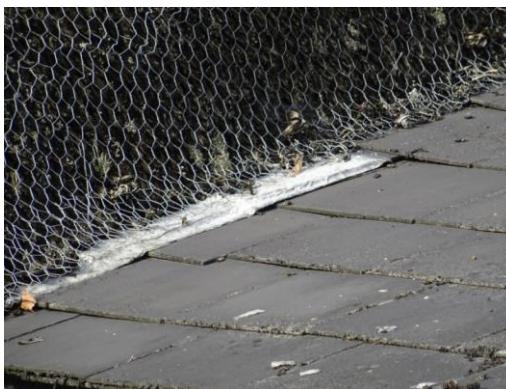
Flash banding has been applied at low level to the left hand side of the roof which suggests that this is an area subject to previous water ingress. We would advise that the flash banding is removed with a permanent flashing detail installed in order to prevent this being an area in need of ongoing maintenance.

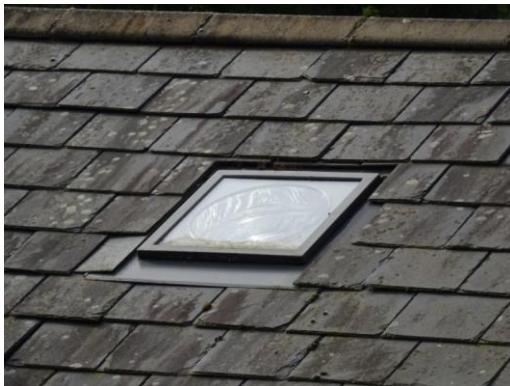
A light tube has been installed within the roof which is slightly begrimed requiring cleaning down, however it is noted to be firmly secured into position.

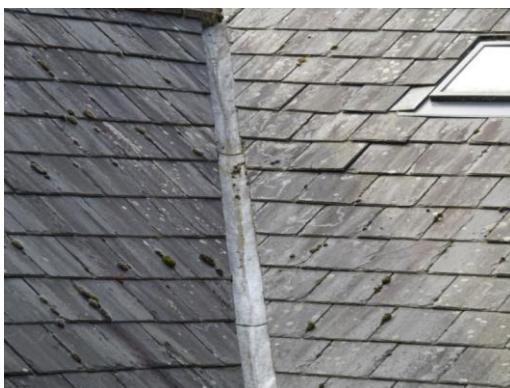
Where the direction of the roofs changed lead valleys have been forged, noted to be in a satisfactory condition and clear of debris at the time of our inspection. It should be noted that it is necessary to keep the valleys clear of debris in order to prevent rainwater backing up into the roof void.

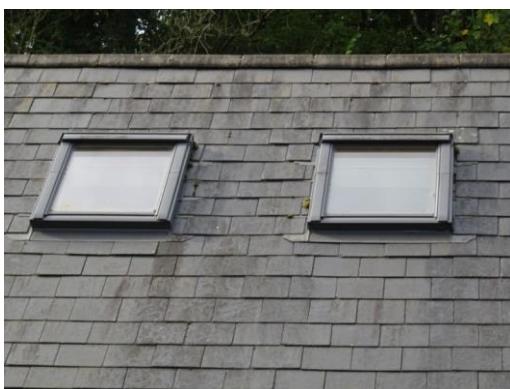
Two modern skylights have been installed within the roof surface which are in a satisfactory condition with no breaking down of the double glazed units noted.

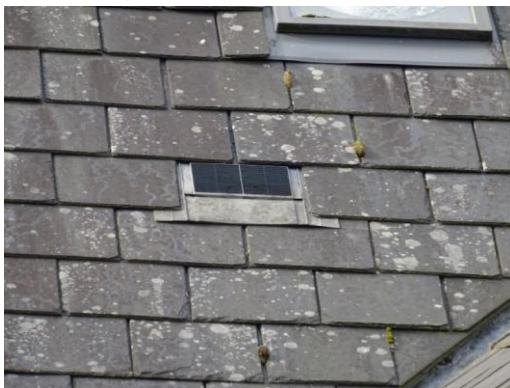
Where a vent has been installed within the roof this is noted to be firmly secured into position.

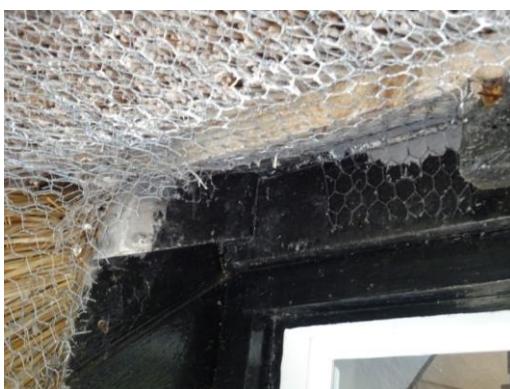
Where a limited inspection of the rafter legs could be carried out to the underside of the thatched roof, no evidence of recent rot or infestation was noted, however they would benefit from decoration in the short term.

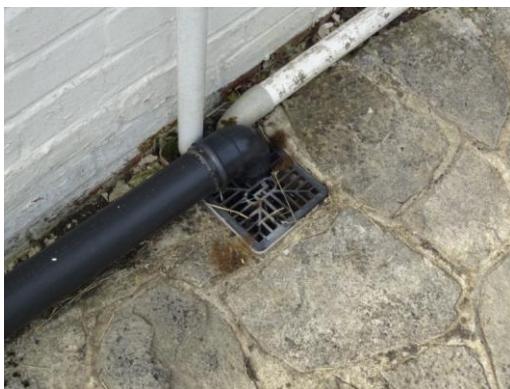
The down water pipe serving the right hand extension roof discharged over a modern polycarbonate gully which was noted to be in satisfactory condition and clear of blockage at the time of our inspection.

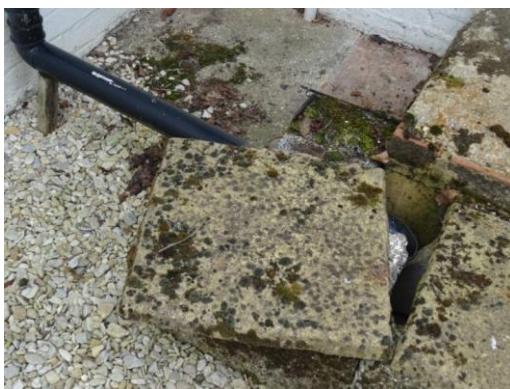
The right hand down water pipe serving the left hand extension discharged over a valley trough which we assume connects directly into the soakaway in the garden, however this cannot be confirmed. Where a limited inspection of the valley trough could be carried out, it was noted to be blocked with debris and requires clearing in the immediate term. Consideration should be given to connecting this down water pipe into a proprietary gully in order to prevent the need for ongoing maintenance.

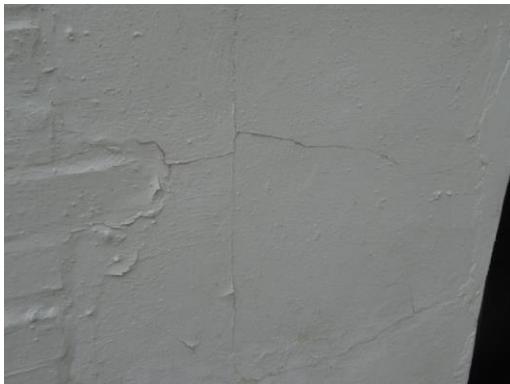
The right hand extension has been constructed in solid brick finished in partly smooth painted render. Various hairline cracks were noted within the render, however are of no significant structural concern.

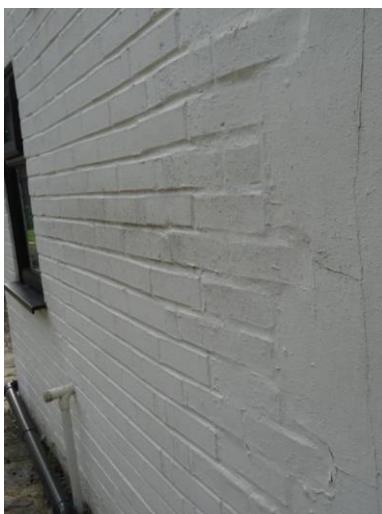
The mortar joints forming the right hand extension are slightly out of plumb however we consider this to be due to poor workmanship and is of no significant structural concern.

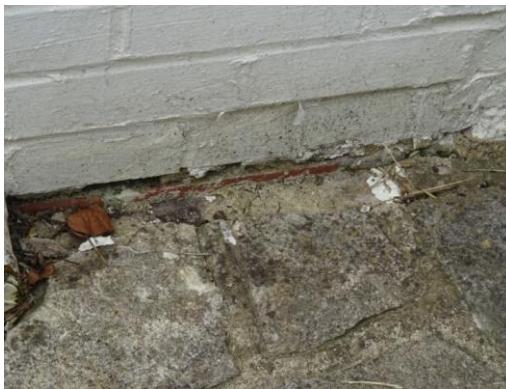
A partial bitumen damp proof course is evident at the base of the right hand extension which has been compromised by the height of the adjacent ground level. Should damp internally occur in this location it will be necessary to pull the ground levels back. We would advise in the immediate term that the low level brickwork is repointed in order to improve the weather tightness of the low level brickwork which will help reduce the risk of damp.

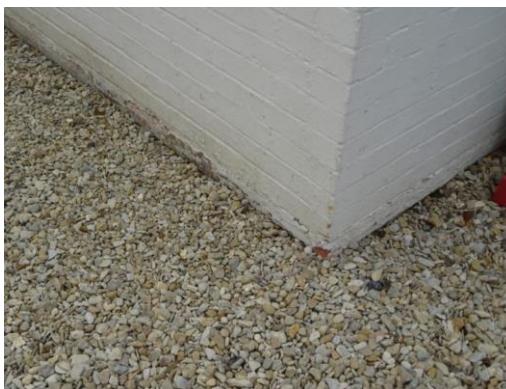
Where we consider it likely that the damp proof course is located, this has been slightly compromised by the height of the adjacent ground level. This is of no significant concern with the adjacent ground level having been formed in gravel will help prevent rainwater splashing up above the damp proof course and reduce the risk of damp.

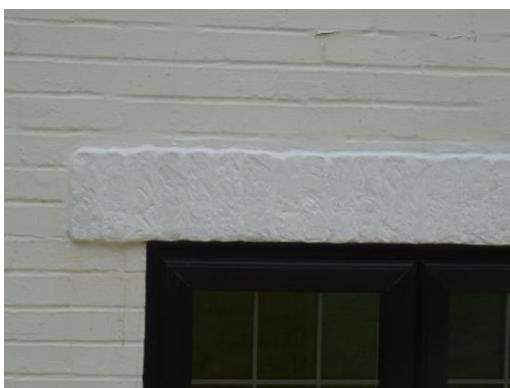
We were unable to identify the lintels above the openings however no structural cracking was noted above as a result of inadequate support. Works have been carried out to the brickwork above the window within the rear facing gable which suggests a retrospective lintel may have been installed, however this should be confirmed with the current vendor.

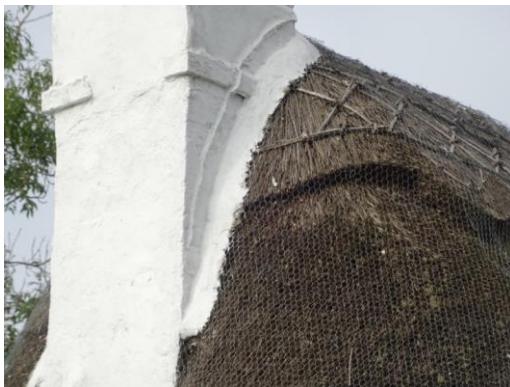
The right hand brick chimney stack and breast is noted to be in reasonable structural order with no significant deterioration of the brickwork or mortar pointing noted.

The chimney breast below the stack has been rendered with no significant deterioration of the render noted.

A clay chimney pot is located to the head of the stack with no damage noted. We would advise that the supporting mortar is checked and renewed as necessary when high level access is next provided.

Cement flashings have been installed to the base of the stack with no significant deterioration of the flashings noted.

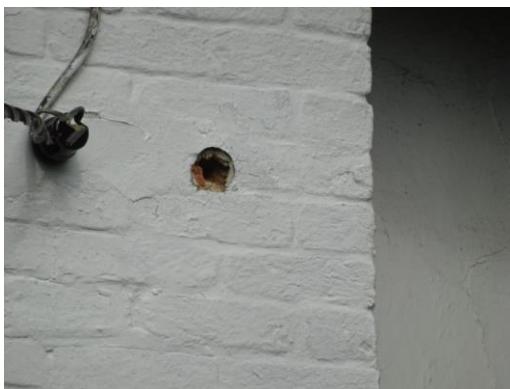
The thatch has been formed in reed with no significant deterioration noted.

The netting has been pulled tight and secured into position.

Minor damage was noted to a single brick at the base of the chimney breast which will require repair.

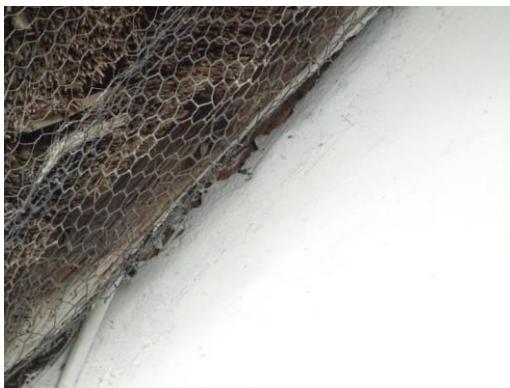
The fascias to the underside of the extension roof are uPVC which are in a satisfactory condition having been firmly secured into position.

Where a limited inspection of the rafters to the underside of the thatch roof could be inspected, localised historic rot was noted which is not considered unusual or considered significant for the age of the property.

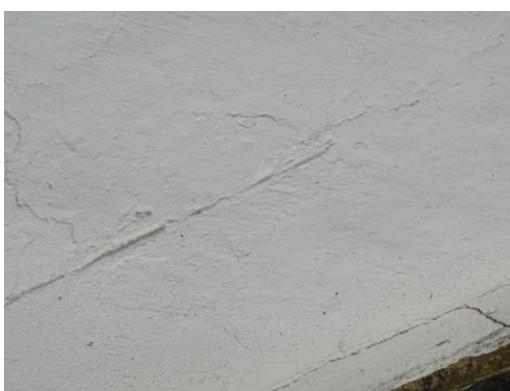
The main elevation has been constructed in solid brick finished with render. Various thermal cracks are evident within the render, however of no significant structural concern.

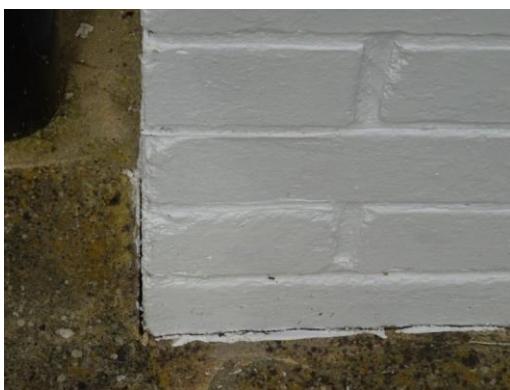
The extension elevation has been constructed in cavity brick with no structural cracking or deformation noted.

The windows are uPVC framed incorporating double glazing which are modern and in a satisfactory condition with no breaking down of the double glazed units noted.

A plastic damp proof course is evident at the base of the elevation which is clear and above tee adjacent ground levels.

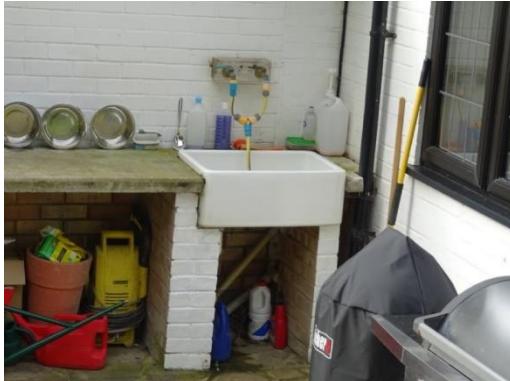
A porcelain sink with a hot and cold tap over has been installed to the left hand side of the elevation, this is dated however of no significant concern. Where the plumbing should be inspected beneath the porcelain sink no evidence of leaks was noted.

A concrete slab seated on dwarf brick walls has been installed either side of the wink which was noted to be structurally sound and firmly secured into position.

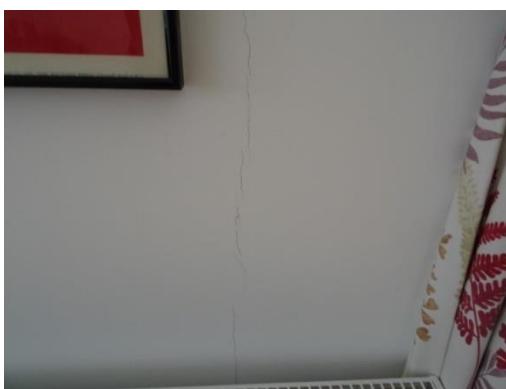
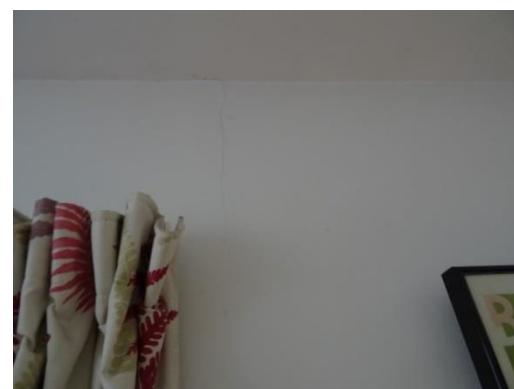
The ceilings is plastered, finished with emulsion. General thermal cracking was noted to the front wall. This is of no significant concern and has most likely occurred as a result of expansion and contraction of the plaster which is due to the heat produced by the radiator. We simply advise that the crack is filled and then decorated.

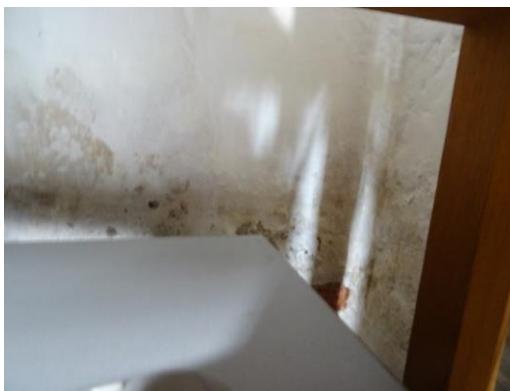
Where the original brick walls could be inspected with a damp detector gauge, above average readings were obtained which has resulted in flaking of the decorative finishes, however this is not considered significant or unusual for the age of the property and we consider it is likely that the damp in this location can be controlled through normal ventilation.

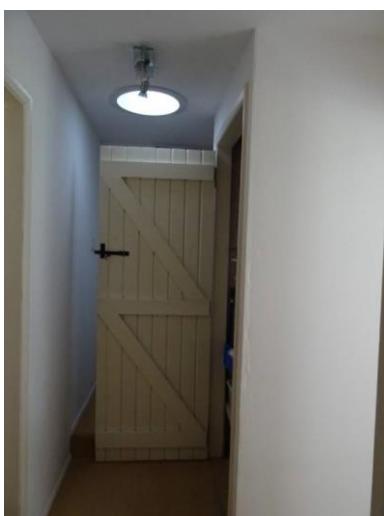
Hall

The ceiling is plastered, finished with emulsion. Minor shrinkage was noted around the corners of the ceiling which is of no structural concern and required filling with a pliable mastic prior to decoration.

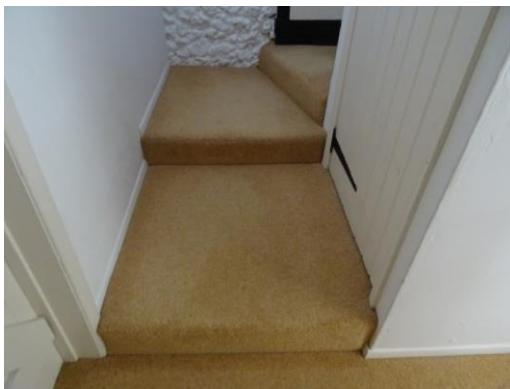
Steps gave access up to the left hand side of the hall. It should be noted the height of the steps is slightly irregular, therefore care should be taken in order to prevent risk of trips and falls.

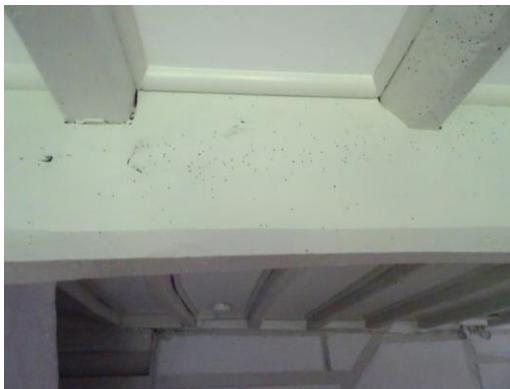
Timber beams supported on a timber column support the ceiling which was noted to be structurally sound with no recent deflection noted.

Wormholes were noted within the timber beams, however when tested with a damp detection gauge the timbers were found to be dry confirming the infestation is dormant.

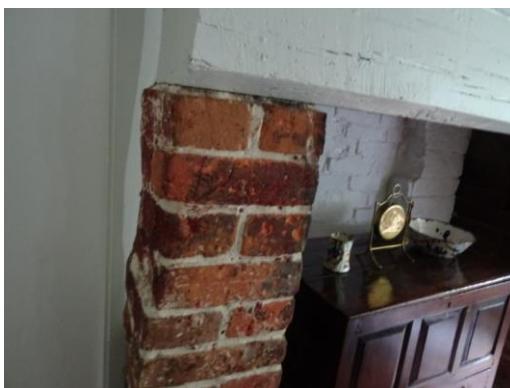
The chimney breasts are located either side of the room to correspond with those noted above. The chimney breasts have been constructed in brick. General perishing of the brickwork was noted due to age related wear and tear however not considered significant with the brick pillars either side of the chimney breast providing adequate support.

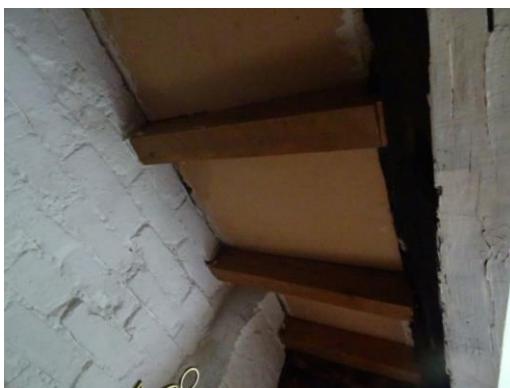
Timber beams support the masonry above the fireplaces which appear to be structurally sound with no recent deflection noted.

The underside of the right hand chimney has been boarded over preventing inspection of the flue. Should you decide to reinstate an open fireplace in this chimney breast then it is likely that the chimney will require the installation of a flue liner.

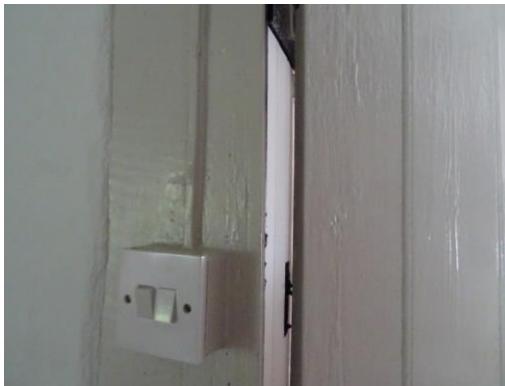
Surface mounted electric cables were noted around the room which would benefit from being ducted in order to comply with current regulations and improve safety.

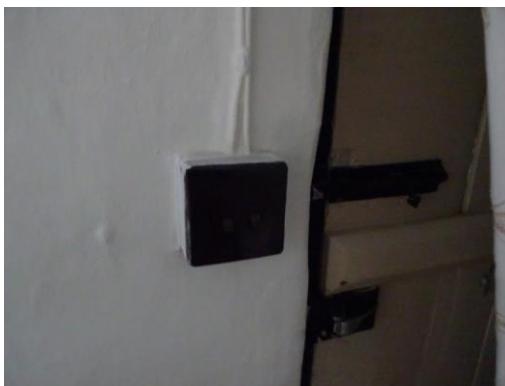
Where the light switches around the room are noted to be dated, we would advise that these are replaced with modern units in order to improve safety.

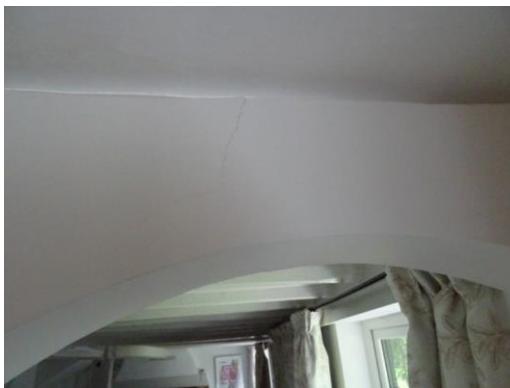
An opening gave access into the dining room. Slight cracking was noted to the head of the arch, however this is not currently considered significant. We would advise that the cracking is filled and then used as a visual monitor. In the unlikely event that further cracking in this location occurs then it will be necessary to rebuild the arch in order to reinstate its structural integrity.

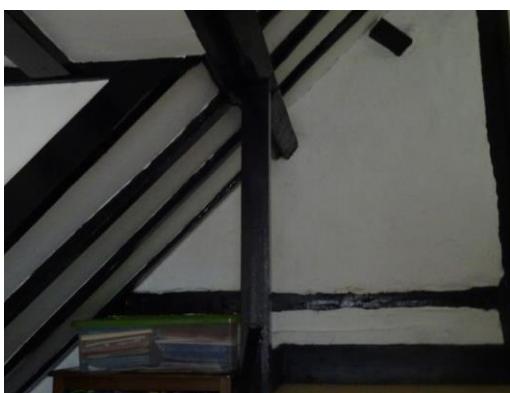
The purlin has been supported on a newel post. Although this would not be considered acceptable by current standards, the post is providing adequate support with no deflection of the purlin evident.

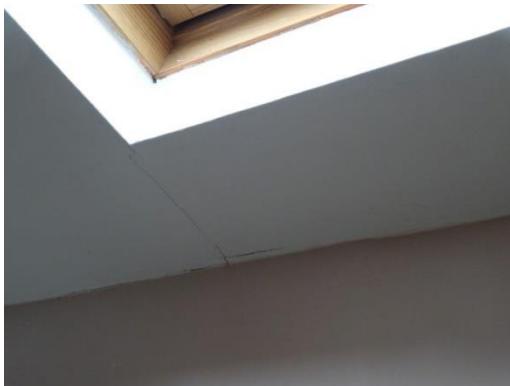
The walls and ceilings are plastered, finished with emulsion. Slight board cracking was noted to the underside of the skylights which is of no structural concern and requires filling prior to decoration.

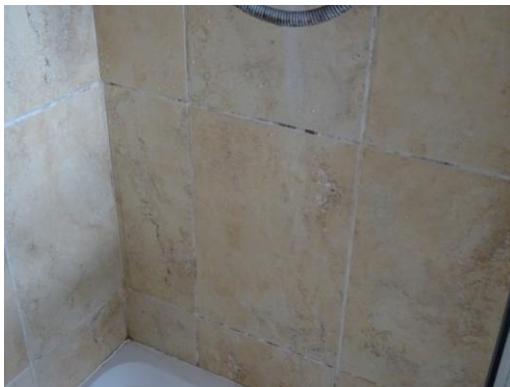
A mechanical extractor has been installed within the room and was noted to be fully operable at the time of our inspection and as a result no significant build-up of condensation was noted. The walls and floor have been surfaced with ceramic tiles with no opening up of grouted joints or splitting of tiles noted. The tiling is relatively begrimed requiring cleaning down with an antibacterial solution.

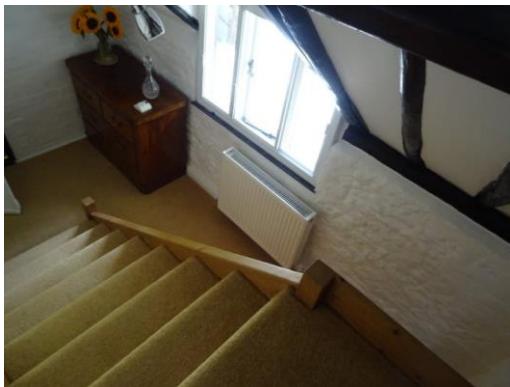
A timber staircase gave access up to the room which felt level and firm underfoot. The staircase is currently considered dangerous in its current condition and we would advise that a balustrade with gaps be no greater than 100mm is installed in the immediate term.

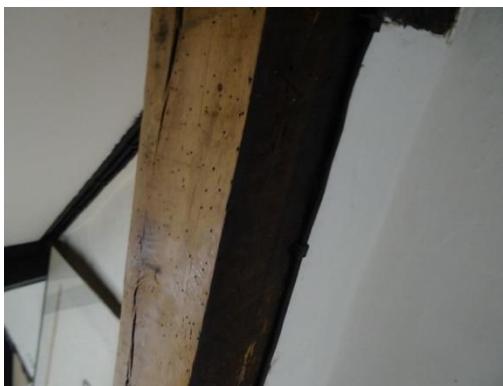
The head height above the staircase is low, therefore care should be taken in order to prevent risk of trips and falls.

Where worm holes were noted to the timbers adjacent the stairwell, the timbers were tested with a damp detection gauge with the timbers found to be dry, confirming the infestation is dormant.

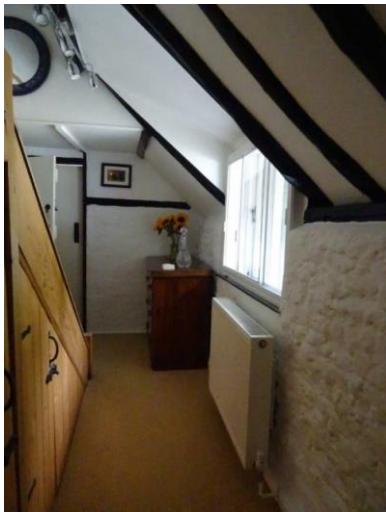
Rear Hall

The ceiling has been formed in fibrous board with no damage noted.

The walls have been constructed in a mixture of brick and stone finished with masonry paint with no structural cracking noted.

The timber roof structure and wall frame is partially exposed and noted to be structurally sound with no evidence of recent rot or infestation noted.

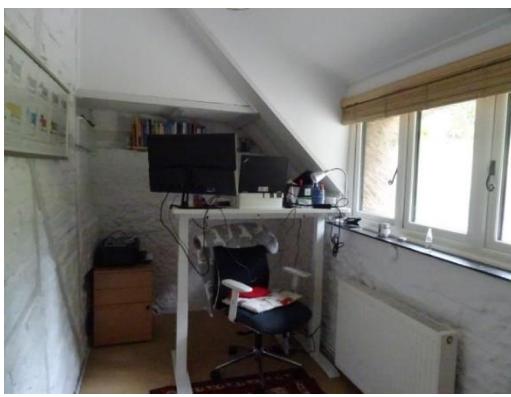
Study

The ceiling has been formed in fibrous board with no damage noted.

The walls have been constructed in a mixture of timber frame with brick infill and rubble stone with no structural cracking noted.

Where the timber wall frame could be inspected it is noted to be structurally sound with no evidence of recent rot or infestation noted. Worm holes were noted to the timber frame, however when tested with a damp detection gauge the timbers were found to be dry confirming the infestation is dormant.

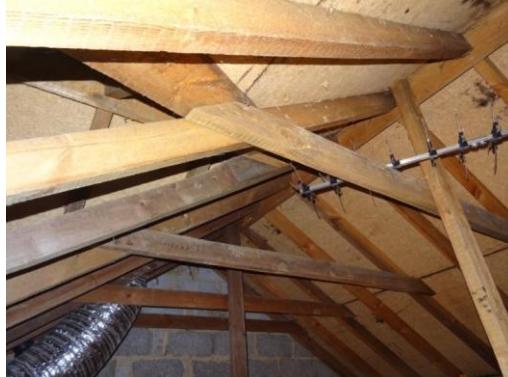
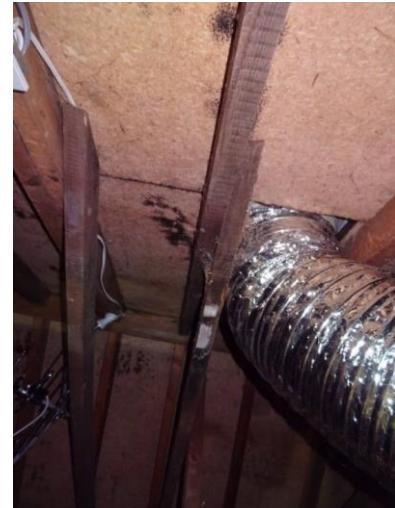
The underside of the roof has been lined with timber board. A general build-up of condensation mould was noted to the underside of the boarding as a result of a lack of ventilation. In order to prevent condensation from persisting which may eventually result in rot of the roof structure, we would advise that ventilation is installed within the roof surfaces.

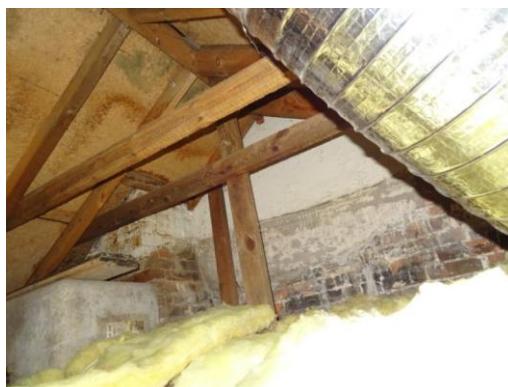
Insulation has been installed within the roof void, however this would benefit from being further uprated in order to reduce heat loss.

An original cold water tank is located within the roof void which appears to have been formed in asbestos cement. Should the cold water tank be disturbed we would advise that this is tested with specialist precautions taken is necessary.

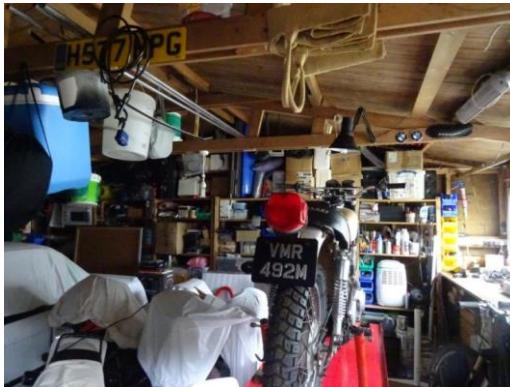
Timber Framed Garage - Internal

Slight damp staining was evident to the underside of the roof where we consider the roof covering above to have failed.

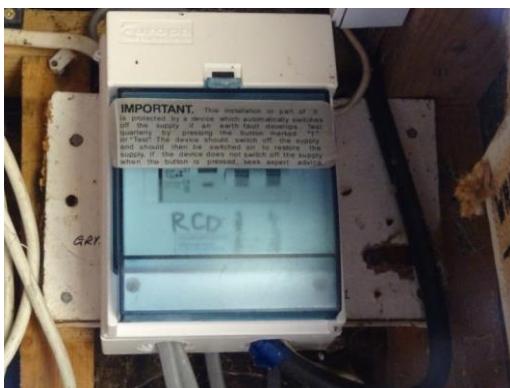
The electric within the garage were relatively modern and isolated by a modern consumer unit. Should the electrics not have been tested within the last twelve months we would advise that they are tested and inspected by a competent qualified electrician.

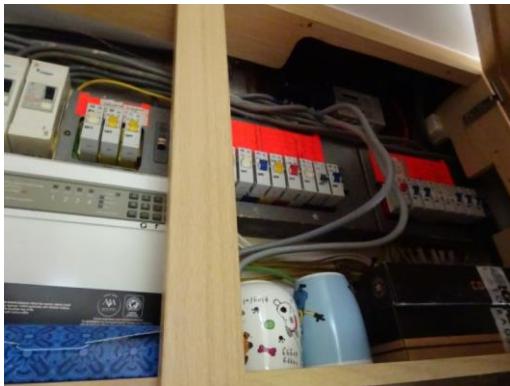
The electrics have been wired in dated plastic covered cables with the distribution board fitted with dated wired fuses. We would advise that the consumer units are uprated to incorporate modern circuit breakers and residual current devices. At this time it will be necessary for a competent qualified electrician to test and inspect the electrical system around the property where it is likely that further upgrading works, or even a complete re-wire may be required. It is often an insurance requirement for thatch properties to have modern wiring.

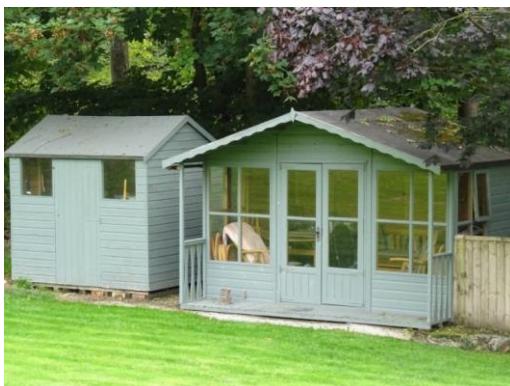
The garden features a timber frame shed and timber frame summer house to the rear which are in a satisfactory condition with only normal wear and tear noted. The summerhouse does incorporate low level single glazing with no safety markings evident, therefore we would advise that a safety film is applied in the immediate term.

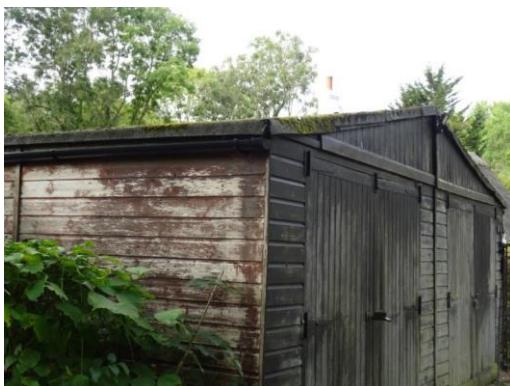
The roof is pitched and covered with felt which was noted to be nearing the end of its serviceable life, therefore will require replacing in the short term. Until such time that the felt roof is re-covered the roof will be at risk of water ingress.

The elevations have been formed in timber frame clad with timber panelling. Localised rot was noted to the timber panelling due to age related wear and tear, therefore will require extensive repair until such time that the cladding is completely replaced.

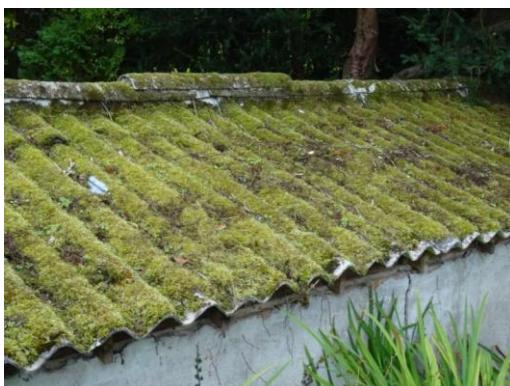
The roof has been formed in corrugated asbestos cement sheets which are of a significant age and have become brittle. As a result the roof will be at risk of water ingress and a release of fibres until such time that it is replaced. We would therefore advise that the roof is replaced in the immediate term, however prior to any work being carried out we would advise that it is tested for asbestos with specialist precautions taken if necessary.

The elevations have been formed in brick finished with render which is generally in poor condition, however no significant structural movement was noted to at the time of our inspection.

Timber side hung doors with a timber cladding surround gave vehicular access into the front of the garage. The door and timber surround are in poor condition with evidence of rot and woodworm noted.

We consider the garage to be at the end of its useable life and would advise that it is demolished and removed. Until such time that the garage is demolished and removed it will require above average maintenance in order to keep it weather tight and structurally sound.

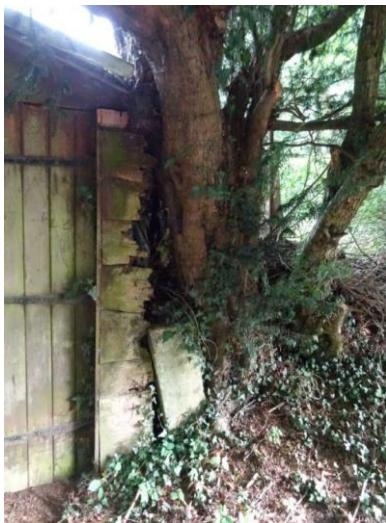
A substantial root system is located adjacent the garage which will be an ongoing risk to the structural integrity of the garage until such time that the garage is removed.

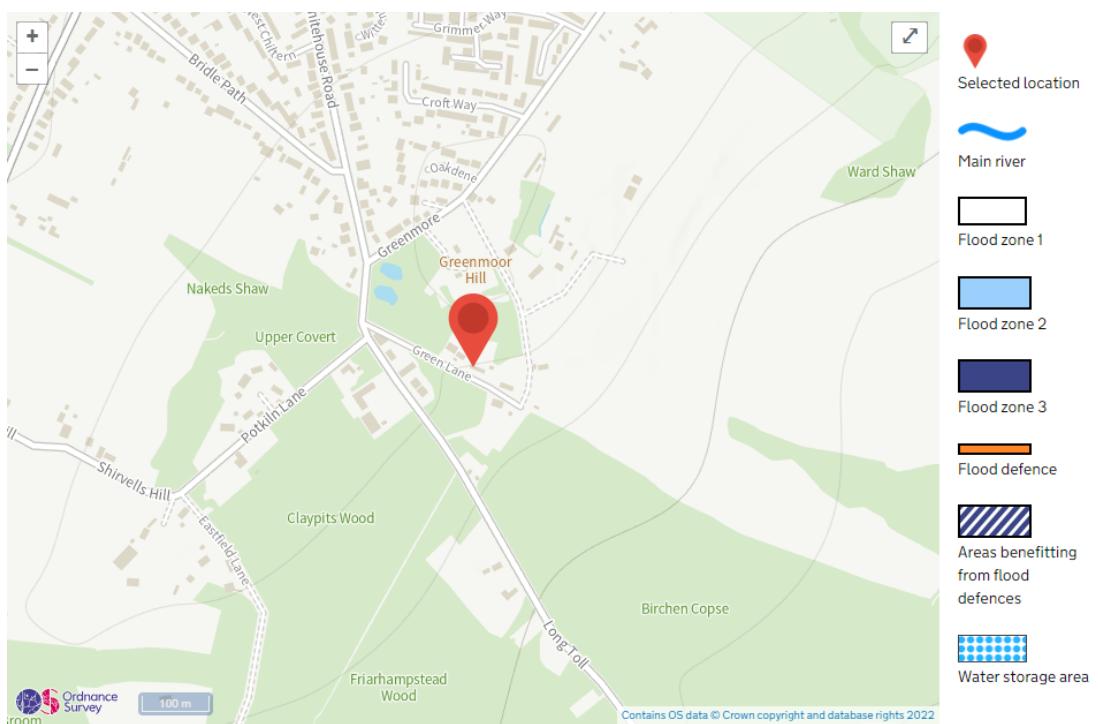
Flooding risk

We have not undertaken detailed investigations into the potential for flooding of the land on which the property lies. However, we have consulted the website at www.environment-agency.gov.uk of the Environment Agency and their information regarding the potential for flooding suggests that the area is not at risk from flooding.

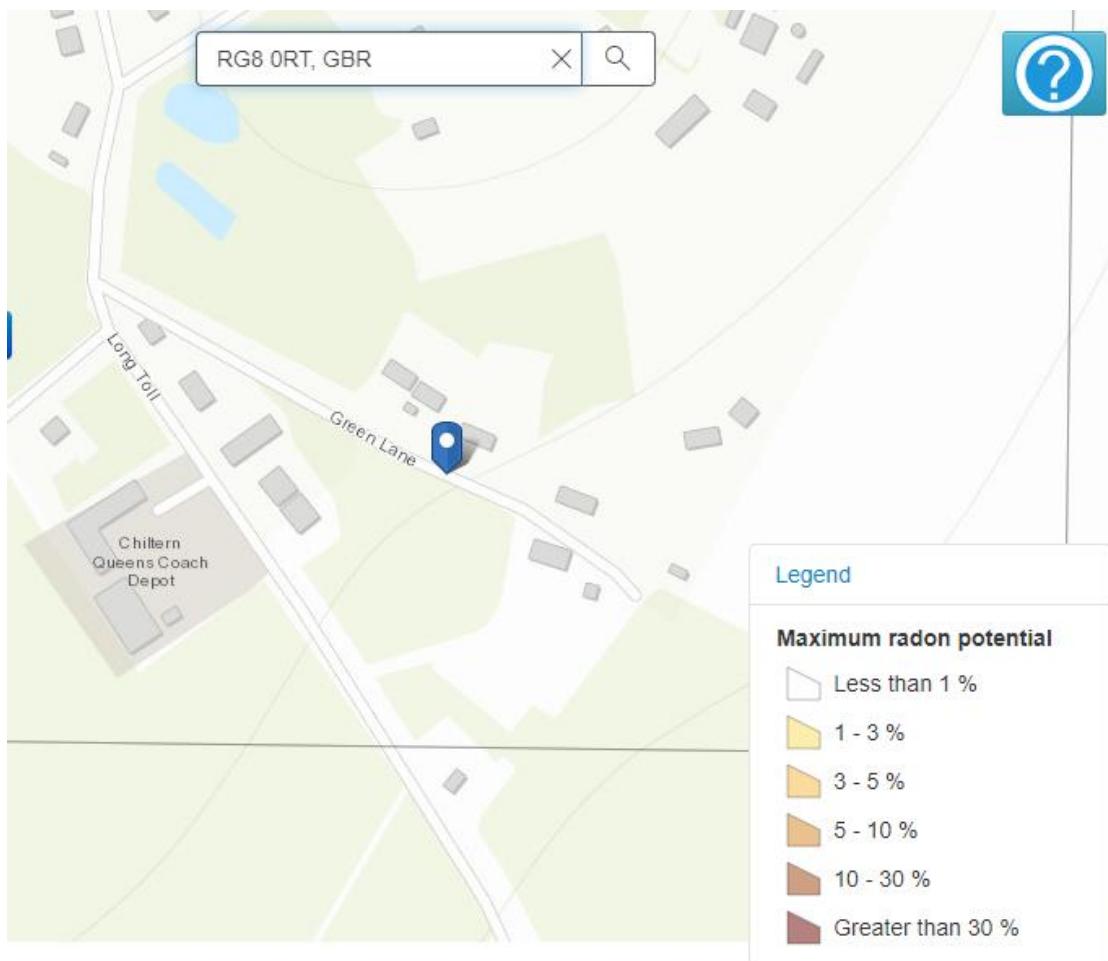
Radon risk

Our desktop survey revealed the property to be located in an area where the likelihood of whether radon gas is present in any given building, as the gas is invisible and odourless. Tests can be carried out to assess the level of radon in the building at a small charge. It is understood there is a testing period, possibly lasting several months, which does not appear to be required in this instance. radon is at its lowest. It is not possible in the course of a building survey to determine

Following the legal searches, if Radon, as an environmental hazard, is something that you are particularly sensitive to, further investigations and, if necessary, testing should be considered for an assessment of the site's exposure.
