BUILDING SURVEY

Level 3

ALLCOTT
RESIDENTIAL

Somewhere Street, Anywhere, Everyplace,
EV1 1WX

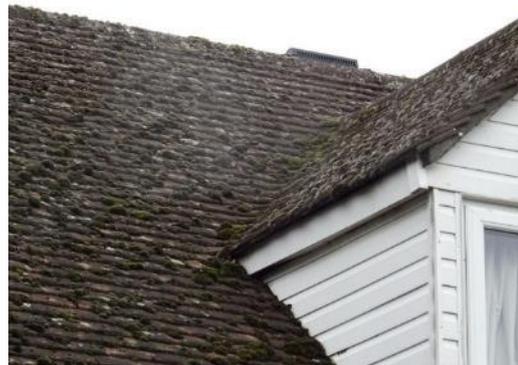
Where the forward facing dormer roofs abuts the main roof, tiled valleys have been formed which are noted to be relatively blocked with vegetation requiring clearing in the immediate term. It should be noted that it is necessary to keep the valleys clear of debris in order to prevent rainwater backing up into the roof void.

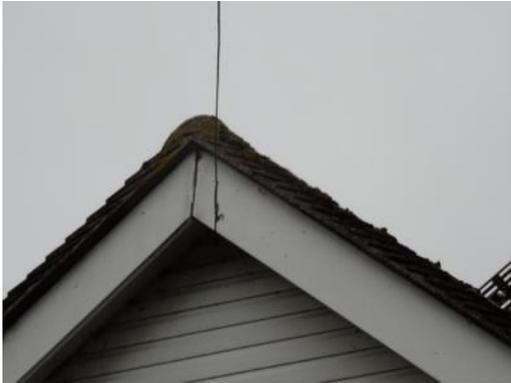
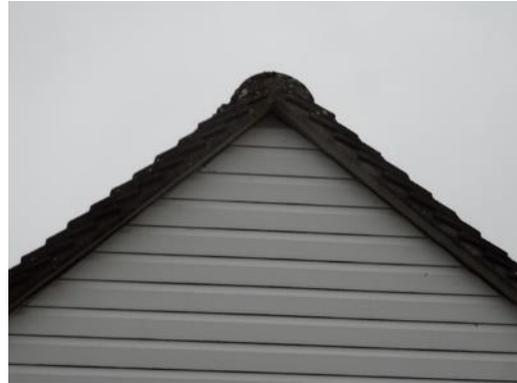
The verge pointing to the forward-facing gables is in good condition with no significant areas of missing mortar noted.

The tile under cloak appears to have been formed in fibrous board. It should be noted that fibrous board in properties of this age and type may contain asbestos. Therefore, should the fibrous board be disturbed, we would advise that it is tested with specialist precautions taken if necessary.

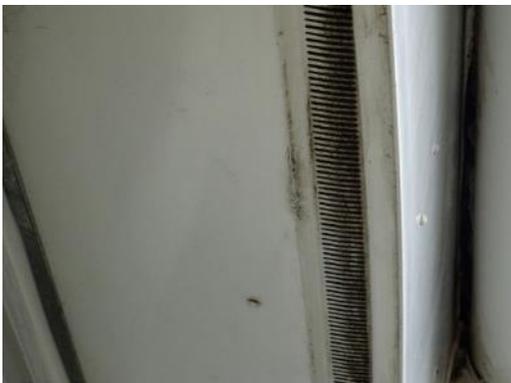
The soffits running along the underside of the main roof have been vented in accordance with good building practice. It is necessary to provide ventilation to the roof void in order to prevent condensation building up.

The gutters and down water pipes are uPVC which are noted to be leaking at the joints requiring renewal of the seals.

The gutters were noted to sag, therefore will require altering of the brackets in order to increase the falls. It is necessary to provide adequate falls to the gutters in order to prevent rainwater sitting within the joints which will result in premature deterioration of the seals.

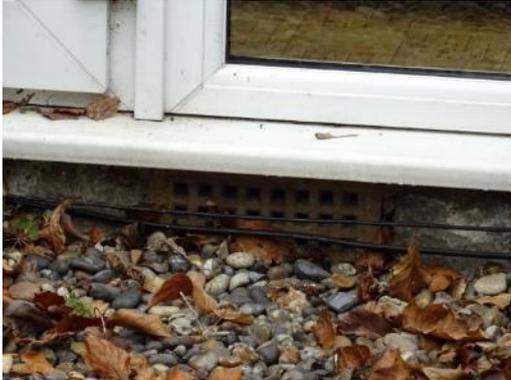
A bitumen damp proof course is evident at the base of the elevation which has been compromised by the height of the adjacent ground level. It is recommended that a minimum distance of two bricks is provided between the damp proof course and the adjacent ground level. We would therefore advise that the ground level is pulled back as necessary.

Air bricks are evident at the base of the elevation which have been compromised by the height of the adjacent ground level. Air bricks are necessary in order to prevent condensation building up within the subfloor area. We would therefore advise that the ground level is pulled back from the air bricks in order to provide adequate free flow ventilation.

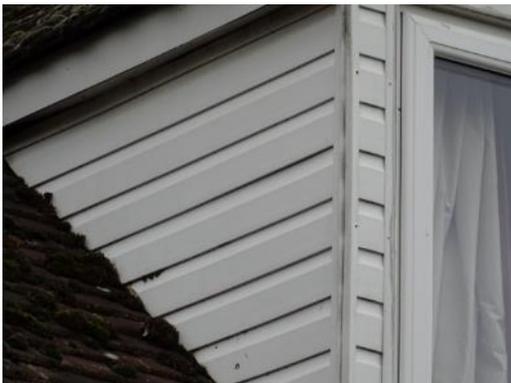
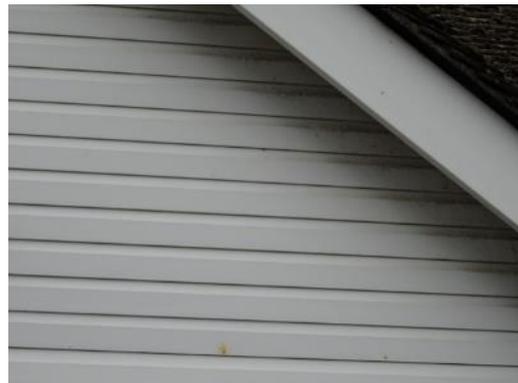
uPVC panelling has been installed to the dormer cheeks and to the main gable elevation albeit relatively begrimed requiring cleaning down. The uPVC panelling is noted to be firmly secured into position.

Various junction caps were noted to be missing which we would advise are replaced in the immediate term in order to prevent risk of water ingress in times of wind driven rain.

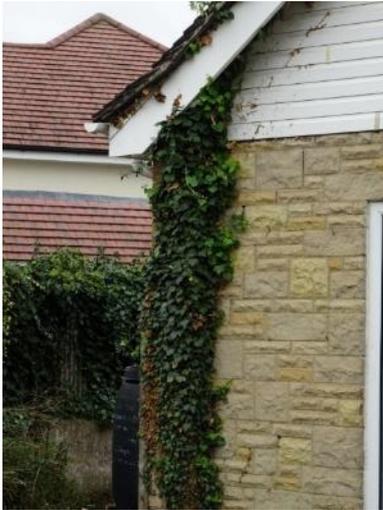
A vine was growing up the left hand elevation which we would advise is cut back and then controlled and maintained in due course in order to prevent becoming a further nuisance.

The windows and patio door are uPVC framed incorporating double glazing which are relatively modern however are tired and begrimed requiring cleaning down and servicing. The windows and doors are considered serviceable with no breaking down of the double glazed units noted. It should be noted that double glazing can vary in quality particularly in respect of the seals around the edges of the glass. Eventually these seals tend to deteriorate resulting in misting and the need for repair or replacement.

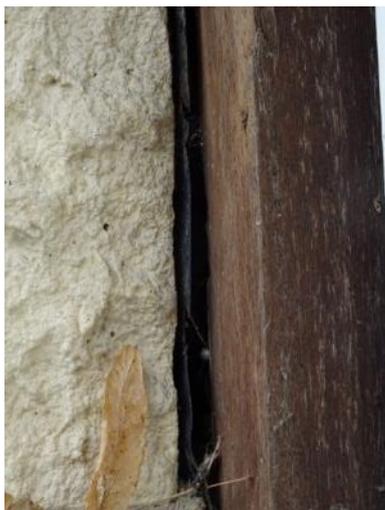
We would advise that the junction between the timber subframe and masonry is filled with a pliable mastic in order to prevent risk of water ingress in times of wind driven rain.

Should rainwater enter beneath the garage door in times of heavy rainfall then we would advise that grille drain is installed along the front of the garage which connects directly to the storm water drainage.

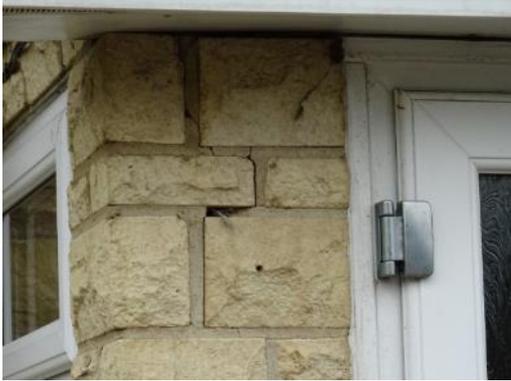
Minor localised repointing is required at high level adjacent the main entrance door. This is of no significant concern and simply a result of reverberation of heavy use of the door and

simply requires raking out with the stonework then repointed with a suitable colour mortar to match.

Proprietary steel lintels support the masonry above the openings with no significant corrosion noted.

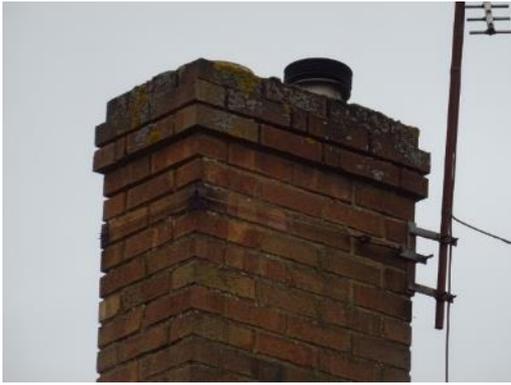
The brick chimney stack requires general maintenance in the form of repointing. We would advise that the chimney is repointed in the immediate term in order to prevent risk of damp ingress.

A clay chimney pot is evident to the left hand side of the stack with no significant damage noted. We would advise that the supporting mortar is checked and renewed as necessary when high level access is next provided.

Consideration should be given to installing a cowl to the head of the chimney pot in order to prevent risk of vermin and water ingress.

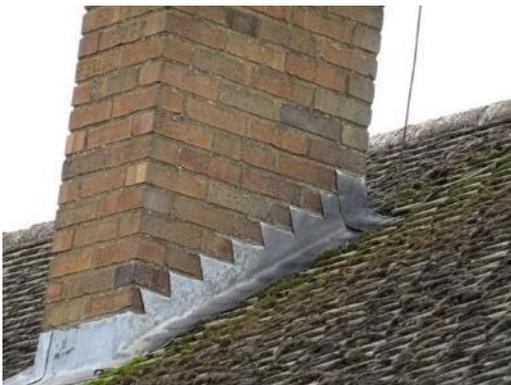
Lead flashings have been installed to the base of the stack with the lead noted to be in a serviceable condition and firmly dressed into the brickwork.

The roof covering is in a serviceable condition with no slippage or deterioration of the tiles noted.

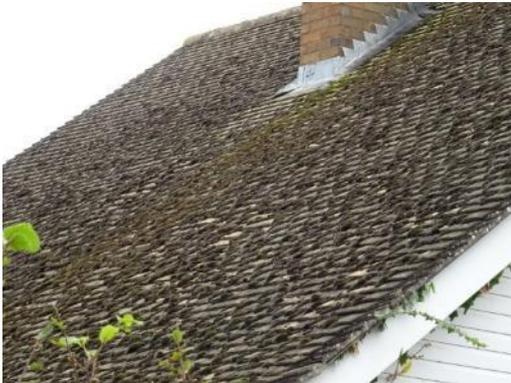
A heavy build-up of moss was noted to the roof surface which we would advise is removed as part of the proactive maintenance scheme for the property.

The gutters and down water pipes are uPVC with no evidence of leaking joints or obvious signs of overflowing noted. The gutters were noted to be heavily blocked with moss requiring clearing in the immediate term.

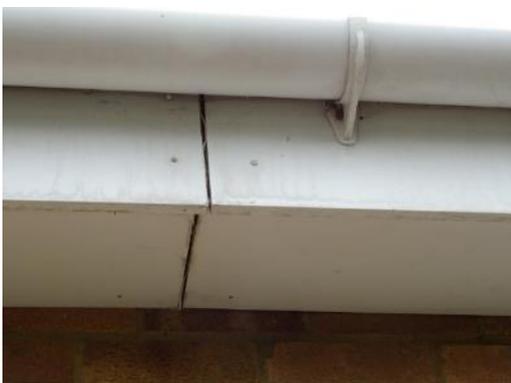
The soffits and fascias are uPVC which have been amateurishly installed however are considered serviceable and firmly secured into position. Should you decide to keep the existing soffits and fascias, we would advise that junction caps are installed in order to prevent risk of vermin ingress into the roof void.

The elevation has been constructed in fair faced cavity brickwork with no significant structural cracking or deformations noted.

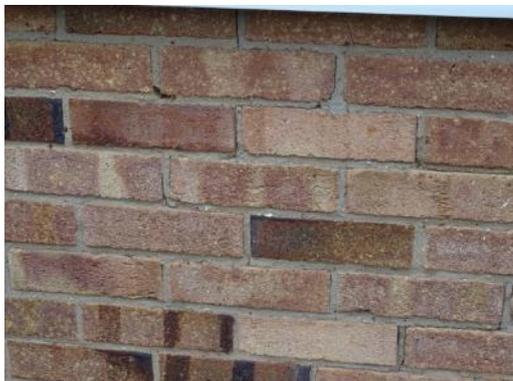
Slight opening up of the mortar pointing is evident beneath the windows however this is of no significant concern and simply a result of excessive force having been applied with the windows were replaced. We would simply advise that the cracked mortar pointing is raked out with the brickwork repointed with a suitable colour mortar to match.

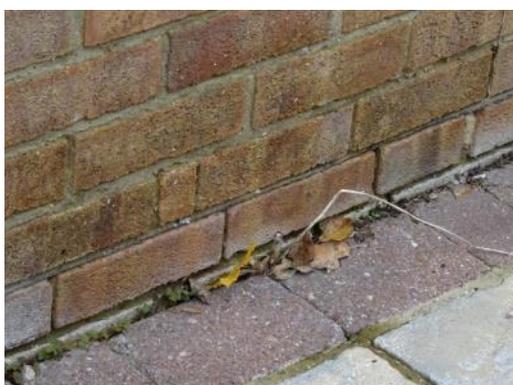
The bitumen damp proof course is evident at the base of the elevation which has been compromised by the height of the adjacent ground level. We would advise that the paving is pulled back with gravel installed in order to prevent risk of rainwater splashing up above the damp proof course which may eventually result in damp internally.

General repointing is required to the brickwork at the base of the elevation which we would advise is carried out as part of the proactive maintenance scheme for the property.

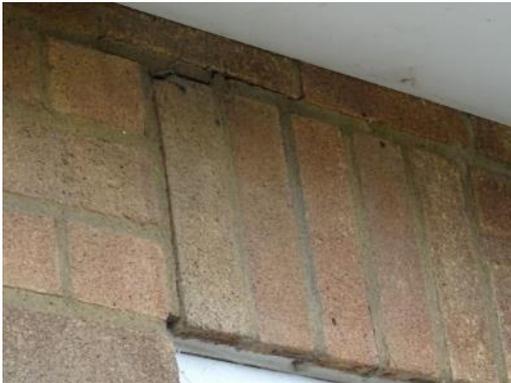
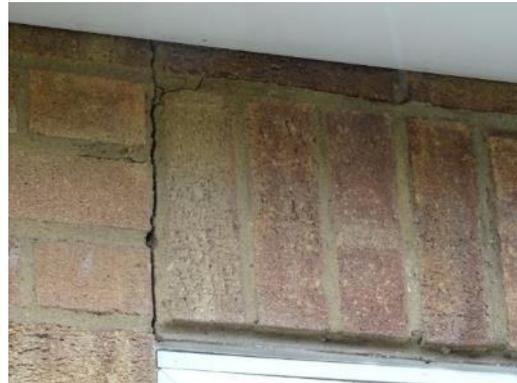
The mastic seal around the edges of the windows is in a deteriorating condition requiring cutting out and renewing.

We were unable to identify lintels above the windows. Slight dropping of the brickwork is evident above the windows, therefore we would advise that prior to repointing being carried out that a single brick above the windows is removed to allow for confirmation of the existence of lintels. Should no lintels be evident, then we would advise that these are installed in accordance with modern Building Regulations.

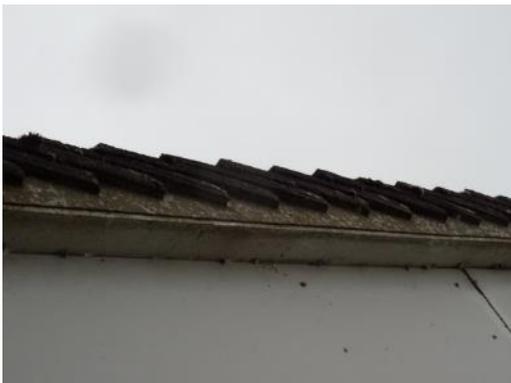
The tile under cloak has been formed in fibrous board with no significant damage noted.

The soffits and fascias are uPVC which have been amateurishly installed but are considered fit for purpose and firmly secured into position.

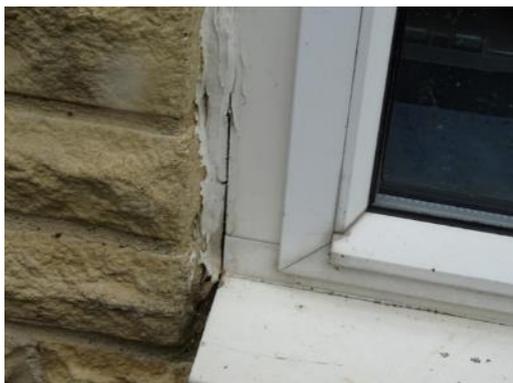
The mastic seal around the edge of the uPVC frames is in a deteriorating condition requiring cutting out and renewing.

The garage pedestrian door has been amateurishly installed as a result of its poor fitting, a timber infill has been installed above the door. This is amateurish however of no significant concern.

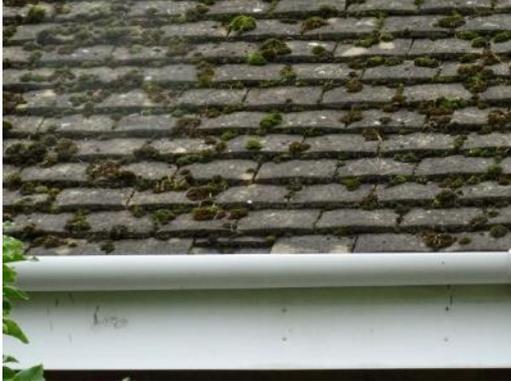
The roof covering is in a serviceable condition with no significant slippage or deterioration of the tiles noted. A single tile at low level to the left hand side of the elevation was noted to be damaged, therefore will require replacing in the immediate term.

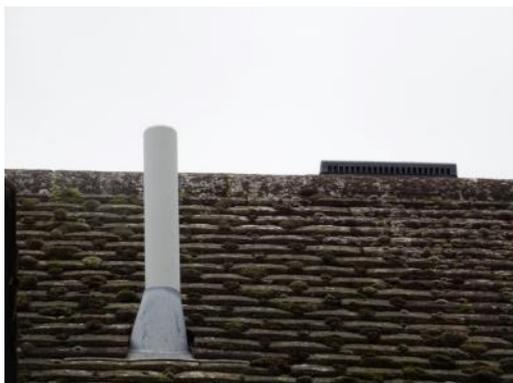
A soil pipe passed through the roof surface which has been correctly flashed back to the tiles with lead. We would advise that a bird guard is installed to the head of the soil pipe in order to prevent risk of vermin ingress.

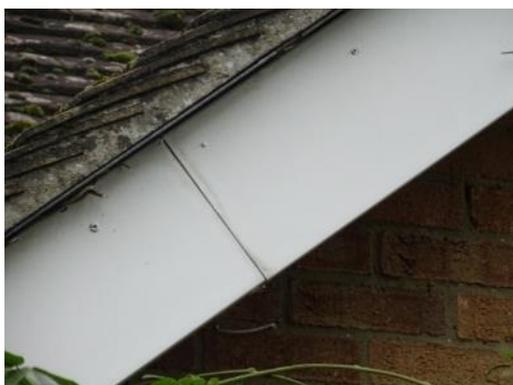
The soffits and fascias are uPVC which have been amateurishly installed however are considered fit for purpose having been firmly secured into position. Should you decide to keep the existing fascias, we would advise that junction caps are installed in order to improve aesthetics.

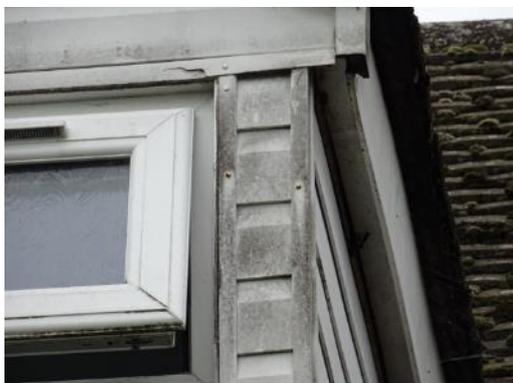
The dormer gables and cheeks have been finished with uPVC panelling, which is relatively begrimed requiring cleaning down however is considered serviceable having been firmly secured into position. Minor localised damage was noted to the uPVC capping above the right hand dormer window which is of no significant concern.

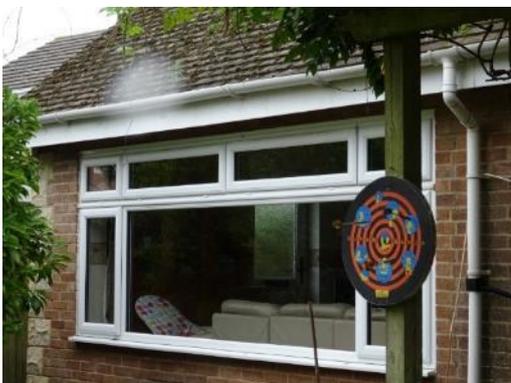
The left hand snug window is relatively low. Safety markings were noted to the window to confirm that the glazing is safety glass.

We were unable to identify lintels above the windows. Slight dropping of the brickwork above the windows was noted. Initially we would advise that the cracked mortar pointing is raked out with the brickwork then repointed with a suitable colour mortar to match with the repair then used as a visual monitor. Should further cracking above the windows occur, it will then be necessary to open up the brickwork above the windows to confirm the existence of lintels with lintels then installed if necessary.

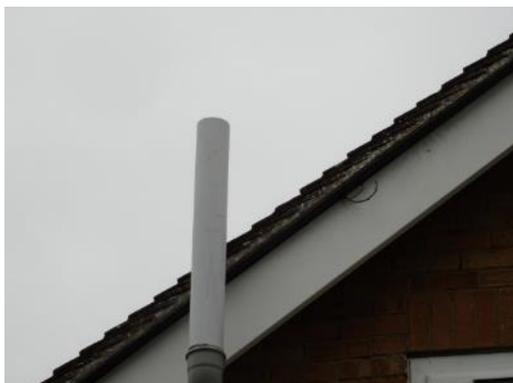
A uPVC soil and vent pipe passed up the main elevation with no evidence of leaking joints noted. We would advise that a bird guard is installed to the head of the soil pipe in order to prevent risk of vermin ingress.

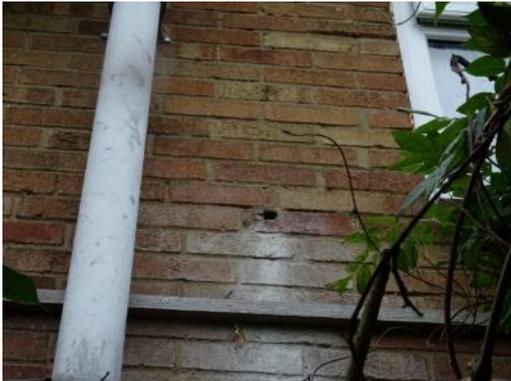
White efflorescence staining is noted to the brickwork to the right hand side of the soil pipe where we consider an overflow pipe to have been continuously discharging. Initially we would advise that the efflorescence is removed with a soft wire brush. The original overflow pipe has been removed which suggests that the defect has been previously noted with repairs carried out as necessary. This should be confirmed with the current vendor. We would then advise that the redundant hole is filled in order to prevent risk of vermin ingress into the cavity.

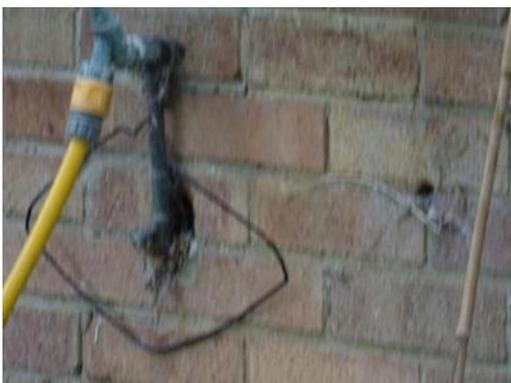
The mastic seal around the edge of the window frames is in a deteriorating condition requiring cutting out and renewing.

An external tap has is located beneath the kitchen window, which is offset from the gulley, therefore we would advise that it is periodically inspected to ensure that it is not left to leak.

Where the tap pipework passes through the elevation, localised filling is required.

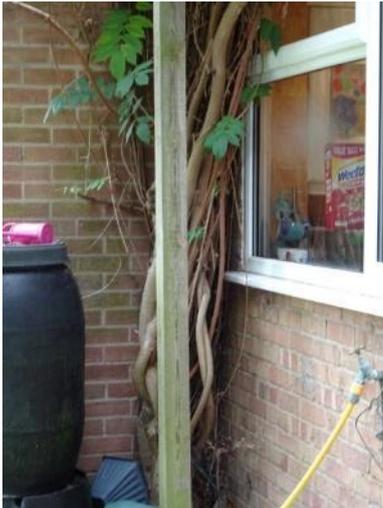
A significant vine was growing up the elevation. Due to the extent of the root system we would advise that this is removed in order to prevent being a risk to the foundations and adjacent drainage.

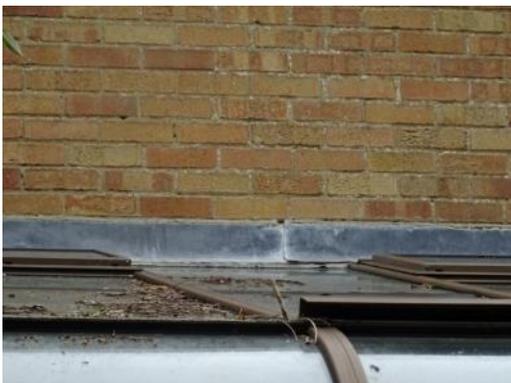
Where the conservatory abuts the main body of the property, lead flashings have been installed with the lead noted to be in a serviceable condition and firmly dressed into the brickwork.

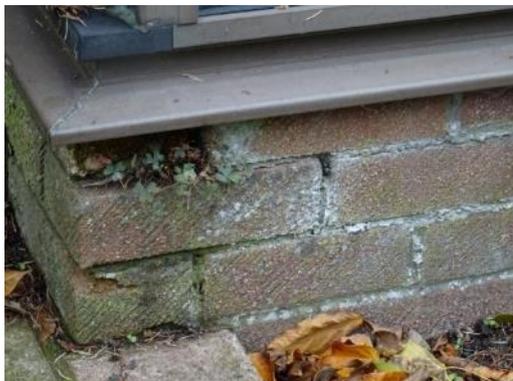
The conservatory has been seated on dwarf brick walls. Various bricks were noted to have debonded therefore will require localised re-building at the time the conservatory is replaced.

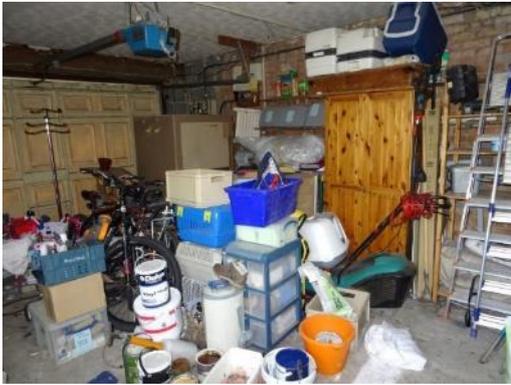
The ceiling is plastered finished with a textured coating with no significant cracking noted. We were unable to confirm that the ceiling provides adequate fire separation between the garage and the habitable room above. Until such time that adequate fire separation can be confirmed, we would advise against storing of flammable liquids and motor vehicles within the garage area.

Should it be confirmed that the ceiling provides adequate fire separation, slight compromising of the ceiling has occurred where service pipes passed through which will require upgrading.

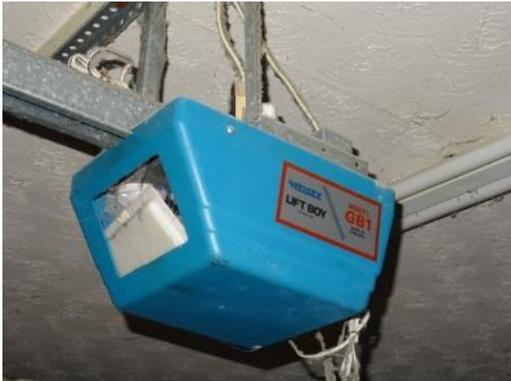
An automatic door opener has been installed however this was noted to be defective at the time of our inspection therefore will require either repair or replacement.

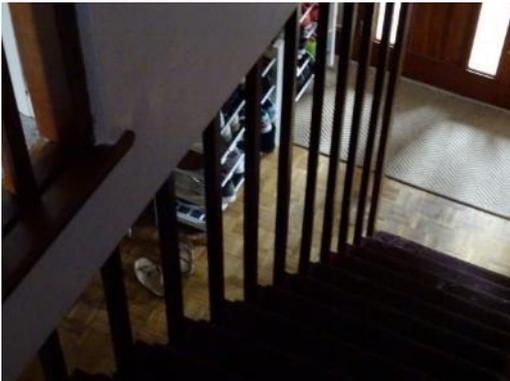
The gaps between the stair balustrade are considered too wide by current regulations. Should you decide to keep the existing balustrade, we would advise that further spindles are installed in order for the gaps to be no greater than 100 mm.

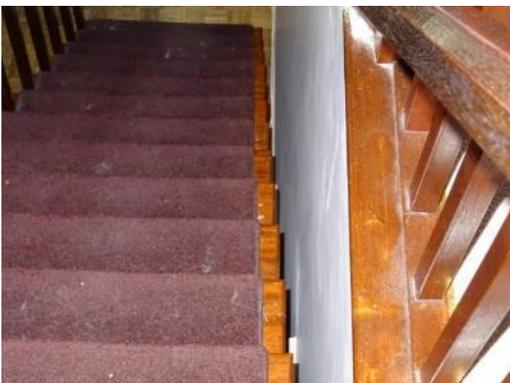
The staircase does not finish flush with the wall and we consider this an area where injury could occur. We would therefore advise that a stair stringer is installed in order for the gaps to be no greater than 100 mm.

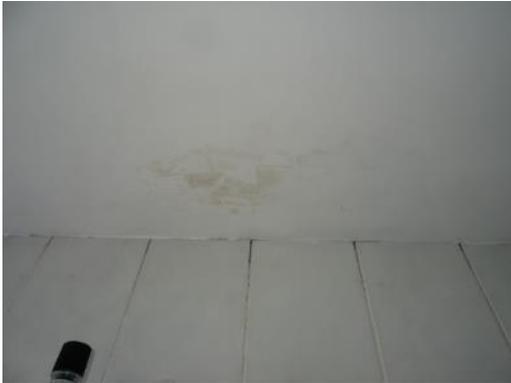
A localised poor repair has been carried out to the ceiling where we consider water ingress to have previously occurred. This appears historic which suggests that this has been identified with repairs carried out as necessary. We would advise that the repair is sanded back prior to next decoration.

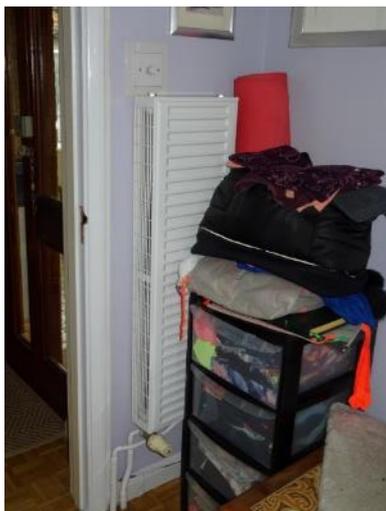
A radiator has been installed to the right hand side of the entrance door. The location of the radiator appears relatively awkward, therefore it would benefit from being repositioned in a conventional manner.

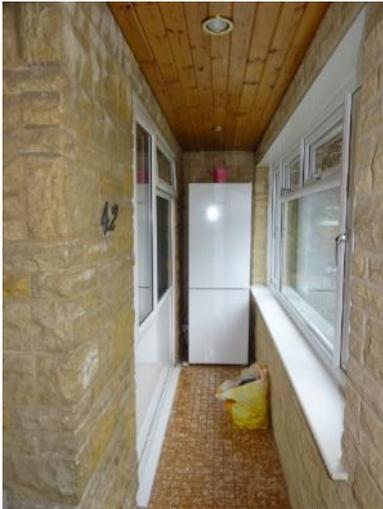
Porch

The ceiling has been formed in timber panelling, which is relatively dated, therefore you may wish to consider removing this at which time the ceiling will require plasterboard and skimming.

Recess lights have been installed within the ceiling which are relatively dated, therefore would benefit from being replaced with low wattage units.

The walls have been constructed in reconstituted stone with no significant cracking noted.

The floor has been surfaced with ceramic tiles. Minor opening up of the grouted joints was noted as a result of general wear and tear however not considered significant.

The window within the main body of the property is uPVC framed incorporating double glazing which are modern and in a serviceable condition with no breaking down of the double glazed units noted.

We are unable to identify a lintel above the window however no significant cracking was noted above to suggest inadequate support.

Where the porch abuts the main body of the property, a straight joint is evident. Slight shrinkage cracking of the mortar pointing was noted however of no significant concern.

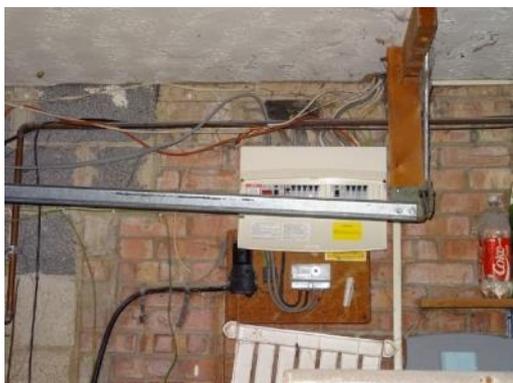
The electrical consumer unit was located at high level on the left hand wall. Where visible the electrical system has been wired in uPVC cables with the distribution board fitted with circuit breakers and a residual current device. We did note various amateurish alterations to the electrical system, therefore would advise that the electrical system is tested and inspected by a competent and qualified electrician in the immediate term where it is likely that upgrading works will be required.

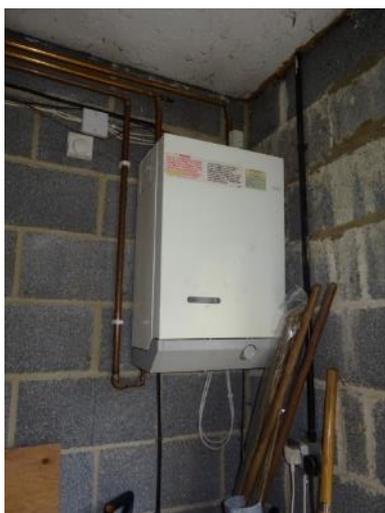
The central heating is provided by the gas fired boiler located within the garage. The boiler is relatively dated however was noted to be fully operable at the time of our inspection with no significant defect noted to either the boiler or the associated pipework where evident. It should be noted that due to the age of the boiler it will be relatively inefficient and require above average maintenance. You therefore may wish to consider replacing the boiler with a modern unit in the short term which will improve the thermal efficiency and re-saleability of the property.

Should the boiler not have been serviced within the last 12 months, then we would advise that it is tested and inspected by a competent and qualified Gas Safe registered engineer.

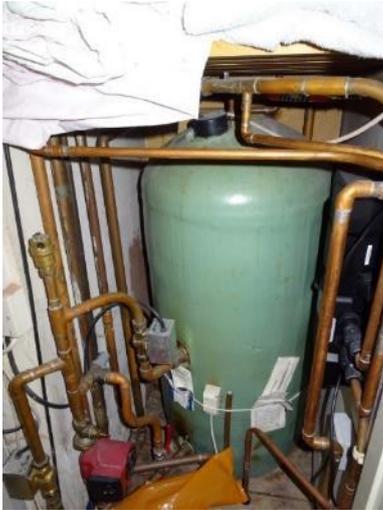
The hot water is stored within a copper cylinder which incorporates a solid lagging jacket located within the airing cupboard. The cylinder is relatively dated but is considered

serviceable with no evidence of leaks noted to either the cylinder or the associated pipework where evident.

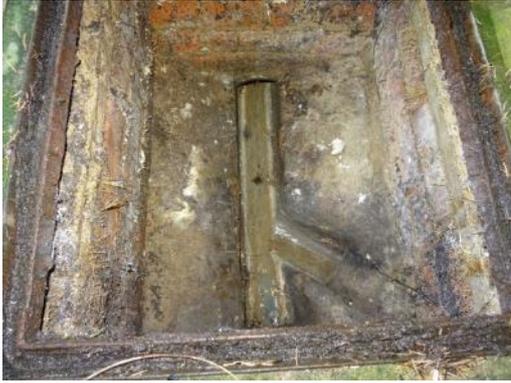
Where the drainage could be inspected via the cast iron drainage chamber to the rear of the property, the drains were noted to be a ridged jointed clay system which were clear of blockages at the time of our inspection.

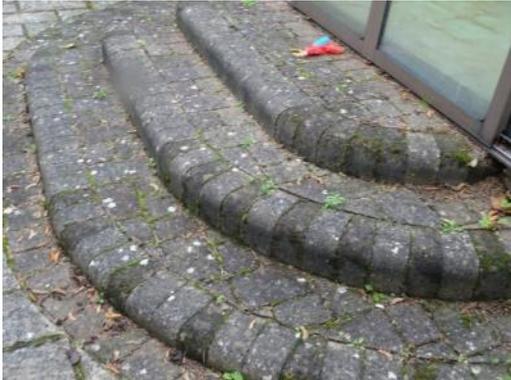
Concrete paviours have been laid adjacent the property which are relatively level feeling firm underfoot however would benefit from general maintenance in the form of removing the vegetation between the joints.

Paved steps gave access up to the conservatory. The height of the steps was irregular therefore care should be taken in order to prevent risk of trips and falls.

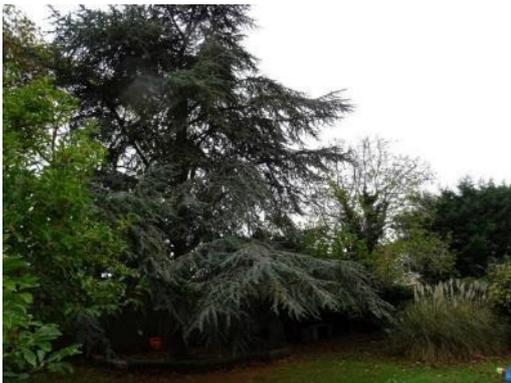
The lawn and associated flower beds require general maintenance in the form of defining the area.

Various trees and shrubs are located around the rear garden which are not considered to be a significant risk to neither the building's foundations nor its drainage. Nonetheless we would advise that they are controlled and maintained in due course in order to prevent becoming a further nuisance to the adjoining owners.

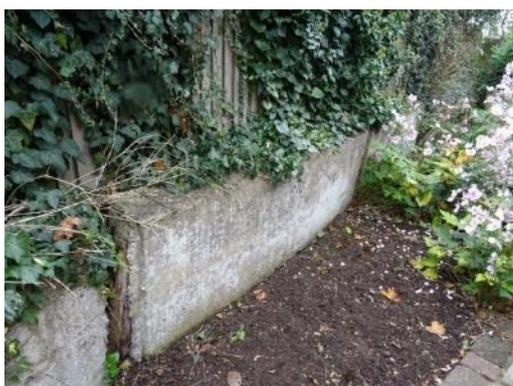
A low level concrete wall has been partially constructed to the left hand side of the garden which was noted to be leaning over. We would advise that the concrete walling is broken out and removed in order to prevent ongoing maintenance and repair.

It should be noted that we consider the concrete walls to be retaining, therefore will require reconstruction at the time of demolition.

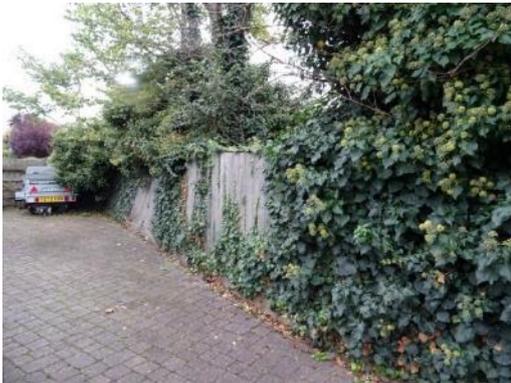
The drive has been laid to block paving, which is noted to slightly undulate underfoot however not considered significant. General maintenance in the form of removing the vegetation between the joints would be beneficial.

The boundaries to the front of the drive is denoted by timber featheredge boarding which is at the end of its serviceable life therefore will require replacing in the immediate term.

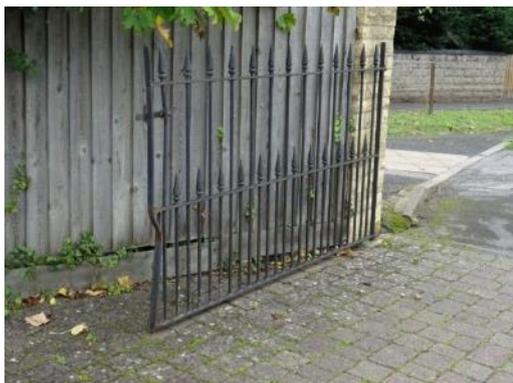
Cast iron metal gates supported on reconstituted stone pillars gave access into the property. The gates were noted to have suffered impact damage, therefore will require replacing.

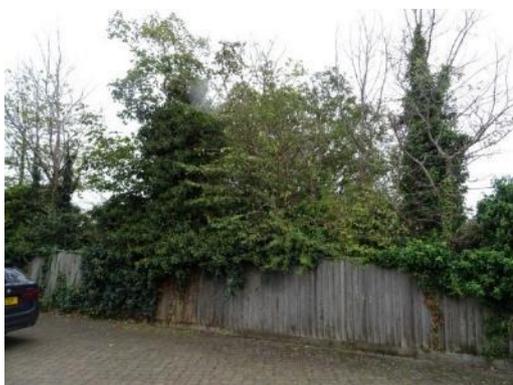
Various trees and shrubs are located to the front of the drive which are not considered to be a significant risk to neither the building's foundations nor its drainage. Nonetheless we would advise that they are controlled and maintained in due course in order to prevent becoming a further nuisance.

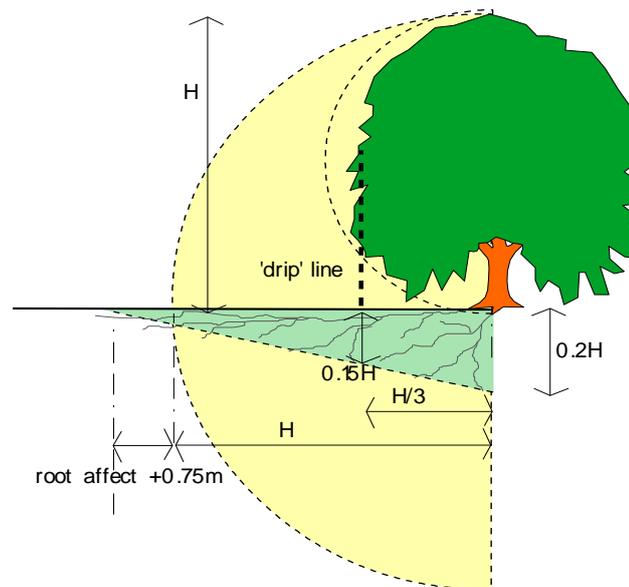
Figure

There are trees in close proximity to the building. The growth of the Horse Chestnut tree located in close proximity to the rear right hand corner should be monitored and, if necessary, controlled in due course.

Typical proportions of a Horse Chestnut. Note the potential root zone.

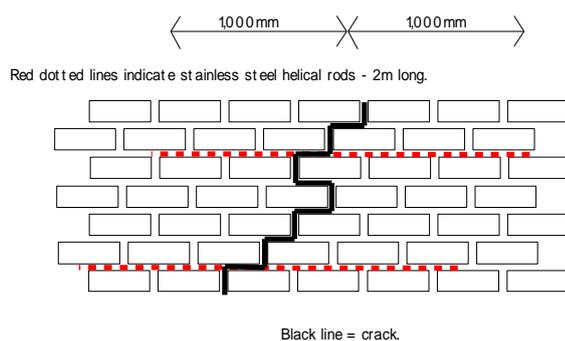
We noted slight movement of the front left hand corner of the property evidenced by external stepped cracking. We consider the movement most likely to have occurred as a result of saturation of the subsoils caused by overflowing of the water butt for a significant period of time. Initially we would advise that the water butts around the property are removed with the down water pipes repaired. Once it can be confirmed the ground has dried out back to its natural moisture content, we consider that no further movement will occur, at which time the cracked mortar pointing can simply be raked out with the stonework stitched and pointed with a suitable colour mortar to match (please see diagram below). We would then advise that the repair is used as a visual monitor and in the unlikely event that further cracking occurs, then it will be necessary to carry out a CCTV survey of the drainage running along the left hand elevation to ensure that there is no below ground defect causing a further softening of the subsoils. Once it can be confirmed the drainage is sound, we again consider that no further movement will occur.

Typical repair detail for cracks wider than 5mm across, and when active movement has been recorded less than 3 mm per annum.

This will involve disc cutting a 20mm deep chase into the bed joint across a crack. An epoxy resin mortar is then pressure grouted into the open joint, and stainless steel rods are set into place.
