# Building Survey

# Project Preface

**Document prepared by:** Matthew Baker BSc (Hons) MRICS

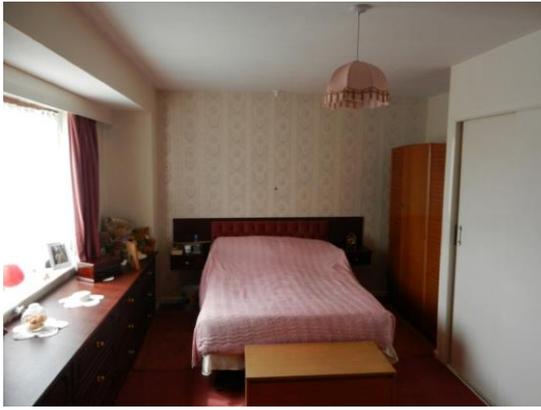
#### **Front Bedroom**

The bedroom is deemed to be in a generally fair condition without significant item of concern. We would anticipate it will require some refurbishment in the short term.

There is some unevenness to floors although this is not generally deemed to be of concern but we would anticipate that some repairs to floorboards will be required upon next removing floor coverings.

The electric fire within this room is of some significant age and we would recommend it is fully tested before use.

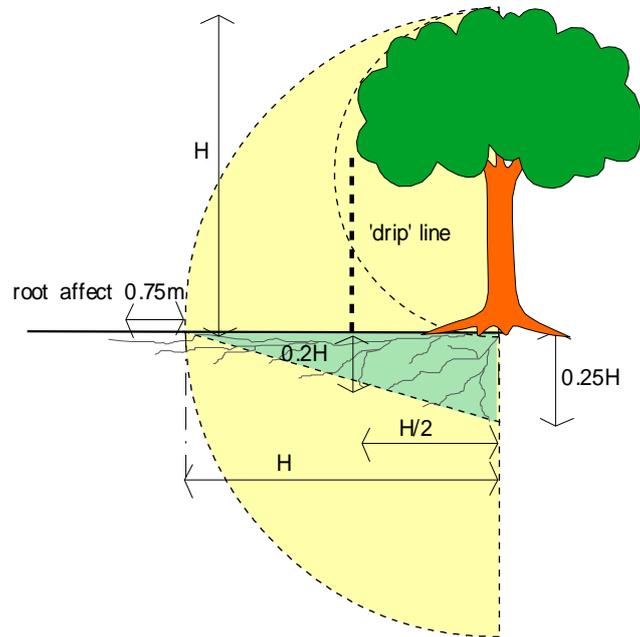
Typical proportions of an Apple tree. Note the potential root zone.

The trees grow at a rate of 250mm a year to reach heights of around 7 - 10mtrs<sup>1</sup>. They have medium root activity and water demand, and can be associated with subsidence when planted close to the building, or in groups.

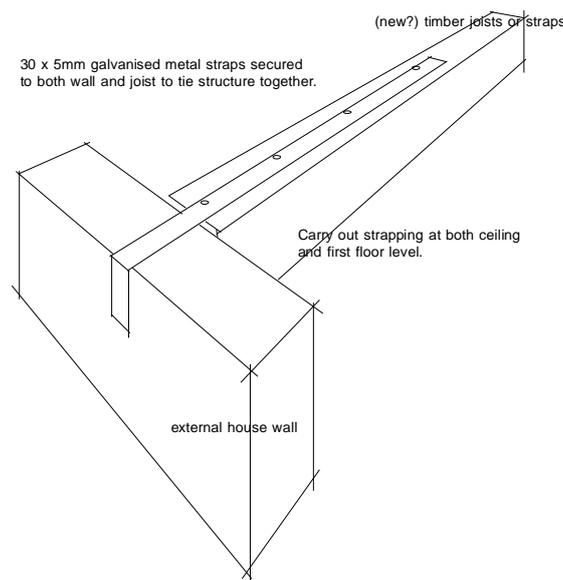
Typical restraint strap detail showing connection between two timbers (or timbers and masonry) using a 30 x 5mm stainless steel strap.

In addition, the wall should be tied to the strengthened structure by means of 30 x 5mm pre-drilled and galvanised metal straps at 1.2mtrs centres. These straps are usually screwed or somehow secured to the wall, and screwed to the side, top or bottom of the timbers at ceiling and first floor level.
