Structural Feasibility Report

Relating to: Removal of Column and Walls at
XXXX
XXXX
XXXX

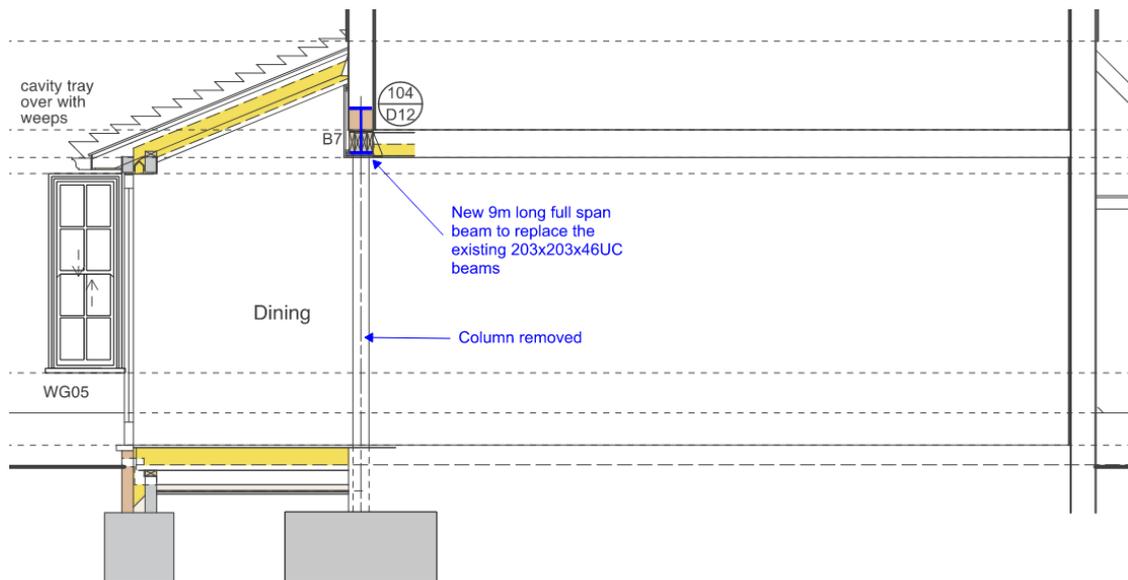
Option 1 Cross Section:

The existing 100x100x8 SHS columns at either end have sufficient capacity to support the new beam, however the foundations they sit on are likely to be insufficient, and therefore would need to be increased in size, either by underpinning, or by removal and replacement.

The disadvantage is that in order to install the new beam, the existing steel beam and column will need to be removed first. Therefore, significant temporary propping will be required to support the rear of the property during installation. In addition, the existing foundations will not be adequate to support the new beam, therefore the existing foundations labelled F1 will need to either be underpinned or broken out and replaced.

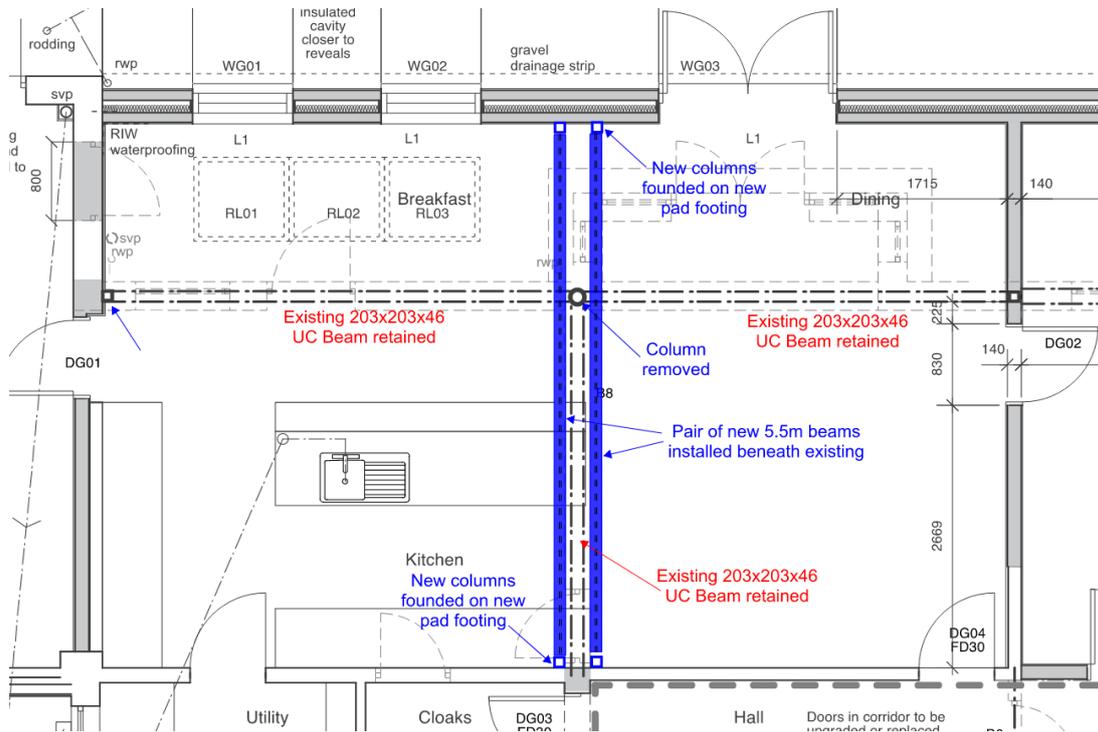
Option 2 Plan on Steelwork over Kitchen:

Preliminary sizing suggests that each new beam would need to be a 203x203x52UC and would be installed either side of the existing column prior to removal. Allowing for deflection and plasterboard casing, this would result in a downstand to the ceiling approximately 250mm deep by 600mm wide. Each new beam would weigh approximately 300kg, therefore potentially they could be installed as a single section without splicing, subject to construction logistics.

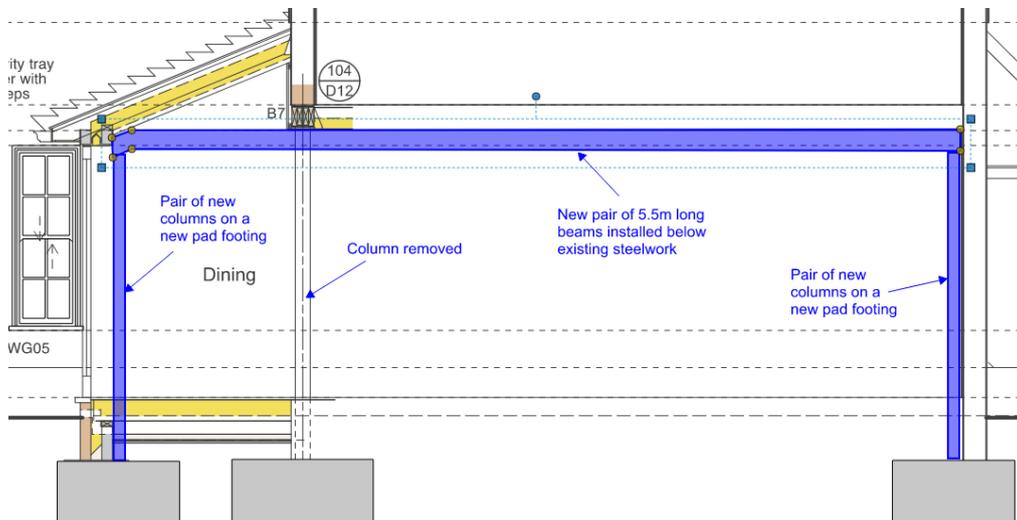
Option 2 Cross Section:

The new columns would be similar to the existing 100x100 SHS columns, and would most likely result in a boxed out pier to the wall approximately 150mm deep. In each location, the floor would need to be lifted and new mass concrete foundations in the order of 1.25x1.25m square cast beneath the existing strip footings to the adjacent walls.

The advantage of this solution is that the new steelwork can be installed prior to removal of the existing column, therefore temporary propping works can be minimised. The new steel sections are also lighter than the single beam in Option 1, therefore they will be easier to install. In addition, the new foundations will be more straight forward to construct as they are not in the location of the existing pad footings.
